11-30-039-21W4M
 Flare Knock Out
 A3066599 LM 3023
 REPORT # A#3066599_GRADY INSPECTION LTD VE VI UT INSP_6NOV2018

PRESSURE EQUIPMENT			
DISTRICT	SHELL TUBE		
FACILITY	MAWT	200	F
A#	A3066599	YR	1995
		MAWP	51
			psi
SERIAL #	LM 3023	PSV	
		psi	
CRN	M7022.2	PSV CRN	
EQUIP#		SERVICED	
STATUS	OUT OF SERVICE	UNIT	
MANUFACTURER	Natco Canada		
DH LSD	L	24 Ft	OD 6 Ft

External Inspection - (Vessel)

Internal Inspection - (Vessel
LSD 11-30-039-21W4M
Jur # A3066599
Serial # LM 3023

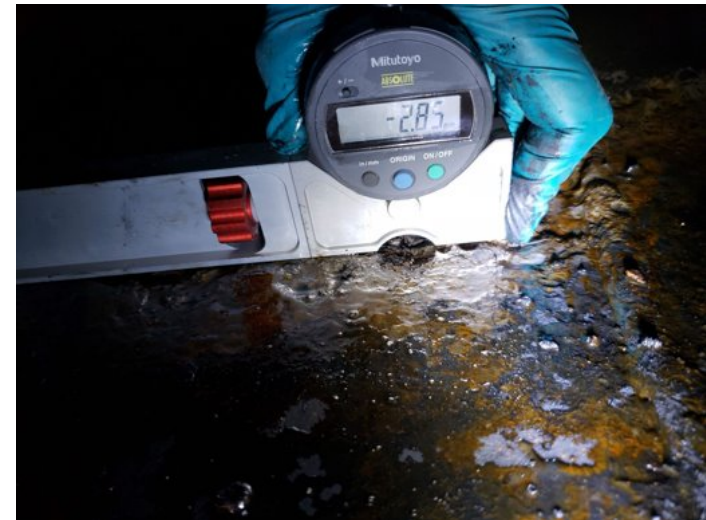
In addition a corrosion line has formed along the 6:00 position of the vessel. The corrosion is limited to the North and Center can sections. A maximum pit depth of 2.85 mm was found at the North end of the vessel. (Limited access due to the coil position).

Shell: 3	Fair	6:00 shell corrosion found on the vessel 16' long x 8" wide located on the North and Center can sections. A maximum pit depth of 2.85 mm was found at the North end of the vessel. Nominal shell thickness of 9.8 mm. 3:00 & 9:00 shell corrosion found on the vessel 24' long x 6" wide. Nominal shell thickness of 9.8 mm with general pitting corrosion at the fluid level mid shell ranging in depth from 0.1 mm - 2.55 mm. Corrosion liquid level is approximately 6" in width. The top half of the vessel is as new.
Tubesheet:	N/A

North Head to Shell 6:00 Pitting

Recommendations for Next Inspection: Option 1: Blast clean and coat vessel to mitigate corrosion found.
 Option 2: Use as is and plan for weld repairs at the next interval. The FKO is PWHT and will require a heat treat or temper bead weld repair once corrosion exceeds the corrosion allowance and is longer than 2" in length in an 8" area.

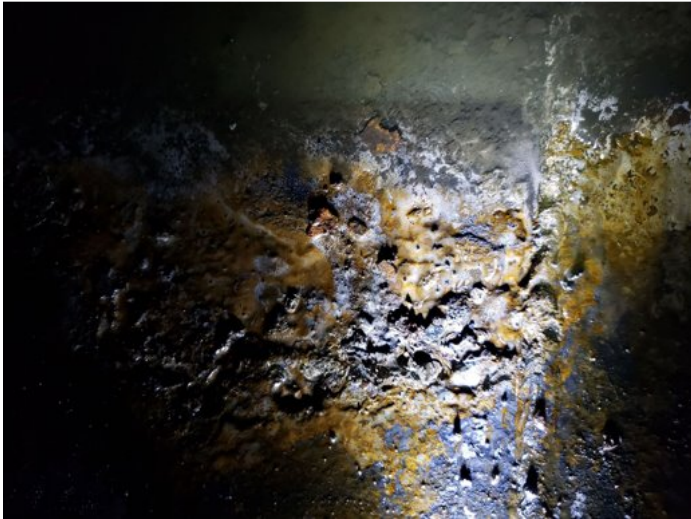
North Head to Shell 6:00 Pitting

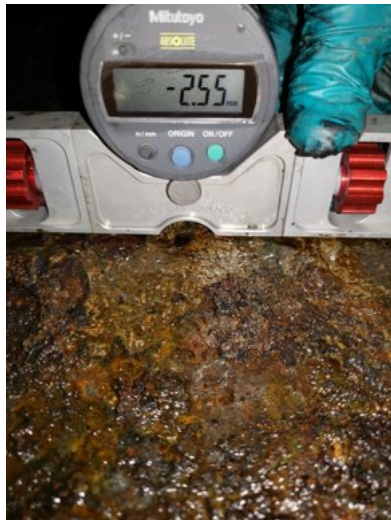
Due to the vessel being out of service for over a 5 year period and half full of fluid, a corrosion fluid line has developed at the 3:00 & 9:00 positions of the shell sections and both heads. Maximum pitting found along this area was 2.55 mm.

North Shell Section West Side 9:00 Pitting

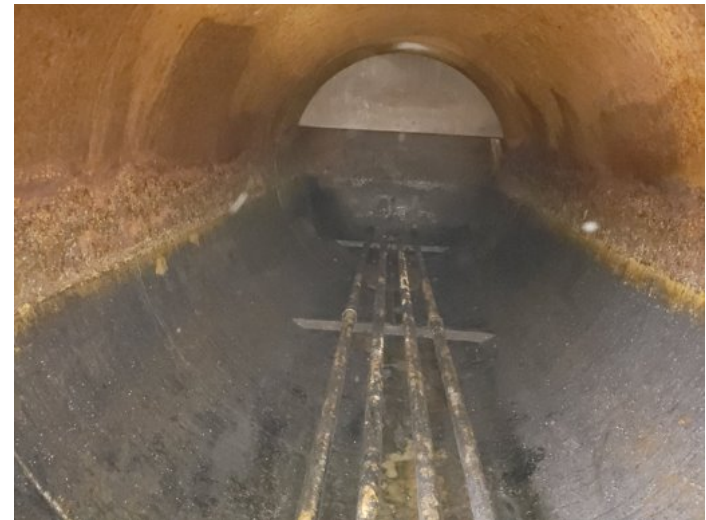
North End of Vessel Showing Fluid Corrosion Line 9:00 & 3:00

Addition of extra inspection ports vertically on the shell and head recommended to monitor existing corrosion lines.

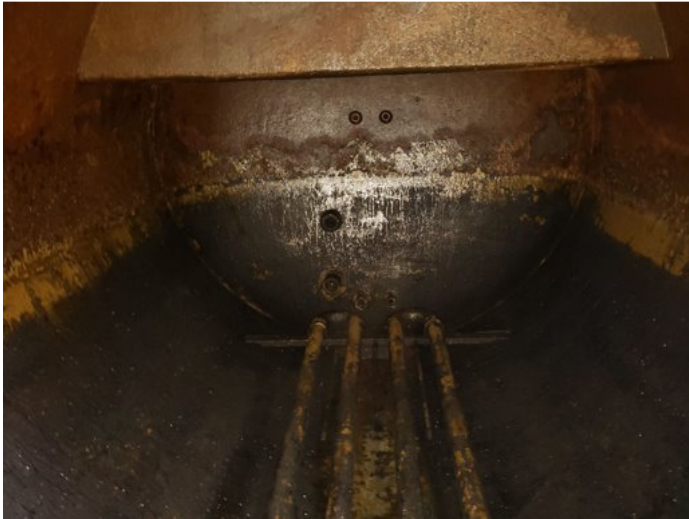
South End of Vessel Corrosion Line

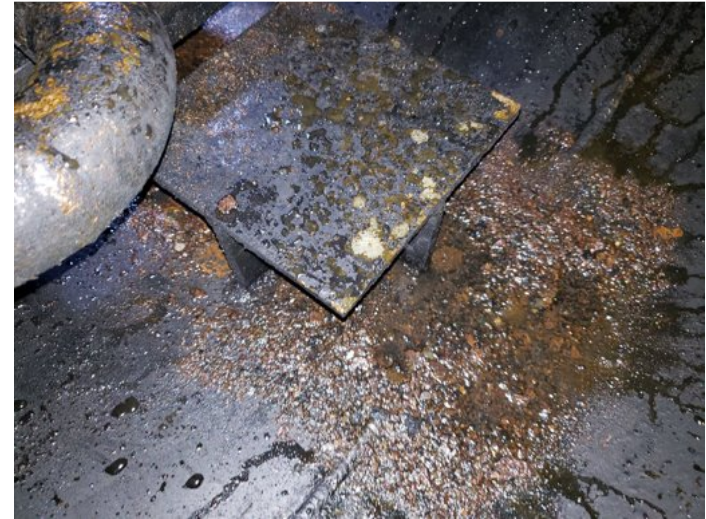
Vortex Breakers, Drains, etc: Good Vortex breaker was at the South End. Welded to the shell. No corrosion on the South End near the vortex breaker.

Vortex Breaker

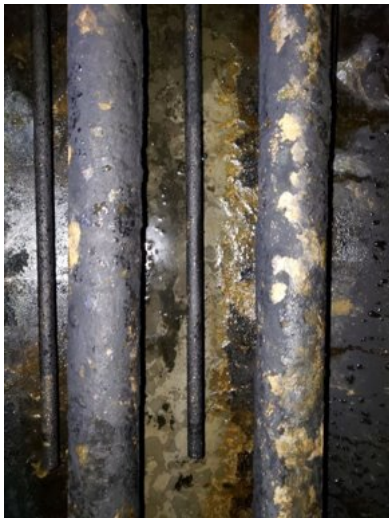
1 - 2" inches of water in the bottom of the vessel limited the access to measure the corrosion on the bottom shell.
 Limited access to the bottom 6:00 of the shell from the placement of the welded in place heater coil.
 Limited access to the shell corrosion due to cleanliness.

Corrosion Line Along 6:00 Below Coil

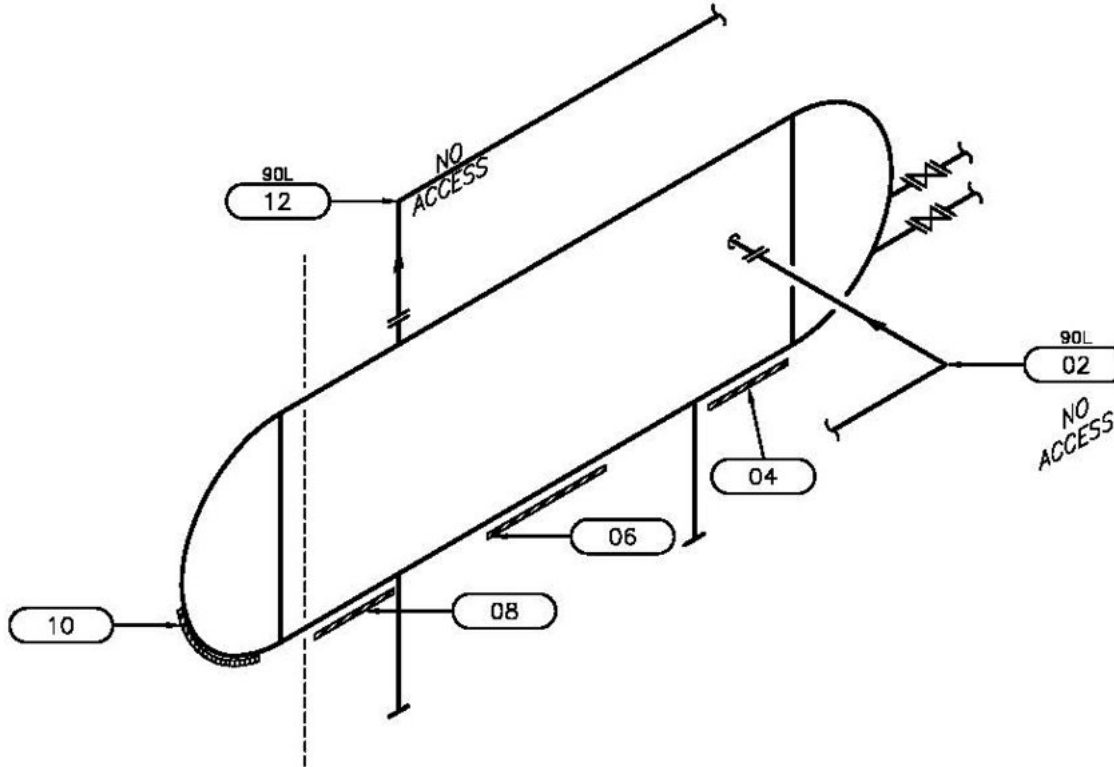
DWG 1

CML	Min	Yrs	Date
06	9.4	3.0	11/5/2021
10	9.1	3.0	11/5/2021
11 Int	7.0	3.0	11/5/2021
09 Int	7.1	3.0	11/5/2021
04	9.6	3.0	11/5/2021
08	9.9	3.0	11/5/2021
