**Canadian Natural Resources Limited
GENERAL PRESSURE VESSEL INFORMATION**

District: Fort St. John BC.	Skid No.
Facility: Bucking Horse Compressor Station	Location (LSD): d-44-A/94-G-10
Vessel Name Equipment Number: Glycol Contactor	
Orientation: Vertical	
Status: In Service	Regulatory Inspection

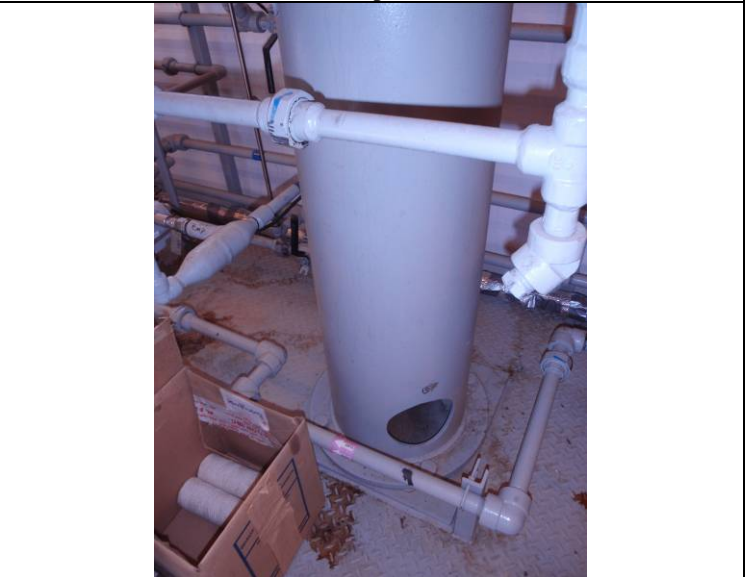
Bolted to skid floor
