**Canadian Natural Resources Limited  
GENERAL PRESSURE VESSEL INFORMATION**

**Job 10.113193**

District: <b>Grande Prairie AB.</b>	Skid No.
Facility: <b>Botha Gas Plant</b>	Location (LSD): <b>07-16-98-05 W6M</b>
Vessel Name Equipment Number: <b>Glycol Contactor</b>	
Orientation: <b>Vertical</b>	
Status: <b>In Service</b>	<b>Regulatory Inspection</b>

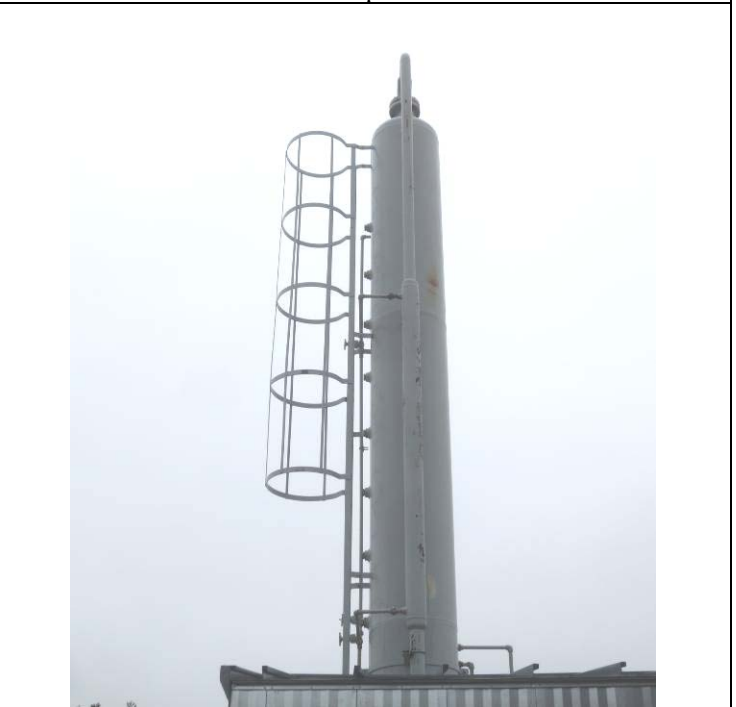
Vessel overview – outside.

<b>Summary:</b> This vessel is in good condition, visual external and ultrasonic thickness inspection carried out – no metal thickness detected below nominal minus corrosion allowance.					
<b>Corrosion rate based on greatest thickness loss (head) 0.026mm per year. Retirement Date to “T”min is year 2230.</b>					
<b>Vessel is fit for service.</b>

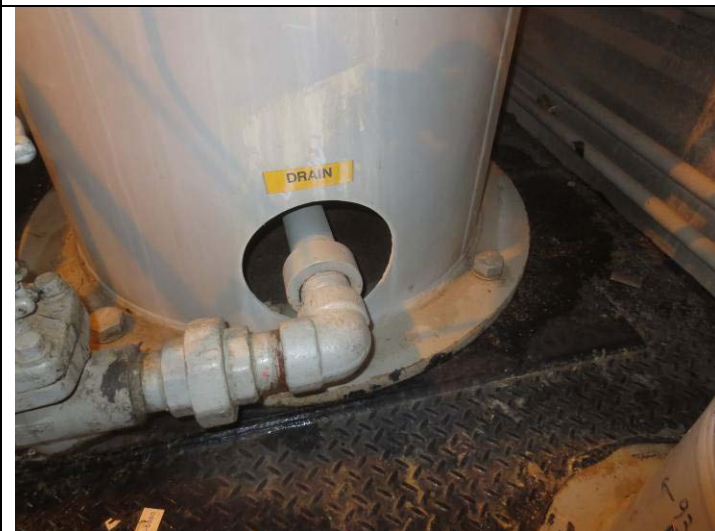
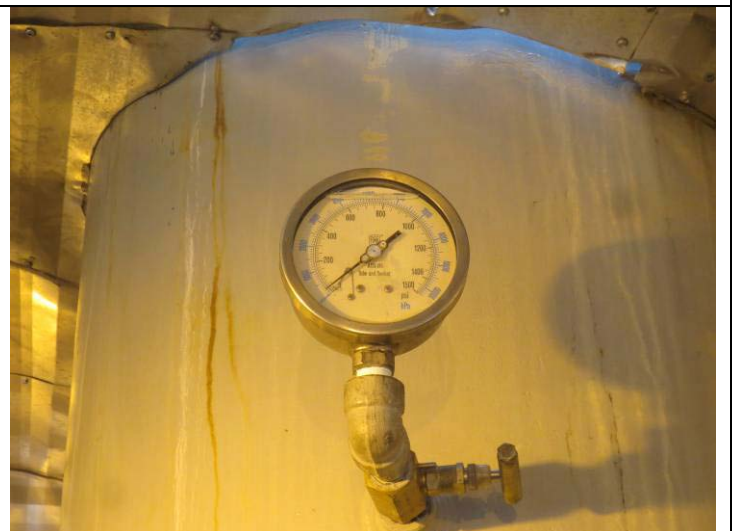
<b>Anchor Bolts</b> Hammer tap to ensure secure. Look for cracking in treads or signs of deformation.	X				<b>Present and tightly secured.</b>
<b>Concrete foundation</b> Check for cracks, spalling, etc.				X	<b>Skid is in good condition</b>
<b>Ladder / Platform</b> Describe general condition, ensure support is secure to vessel, and describe any hazards.				X	<b>None</b>
<b>Nozzle</b> Assess paint, look for leakage, and ensure stud threads are fully engaged. Record any damage, deflection, etc. Are nozzles gusseted?	X				<b>Flanged and threaded nozzle joints are fully engaged. No damage or deflections – no leaks. Nozzles are not gusseted.</b>
<b>Gauges</b> Ensure gauges are visible, working, no leakage, and suitable for range of MAWP/ Temp.	X				<b>Clear and clean – no leakage. Pressure 0-1500psi</b>
<b>External Piping</b> Ensure pipe is well supported. All clamps, supports, shoes, etc. in place. Look for evidence of structural overload, deflection, etc. Paint condition, external corrosion?	X				<b>Piping is well supported; no deflection, all clamps and supports are in place. Piping paint is in overall good condition with no external corrosion.</b>

Skirt is well supporting, anchor bolts are tight.

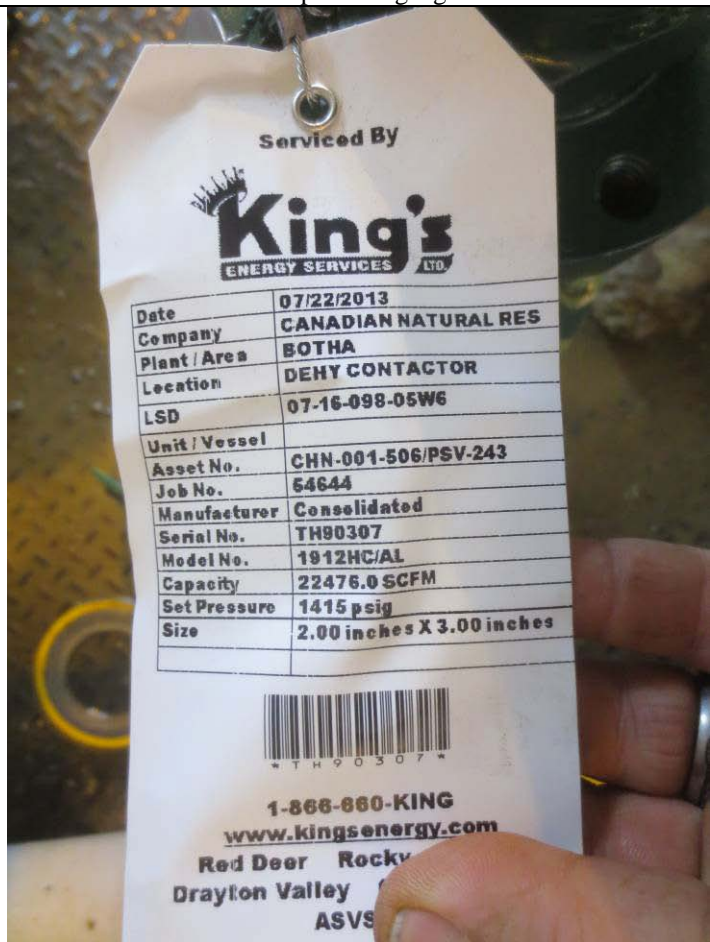
PSV location.

<b>Valving</b> Ensure no leaks are visible. Valves are properly supported and chained if necessary.	X				<b>Valves are supported properly – no leaks.</b>
<b>PSV</b> Ensure PSV is set at pressure at or below that of vessel.	X				<b>Location: Shell - Set below MAWP of vessel. Block valve between vessel and PSV. Valve locked open. Discharge piping is same size as valve outlet. Seal in place.</b>
<b>NDE methods</b> Was UT/ MPI done on vessel (MI coordinator to review results)	X				<b>Ultrasonic corrosion survey to be carried out, no metal thickness detected below nominal minus corrosion allowance.</b>
<b>Other:</b>					
<b>Recommendations or corrective actions: (Vessel is Fit for Service or describe corrective actions required)</b> (MIC to review corrective actions with Operations, discuss with Chief Inspector where necessary, and get remedial action implemented)					
<b>Recommendations:</b> No recommendations.
