**Canadian Natural Resources Limited
GENERAL PRESSURE VESSEL INFORMATION**

05.002795

District: Fort St. John BC.				Skid No.		
Facility: Bucking Horse Compressor Station				Location (LSD): d-44-A/94-G-10		
Vessel Name Equipment Number: Flare Knock out Drum						
Orientation: Horizontal						
Status: In Service				Regulatory Inspection		
PRESSURE VESSEL NAMEPLATE DATA						
“A” or “G” or “S” (Sask.) or BC Registration Number. A 501923				CRN Number: R-2525.213		
Vessel serial number: 13052				Size: 8 ft. x 10 ft.		
Shell thickness: 9.5mm				Shell material: SA 516 70N		
Head thickness: 8.0mm				Head material: SA 516 70N		
Tube wall thickness:				Tube material:		
Tube diameter:				Tube length:		
Channel thickness:				Channel material:		
Design pressure	Shell: 50 PSI			Operating pressure	Shell:	
	Tubes:				Tubes:	
Design Temp.	Shell: 200 Deg F			Operating temperature	Shell:	
	Tubes:				Tubes:	
X-ray: Nil				Heat treatment: Nil		
Code parameters: ASME VIII, Div 1				Coated: Not stated		
Manufacturer: Bilton				Year built: 2003

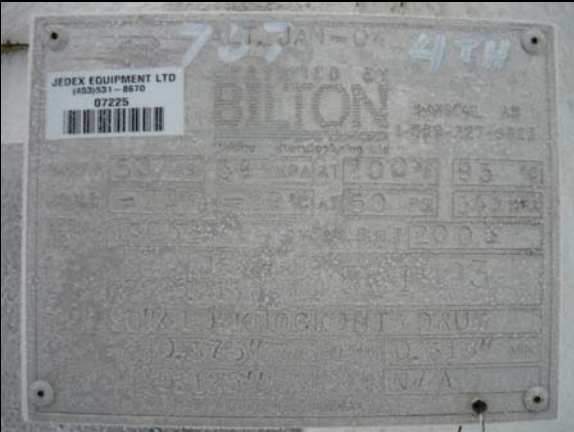
vessel data plate

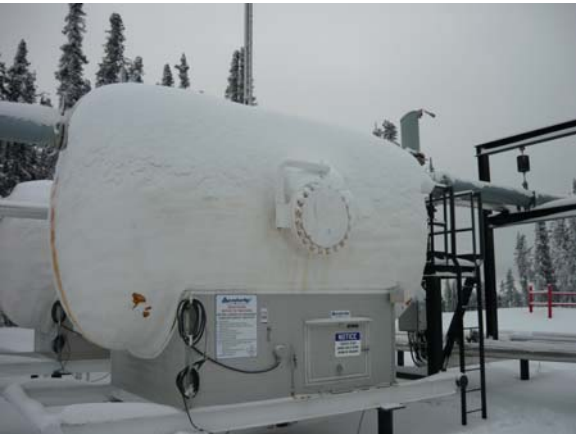
vessel overview
