Canadian Natural Resources Limited
GENERAL PRESSURE VESSEL INFORMATION **Job # 10.111579**

District: Fort St. John BC.	Skid No.
Facility: Jedney Field	Location (LSD): d-B1-L/94-G-8
Vessel Name Equipment Number: Flare Knock Out Drum	
Orientation: Horizontal	
Status: In Service	Regulatory Inspection

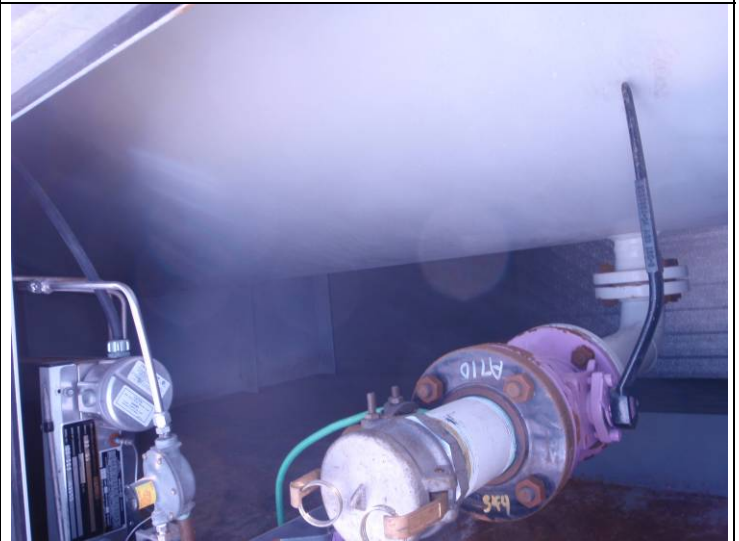
No underside corrosion - Truck-out piping is in good condition.

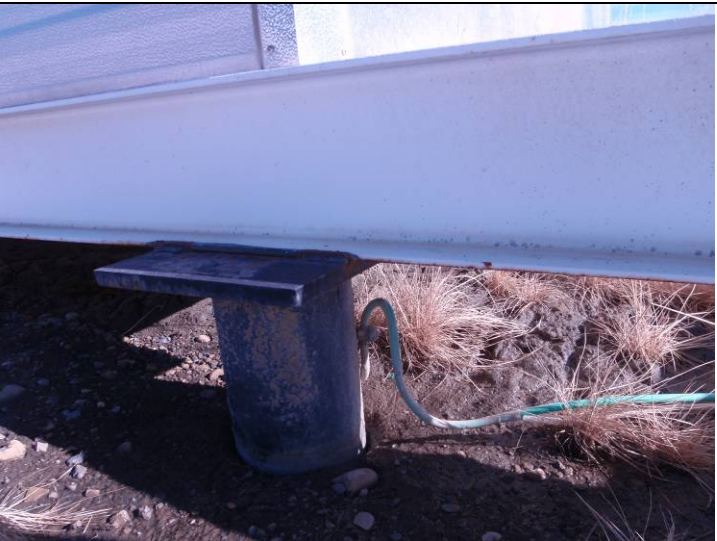
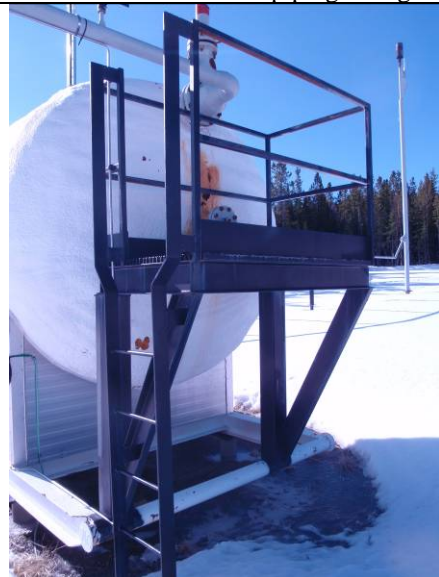
Vessel is welded to the pilings / Ground wire attached

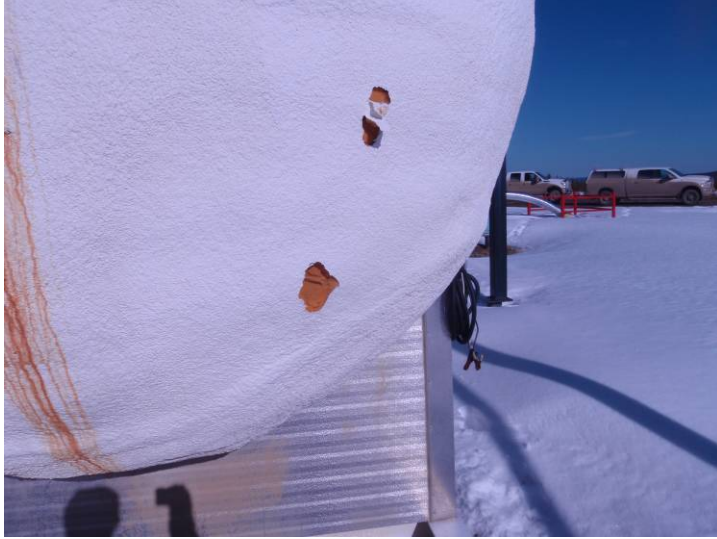
External Inspection Items	G	F	P	N/A	Comments
Insulation Verify sealed around manways, nozzles, no damage present, and there is no egress of moisture.	X				Insulation is in good condition. Two isolated areas of damage on each head. No exposed metal.
External Condition Assess paint condition, areas peeling, record any corrosion, damage, etc (record location, size and depth of corrosion or damage)	X				(Underside) Paint in good condition- no exposed metal. No external Corrosion
Leakage Record any leakage at flanges, threaded joints, weep holes on repads, etc.	X				No leaks observed.
Saddle/Skirt Assess condition of paint, fire protection, concrete. Look for corrosion, buckling, dents, etc. Look at vessel surface area near supports. Verify no signs of leakage at attachment to vessel and attachment welds are acceptable. Ground wire attached?	X				Saddle: bolted directly to skid frame. No buckling or dents. No corrosion at attachment welds to vessel. Ground wire attached to skid.

damage to insulation – outlet

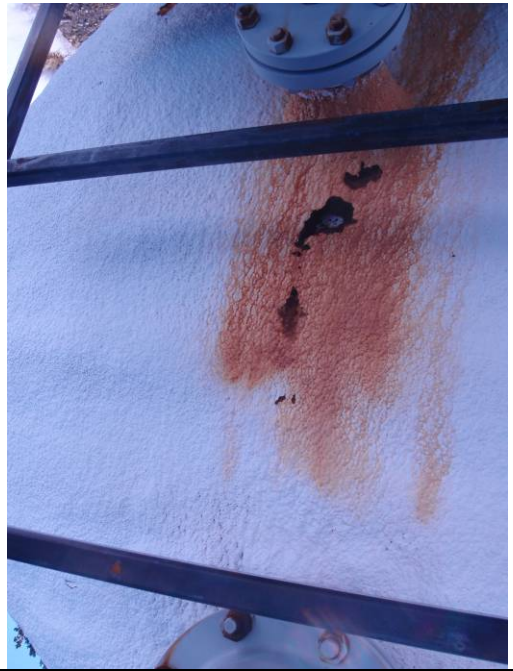
damage to insulation - inlet
