Report #:	1377	98-BV-12	IRISI	NDT Job #:	-	137798	Date:	APRIL 07, 2009	Page	1	of	1	
Client:	CNRL		-	PO/Job #:	1020	0011.5430.1	15-G816	Contact:	KEIT	H MCIN	TOSH		
Job location:	ETZIKOM COMPRESSOR STATION, MEDICINE HAT WEST, A						В	Tel:	780-9	91-764	4		
	LSD: 0	8-24-006-10	W4M					Fax:					
Procedure(s):	UT TH	ICKNESS											
Code(s):	Code(s): ASME SECT VIII

Item Inspected:	Inlet se	eparator A04	196494				Material:	Carbon St	teel				
Method:	Method: Contact IImmersion Other:						Surface Temp (C): $\square < 5^{\circ} \square > 5^{\circ} / < 60^{\circ} \square > 60^{\circ}$						
Type:	□ P/E	□ T/T □ I	Jual 🗌 I	Automated	TOFI	5	Scanning Su	rface: 🛛 🖓 🤇	DD 🛛 I	D 🗌 (Other:		
Application: 🛛 Laminar 🗋 Shear Wave 🗋 Volumetric 🖾 Thickness Surface Condition: Good													
Instrumentation	1: Manu	facturer: Ki	rautkran	mer	Type:	DMS-2		Instrument	Ser. #:	31530			
Calibration:	Date:	Feb 03, 200)9	Reference F	law Size:			IRISNDT #: 31530					
Calibration Blo	ck(s):	Type: Step	Wedge	- I IRISM	NDT #:	125214	Type:		-	IRISNE)T #:		
		Type:		IRISN	NDT #:		Type:			IRISNE)T #:		
Couplant: Bra	and: Ec	hogel	Type:	971		Cable:	Type:	Coaxial		Lei	ngth:	36''	
		PROBE				S	ETTINGS - dB	3	RAM	NGE -

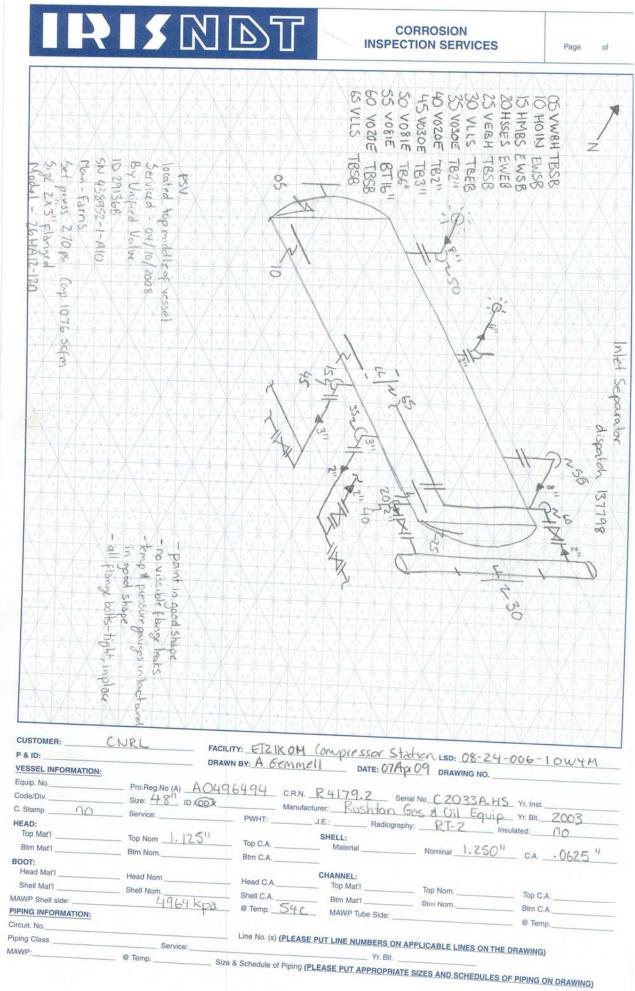
A0496494 UT Readings Readings in inches

Krautkramer	Dual	01F988	0	8.0 MHz	0.250	55dB	+6 dB						
		ļ	<u> </u>		 							 	
			<u> </u>		<u> </u>							L	
INSPECTION DETAILS													
Scope: Carry out UT examination of Inlet separator A0496494. Check for corrosion of the shell, heads and elbows to verify the integrity for service and identify any areas of concern. Examination revealed the following:													
Results: UT examination was carried out; all readings taken were 10"band scans with 3 readings per band/location.													
Mini	Minimum, maximum and average scans were taken in each location and recorded.												
All r	All readings were found to be above nominal on the shell, heads and elbows.												
No areas of concern were found at time of inspection.													
Recommendations: Carry out visual external inspection at the next opportunity and also continue to carry out UT Corrosion survey at the required frequency. See attached drawing, pictures and UTM file for locations and thicknesses recorded.

Final Comment:													
Inlet separator A0496494 was found to be in good shape. Assistant: ADELE GEMMELL Te						Techniciar	n: BLAIR V	VERGE					
ASSISTANT ADELE GENINELL CGSB SNT UT Level: I II III No.#:						\boxtimes CGSB \square SNT UT Level: \boxtimes I \square II \square III No.#: 5586							
Unit: 393 Km: Travel Time:						Signature:							
Start: Stop: Work hrs:													
OT Meal Subsistence required Total hrs: Client Name:													
Consumables:						Signat
