VISUAL INSPECTION REPORT – Pressure Vessel

<input type="checkbox"/> Installation <input type="checkbox"/> External <input checked="" type="checkbox"/> Internal					
Date:	Nov 05, 2014	Description:	<input checked="" type="checkbox"/> Vessel <input type="checkbox"/> Exchanger <input type="checkbox"/> Furnace <input type="checkbox"/> Boiler		
Inspector:	Ed Tymensen	Unit #:	n/a	Equip #:	PV-610
Agent Co:	Streamline Inspection	Equip. Name:	Treater		
Owner:	CNRL	Jurisdiction #:	A0403457	CRN #:	L-0015.2
Region:	Slave Lake	Manufacturer:	RCI Resource Constructors (Canada) Inc		
Area:	Brintnell	Year Built:	1998	S/N:	97015-2-30
Facility:	12-09 Battery	Location/LSD:	12-09-081-22w4m

Notes: VESSEL ALTERATION - Completed Nov 26 to Nov 30.

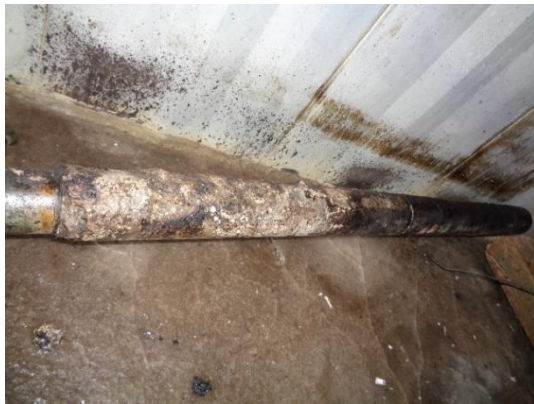
ANODE APPROX 20% CONSUMED

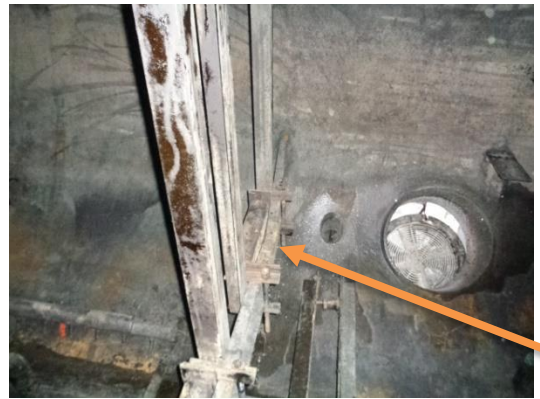
DEFORMATION NOTED ON FIRETUBE BACK SUPPORT BEAM

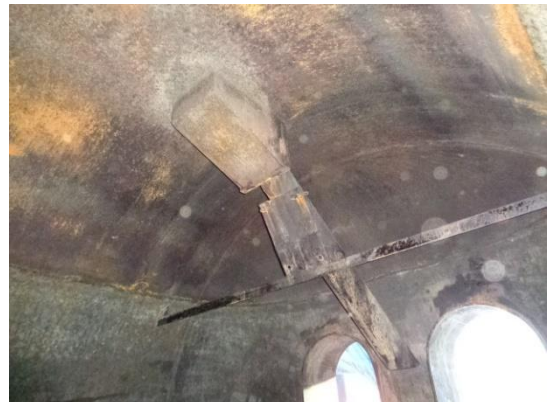
INLET DEFECTOR - WAS REMOVED FOR ADDITION OF INLET HORSESHOE DOWNCOMER

<input checked="" type="checkbox"/> Impingement plate	<input checked="" type="checkbox"/> Secure <input checked="" type="checkbox"/> Good Condition	Comment inlet deflector - to be replaced by inlet horseshoe downcomer
	<input checked="" type="checkbox"/> Suction tube	<input checked="" type="checkbox"/> Secure <input checked="" type="checkbox"/> Good Condition	Comment
	<input checked="" type="checkbox"/> Demister	<input checked="" type="checkbox"/> Secure <input checked="" type="checkbox"/> Good Condition	Comment No signs of fouling
	<input checked="" type="checkbox"/> Other:	<input checked="" type="checkbox"/> Secure <input checked="" type="checkbox"/> Good Condition	Comment water jet desand lines, drain lines, firetube supports, baffle plates, weir plate, desand 'V' trough at 6:00 position
Inspection Summary	A visual internal inspection was conducted on Treater after it had been adequately cleaned. Internal access to the Hot End was through firetube nozzles. Internal access to Cold End was through side shell manway. Vessel is NOT coated.

This vessel is Fit for Service: <input checked="" type="checkbox"/> Yes <input type="checkbox"/> No				
Insp. Summary	<p>After the visual internal inspection was completed vessel alterations were done:</p> <ul style="list-style-type: none"> - removal of inlet deflector - welding an inlet horseshoe downcomer onto shell / installing associated components <p>- see page 3 for details of alteration.</p>				
Recommended Actions:					NCR/IDR

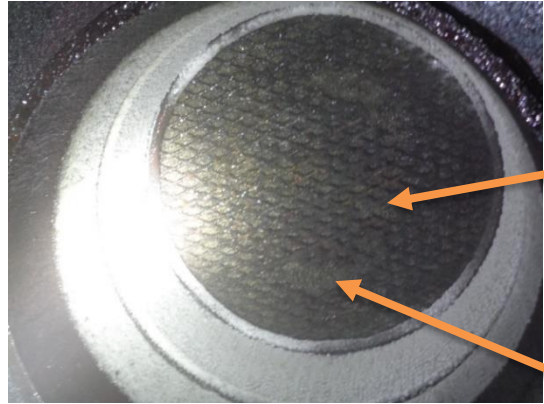
DEMISTER - GRATING IS STARTING TO CORRODE AWAY

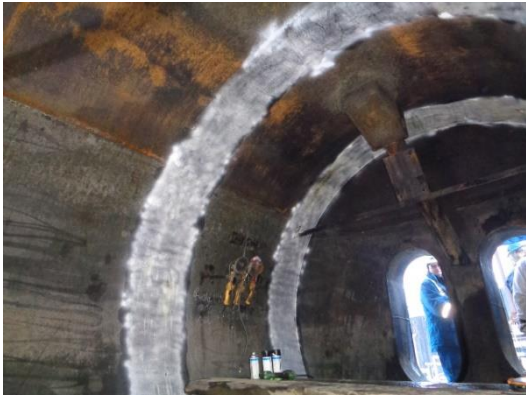
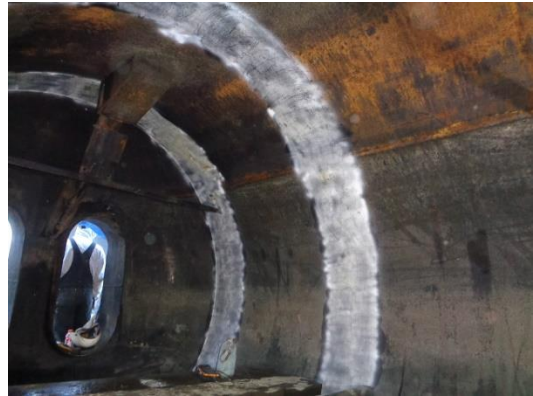
NOVEMBER 26
 - 2 x 2" wide bands where new inlet horseshoe downcomer is to be welded to shell were MPI'd and UT inspected. No indications were noted with either method.
 - Existing inlet deflector box and firetube overhead desand line support beam were cut off but not ground flush to shell (therefore no MPI was required at these locations)

2 x 12" WIDE BANDS WERE MPI AND UT INSPECTED WHERE NEW INLET HORSESHOE DOWNCOMER WAS TO BE WELDED ON SHELL

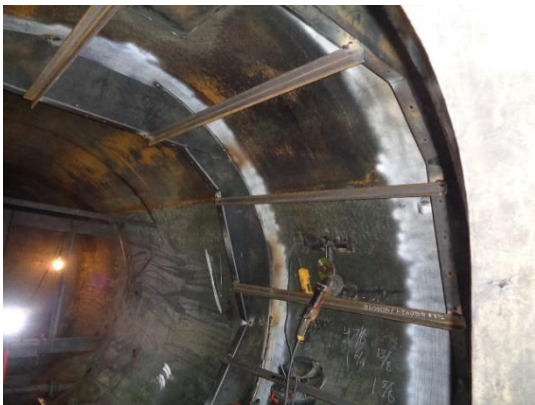
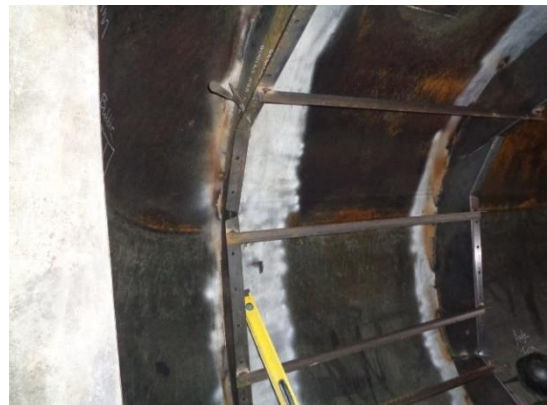
DOWNCOMER TACKED INTO PLACE

NOVEMBER 27
 - Inlet horseshoe downcomer components were fit and tacked into place

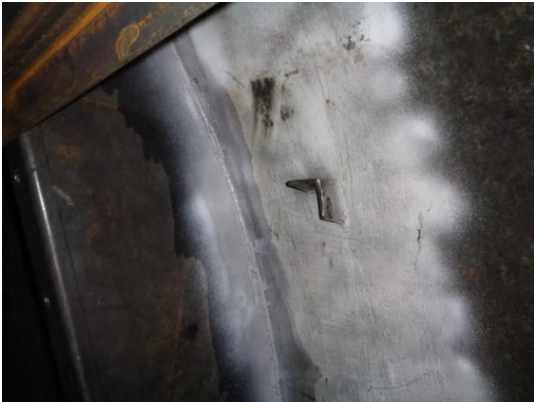
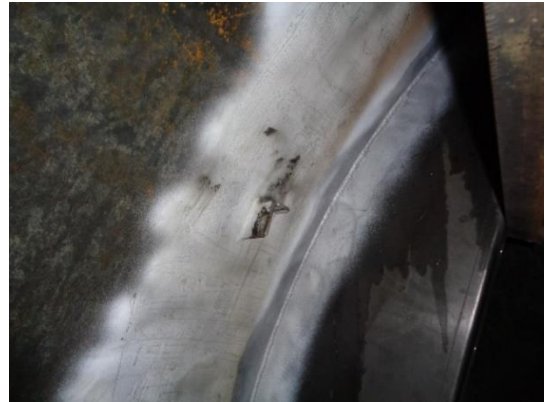
FIRETUBE OVERHEAD DESAND LINE SUPPORT BEAM CUT OFF BUT NOT GROUND FLUSH TO SHELL

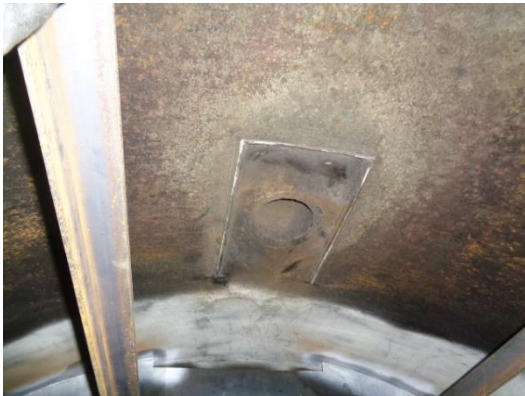
OLD INLET DEFLECTOR CUT OFF BUT NOT GROUND FLUSH TO SHELL

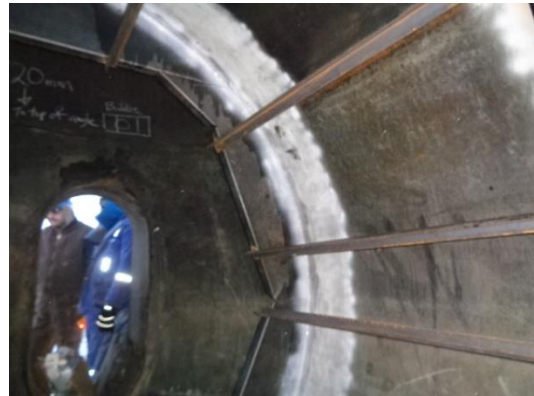
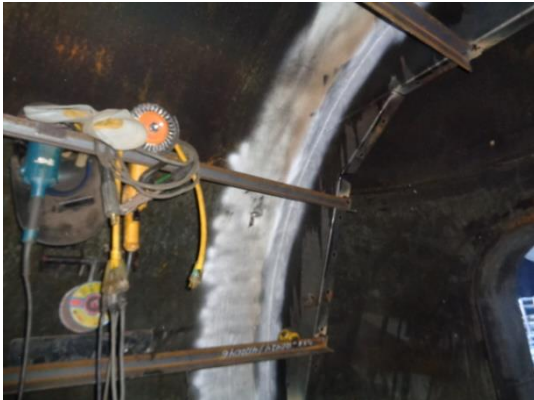
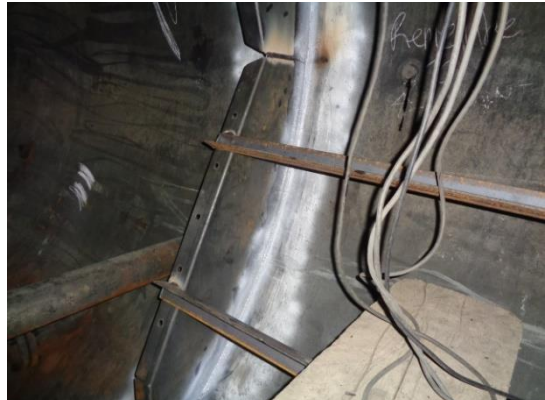
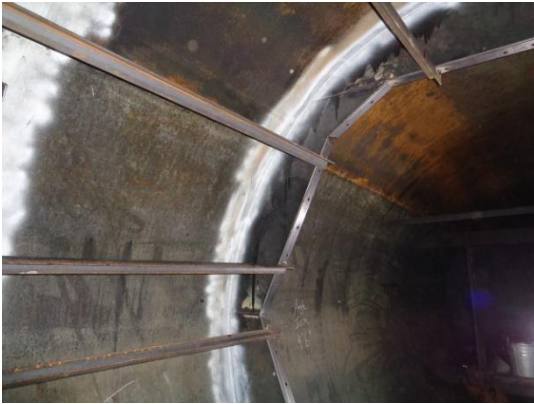
NOVEMBER 29
 - Inlet horseshoe downcomer was welded into place following CNRL Procedure #TC-OVR-PRO-INT-000010.
 - Attachment fillet welds completed Nov 28 were MPI'd 12 hours after welding was completed. No indications were noted.
 - Inlet horseshoe downcomer panels and associated components were bolted into place

NOVEMBER 30
 - Attachment fillet welds completed Nov 29 were MPI'd 12 hours after welding was completed. No indications were noted.
 - Spare set of firetubes were installed

MPI ON FINAL DOWNCOMER TO SHELL FILLET WELD (POST 12HRS)

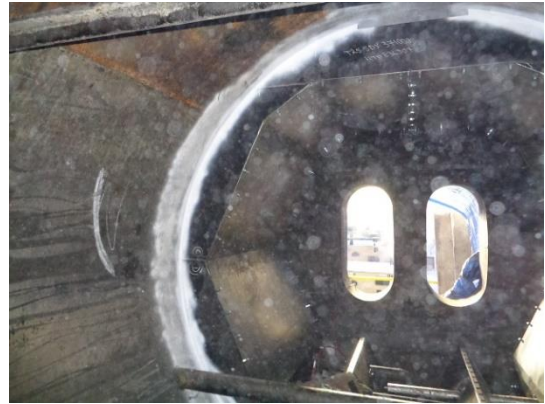
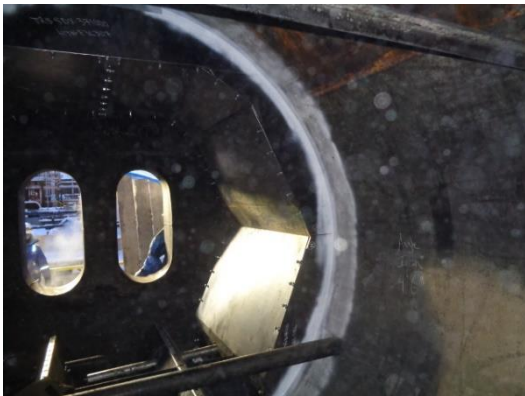
MPI ON FINAL DOWNCOMER TO SHELL FILLET WELD (POST 12HRS) - HORSESHOE PANELS BOLTED IN
