# VESSEL INSPECTION SUMMARY

Report #: **141156-PM-59**  
Inspect Date: 03/31/2010  
Page: 1 of 5  
IRISNDT #: 141156

Client: CNRL District: St. Albert Field: East Michichi  
Facility: 04-08-031-18W4M Unit / Skid #: LSD: 04-08-031-18W4M  
Jurisdiction #: A0227279 Equip Tag #: Serial #: 27935A  
CRN #: C4936.2134 Nat'l Bd #: Year Built: 1986  
Manufacturer: WESTERN VALVE Equipment Description: NGL BULLET  
Status: In Service - Date Removed From Service: Service: Sweet  
MAWP Shell: 1724 kPa @ 66 °C Height/Length: 656 in. Code Stamp: ☒ Y ☐ N  
MAWP Tube: 1200 @ 150 °F Size/Diameter.: 108 in. I.D. Insulated: ☐ Y ☒ N  
MDMT: RT: RT-2 Volume: PWHT: ☐ Y ☒ N  
Support Type: Saddle Manway: ☐ Y ☒ N  
C.A.: 1.6000 mm Coated: ☐ Y ☐ N Clad: ☐ Y ☐ N J.E.: Remote Access: ☐ -

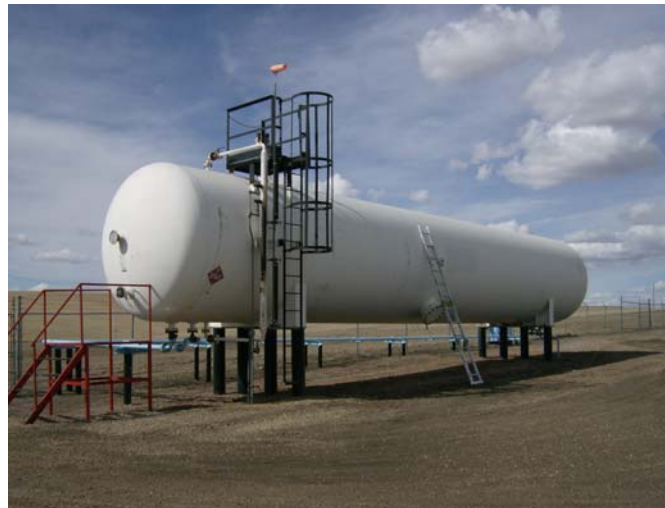
Figure 2 overview
