**Canadian Natural Resources Limited
GENERAL PRESSURE VESSEL INFORMATION**

Job 10.115180

District: Grande Prairie, AB	Skid No.
Facility: Wapiti Compressor	Location (LSD): 07-01-69-09 W6M
Vessel Name Equipment Number: Inlet Separator	
Orientation: Horizontal	
Status: In Service	Regulatory Inspection

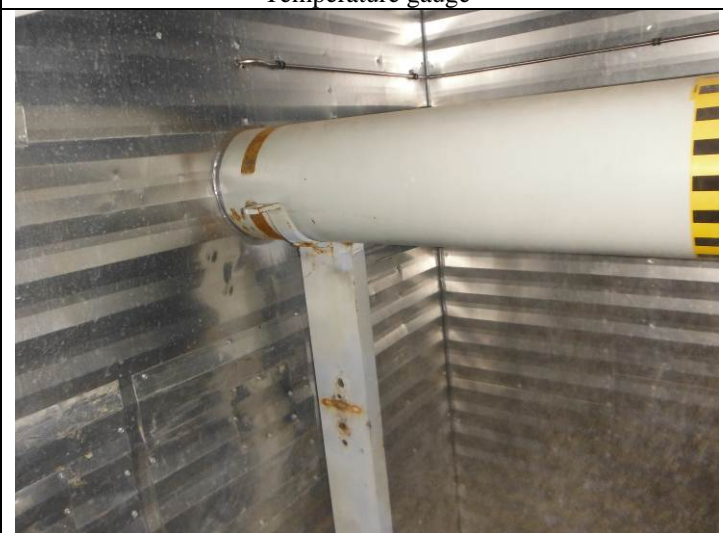
Missing pipe clamp

Recommendations or corrective actions : Vessel is Fit for Service or describe corrective actions required)
(MIC to review corrective actions with Operations, discuss with Chief Inspector where necessary, and get remedial action implemented)
Recommendations: 1. Service PSV – last serviced in 2006. 2 Replace missing pipe clamp.
Summary: Vessel is in overall good condition, visual external inspection and ultrasonic corrosion survey performed – pipe metal thickness detected below nominal minus corrosion allowance. Thickness calculations carried out to ensure sufficient metal exists for safe operation.
Corrosion rate based on greatest thickness loss – no corrosion rate to assess.
Vessel is fit for service.

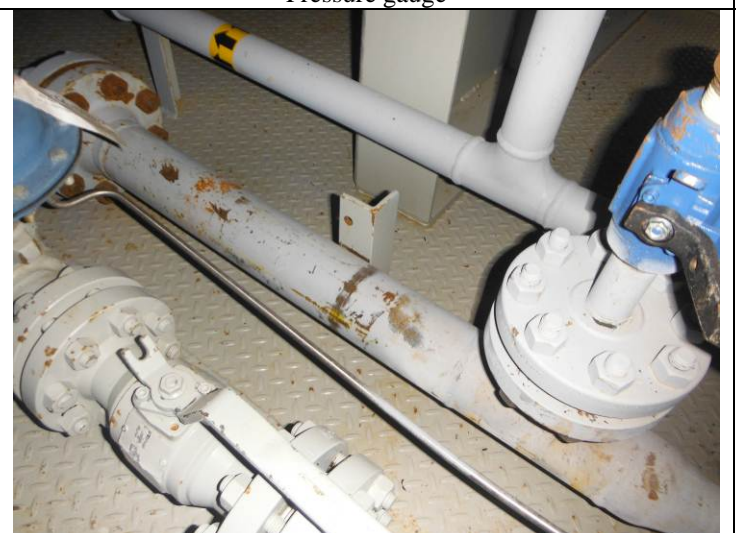
Missing pipe clamp
