NDE REPORT # 20130623a

Job location: Milligan Battery
 Procedure(s): MT Rev. #:
 Code / Standard: ASME VIII Div. 1
 Client Specification:

Part (s) Examined: 3 and 4 inch nozzles weld repair – A0225408 Free Water Knockout
 Calibration Standard: CP-103 Material: Carbon Steel Thickness:
 Surface Condition: Weldment Ground Machined Sandblasted Painted Other:
 Method: MT PT VT Other: Surface Temp (°C): < 5 > 5 < 60 > 60

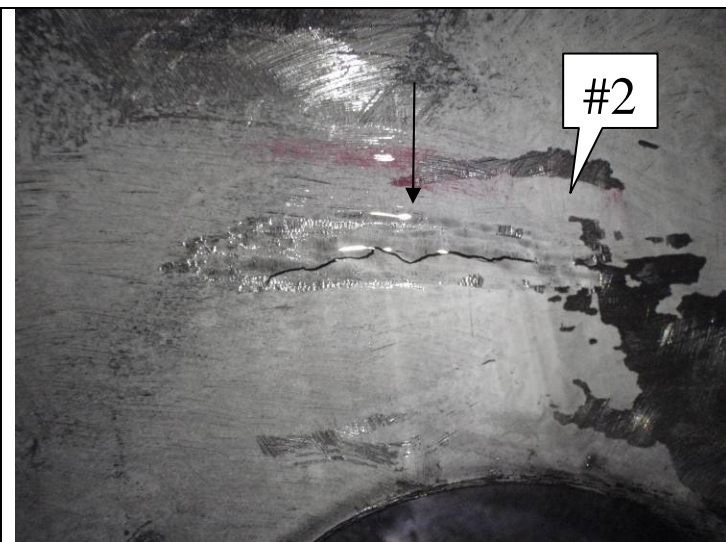
Results: MPI reveled one 2 inch crack on repaired nozzle #2 – metal was excavated down 0.400 inch into shell to remove defect – metal loss was re-filled and MPI performed again – No further cracking detected

Crack found on 4 inch nozzle after 0.150 inch excavation

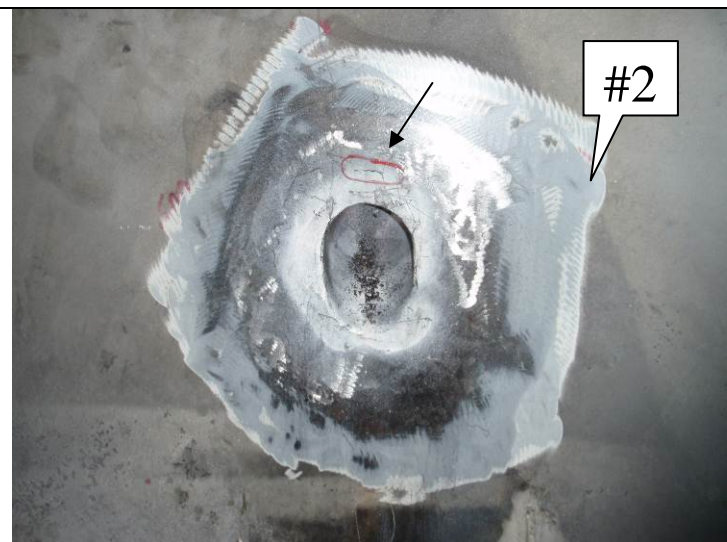
4 inch nozzle – indication detected

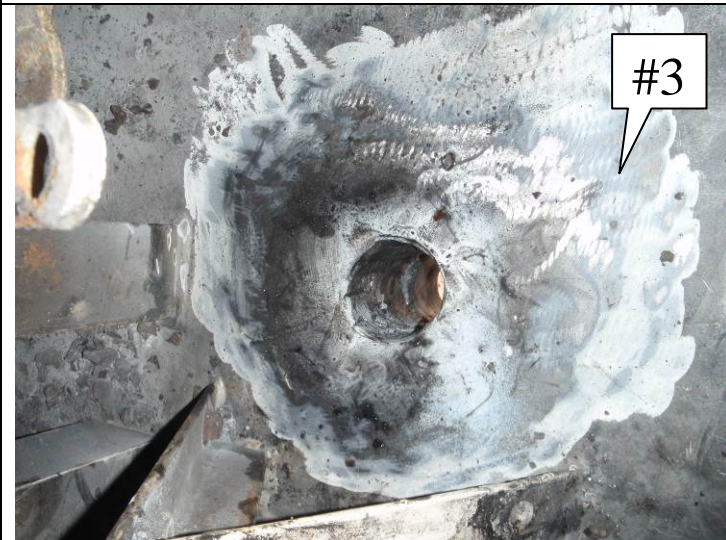
3 inch nozzle on shell 6 o'clock – no indications

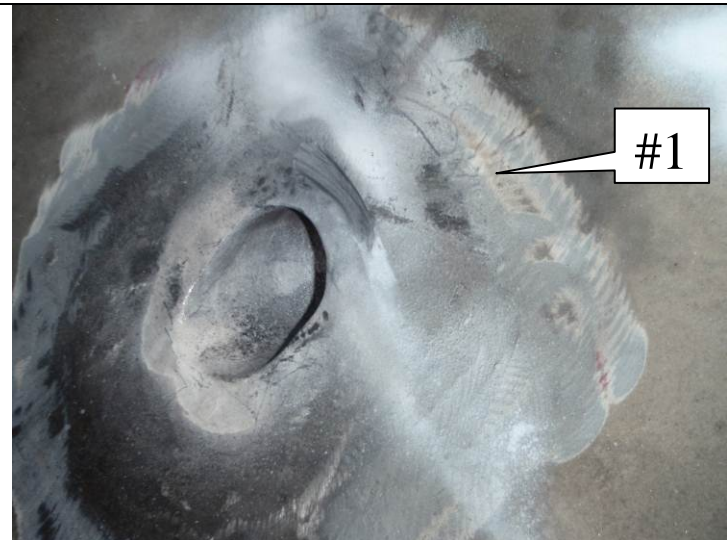
4 inch nozzle – no indications

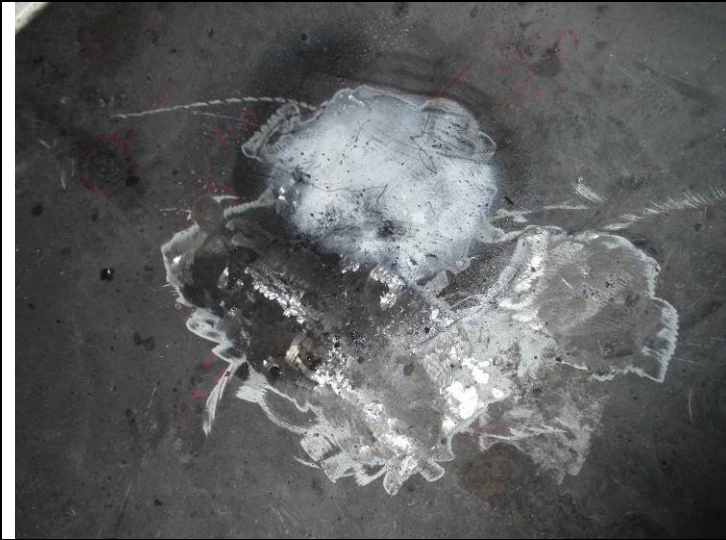
Shell fill welded and ground flush – no indications
