RAE Inspection Service (1979) Ltd.

FOLLOW UP REPORT

Equipment: FREE WATER KNOCKOUT

Field Inspection Report

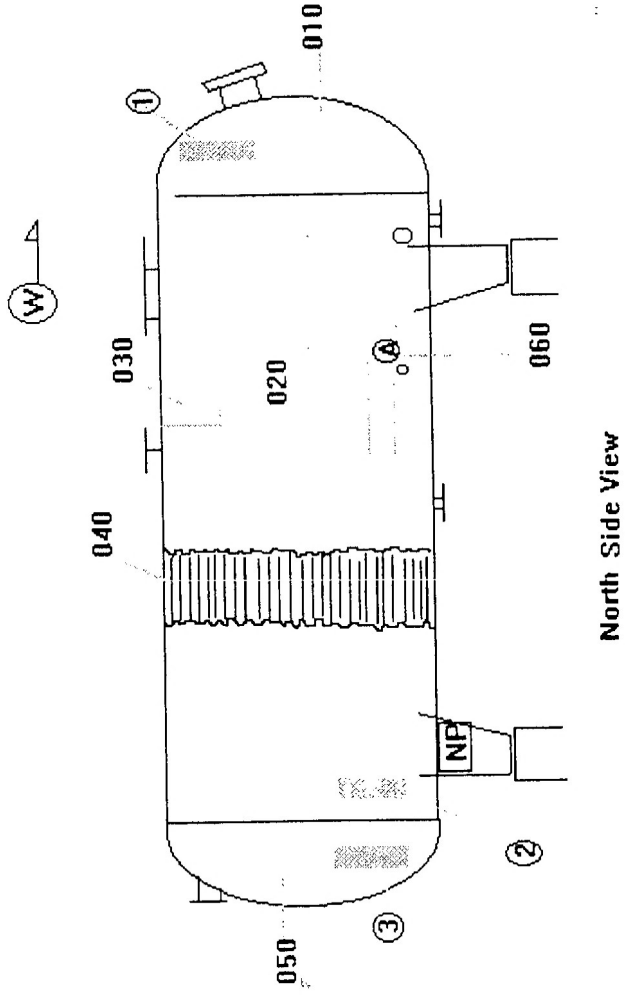
VESSEL SKETCH:

AREA	COMMENTS
010	Coating in excellent condition. Manway in good condition.
020	Shell coating in excellent condition. Attachment welds, nozzles, piping and brackets are in good condition.
030	Top shell box externally in good condition. Internal not inspected at this time.
040	Filter/screen is a plastic type material, clean, solid, mounted in place and in good condition.
050	No internal access to inspect the east head and shell east of filter/screen.
060	Anode was about 90% consumed and replaced during shutdown.
External	Vessel painted and in good condition. Nozzles, flanges, instrumentation and gauges are in good condition.

No access internally to the east end of the vessel.

- Next inspection in the year 2001.
