**FIRE-TUBE INSPECTION REPORT**

**Fire-Tube Number:** 40159 A

**ABSA Number:** 102602

**Date of Inspection:** MAY05/08

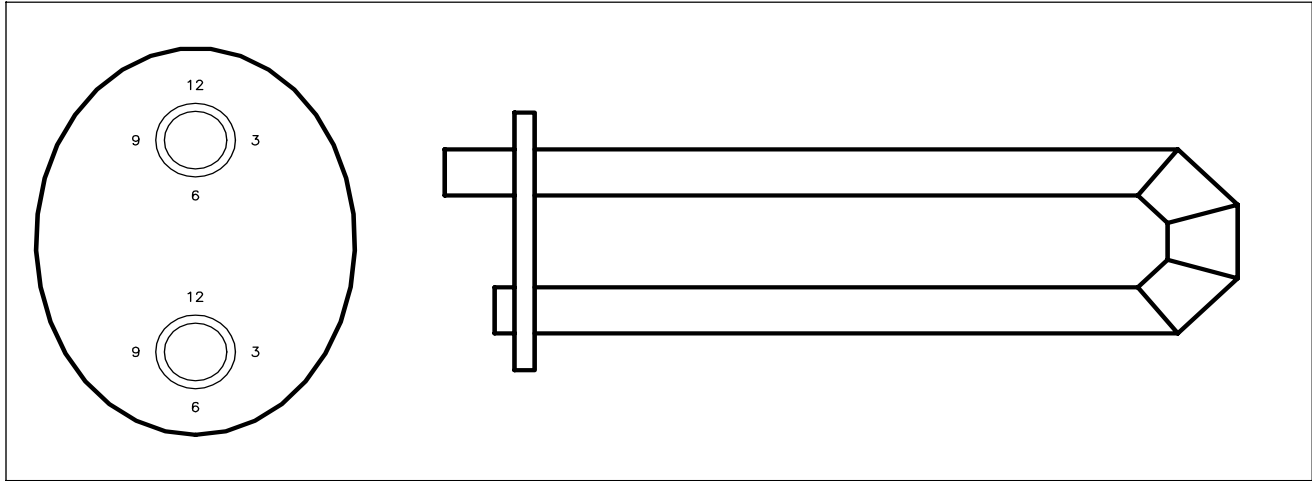
PLEASE SEE MAG REPORT FOR INDICATIONS FOUND BY M.P.I

SMALL PITS WERE LOCATED ON BOTH SIDES OF THE FIRE TUBE. THESE PITS WERE RANGING IN DEPTHS OF 1 TO 2.5mm THE WORST PITTING WAS LOCATED ON THE EXHAUST SIDE OF THE FIRE TUBE AT A DEPTH OF 2.5mm

Top				Bottom			
	12	3	6	9	12	3	6	9
	7.4	7.3	7.5	7.2				
	7.6	7.4	7.4	7.1				
M	7.2	7.2	7.4	7.4				
M	7.1	7.4	7.4	7.1				
M					7.5	7.2	7.4	7.4
					9.7	9.6	9.8	9.7
					9.8	9.6	9.8	9.7
