GENERAL NDE REPORT

Date June 23, 2010 Page 1 of 2
 RTD Job #: 105.00150
 RTD Dep. #:

Client: Canadian Natural Resources Ltd.
 Address: Grande Prairie, AB
 P.O.#:
 Client Rep.: Ajmal Khan

Description: To perform Magnetic Particle and Visual inspection on the fire tubes removed from Oil Treater A2518844

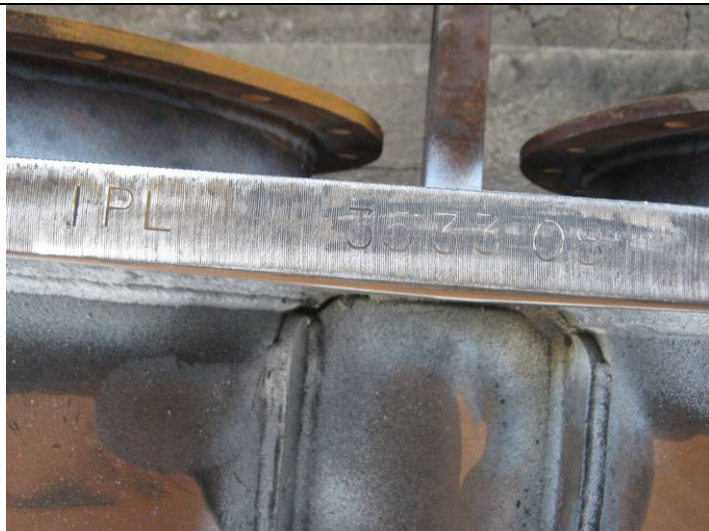
Fire tube #1 - Serial Number IPL 3533009

Results: **Magnetic particle inspection performed. No cracking detected. No mechanical damage.**
Cluster pitting identified at the 10:00 to 2:00 position throughout the length of the fire tube. Maximum pit depth to 0.050 inch.

Repairs: **None at this time.**

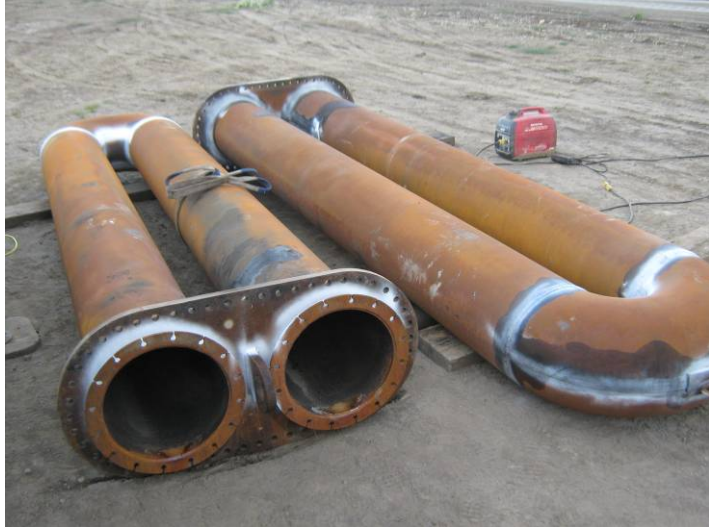
Overview - Fire tubes
