MATRIX INSPECTION

VESSEL INSPECTION SUMMARY

Report #: **137922-WF-1**
 Inspect Date: 08/22/2009
 Page: 1 of 10
 IRISNDT #: 137922

Treater – A0403456

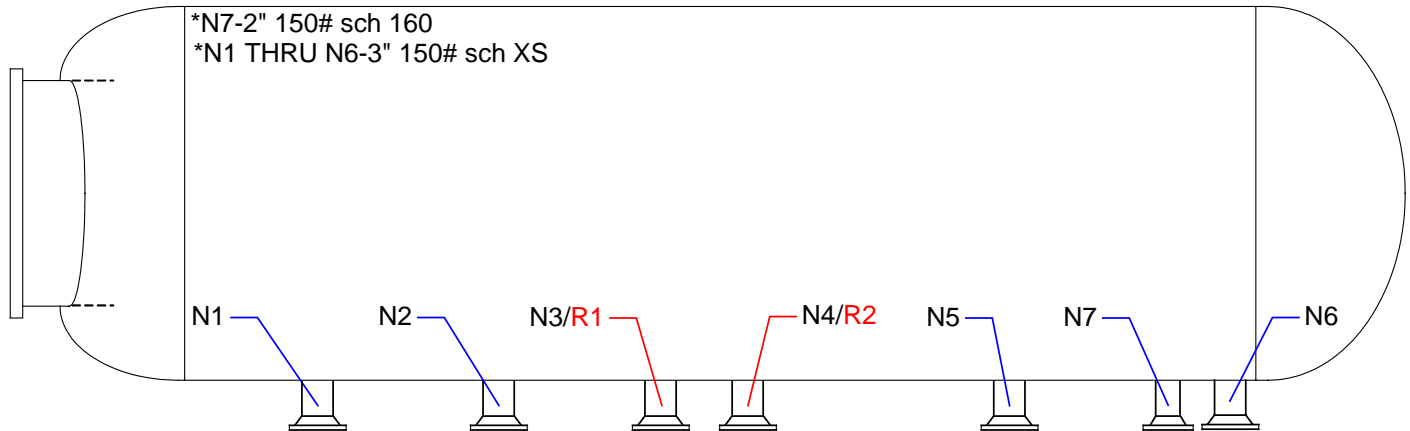
- For the purpose of this inspection and consequent repairs the nozzles on the bottom shell were identified N1 through N7. Refer to the attached drawing for nozzle orientation and depth of corrosion to each nozzle.

Nozzle No.	Wall Loss	Remaining Wall "t"	Repair Method
N1	0.020"	0.280"	N/A
N2	0.040"	0.260"	N/A
N3	0.090"	0.210"	Weld Overlay
N4	0.125"	0.175"	Weld Overlay
N5	0.010"	0.290"	N/A

*Note: No corrosion noted on nozzles N6 & N7. No corrosion noted on the shell adjacent to any of the nozzles.

- Nozzles N3 & N4 were selected for weld build up to the wasted areas. The area to be welded on N3 was approximately 200 degrees around the circumference and up to 1.5" longitudinally. The area to be welded on N4 was approximately 300 degrees around the circumference and up to 2.5" longitudinally. Refer to page 4 of this report for further repair details.

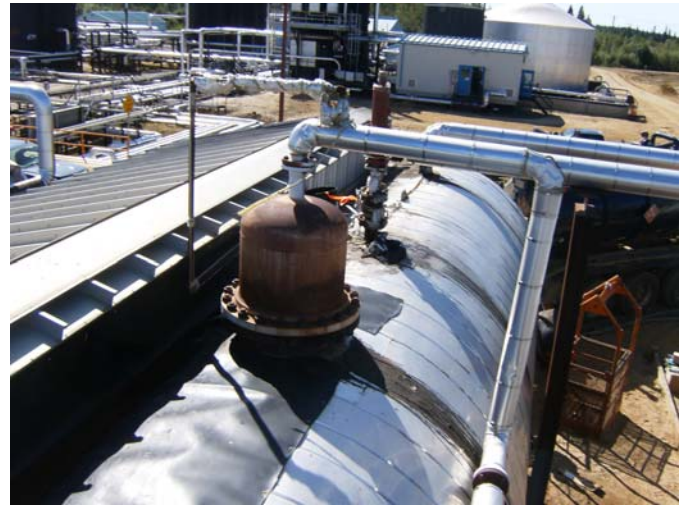
- The top shell insulation is stained with oil below a nozzle with a blind flange connection and below the gas dome flanges. The staining appears old from a previous leak or spill.

Figure 004_Gas Dome & Oil Stain_22Aug10

- Ensure the vessel is 100% clean at future inspection intervals.
Replace the wooden anode support rollers.
Clean and paint the bottom shell, nozzles and gas dome to assist surface condition.
Seal the upper shell insulation to prevent moisture ingress, which is collecting on the bottom shell. Replace the insulation on the bottom shell as required.
Remove the oil stains from the top shell insulation.

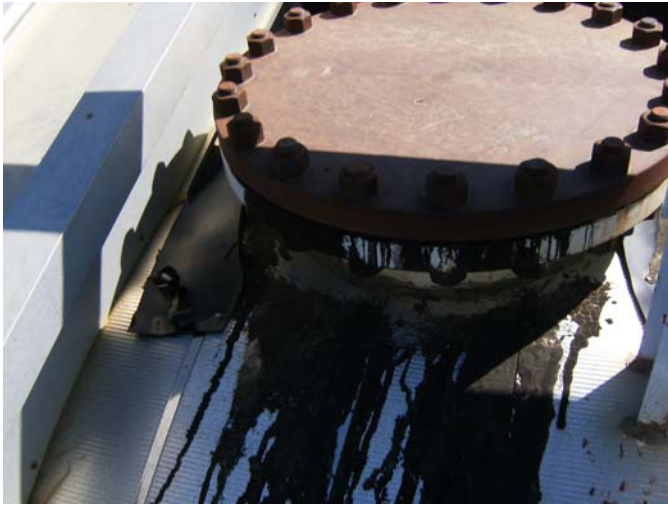
Figure 005_Top Shell Nozzle & Oil Stain_22Aug10

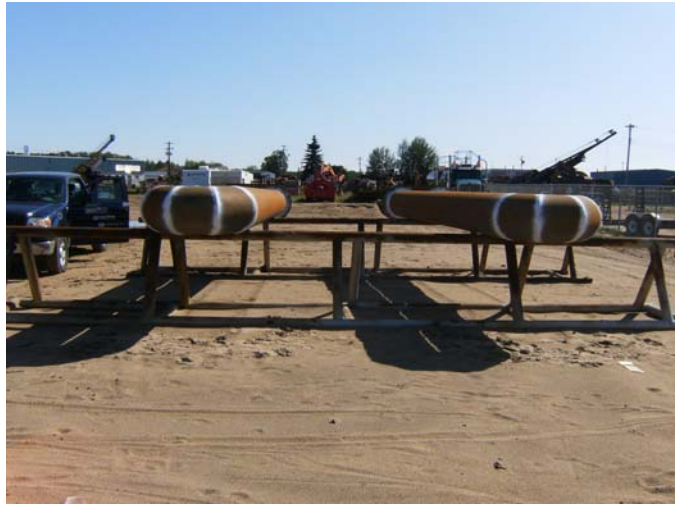
- The fire tubes are straight and free of any significant external corrosion. UT was carried out at random throughout the tube and a thickness range of 0.350"-0.369" was recorded (20" OD pipe). MT was carried out on all external welds on the product side of the tube sheet. No rejectable indications were noted; refer to IRINDT report #137922-MT-WF-02 for details.

Figure 006_Fire Tubes_22Aug10

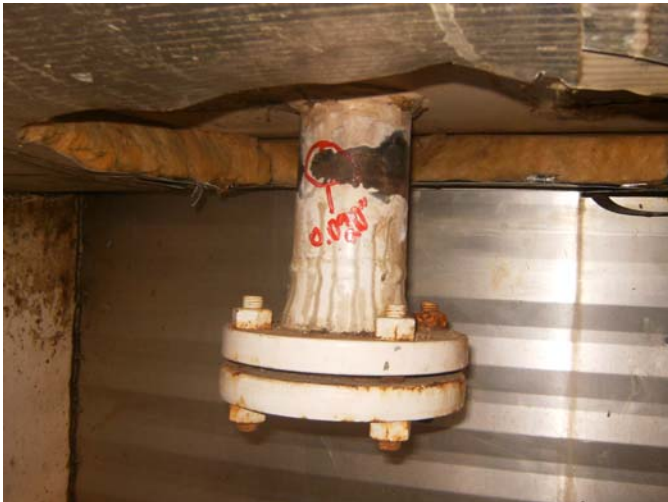
Figure 007_Nozzle N1_22Aug10

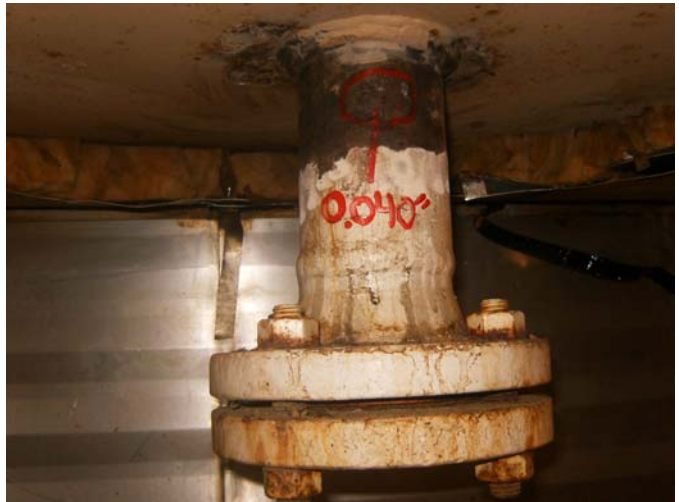
Figure 008_Nozzle N2_22Aug10

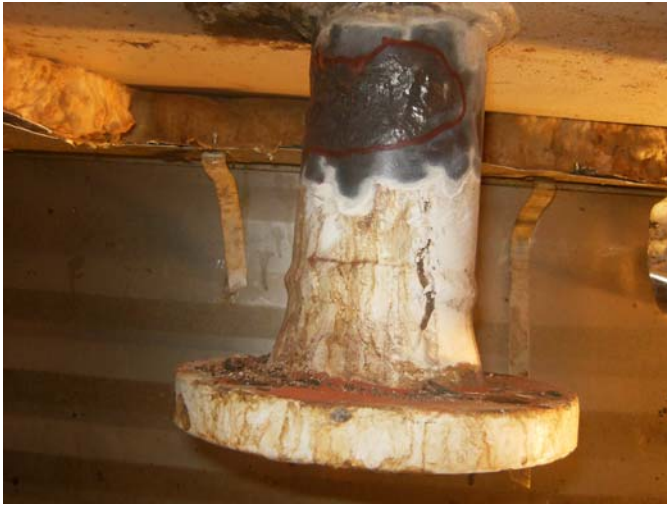
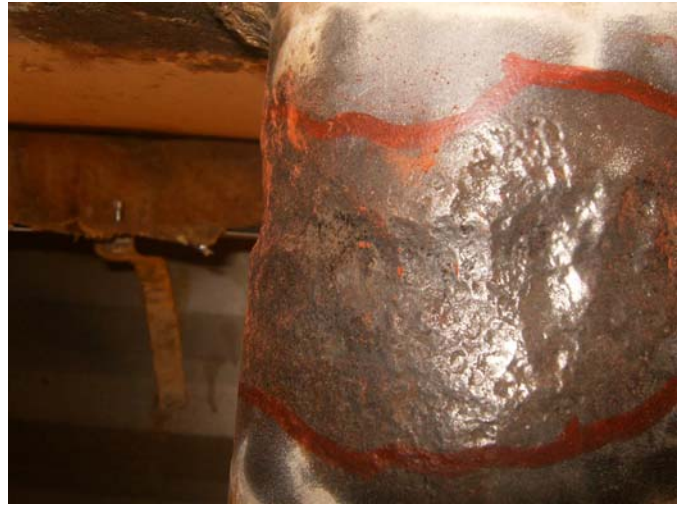
Figure 009_Nozzle N3_22Aug10

Figure 010_Nozzle N3_22Aug10

- The corroded areas to be welded were cleaned to sound metal and inspected with MT and UT prior to welding. No rejectable indications were noted; refer to IRISNDT report# 137922-MT-WF-01 & 137922-UT-WF-01 for details.
Murland Projects Inc completed all repair work.
The nozzle projections were preheated to 180F prior to welding. The weld overlay was completed with E-7018 electrodes. The weld cap was blended flush with the adjacent parent material of the nozzles. All repair work on the nozzles was visually acceptable.
All welding was inspected with MT 12 hours after welding was completed. The MT was carried out by Team inspection. No rejectable indications were noted; refer to Team report #MT-262-BG for details.
No hydrostatic test was required. Refer to the attached photos and drawing for details.

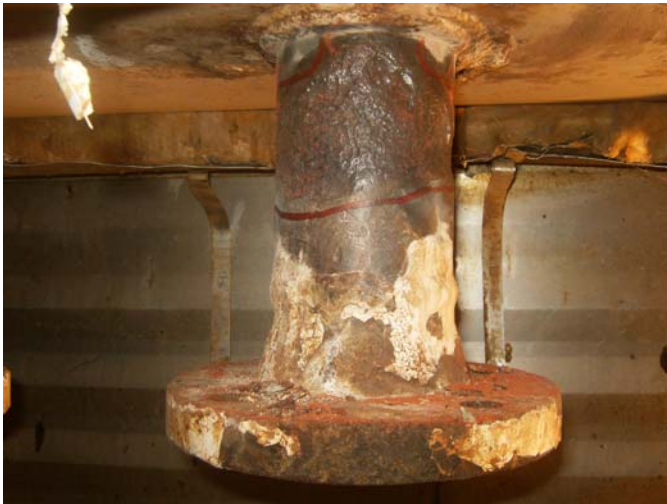
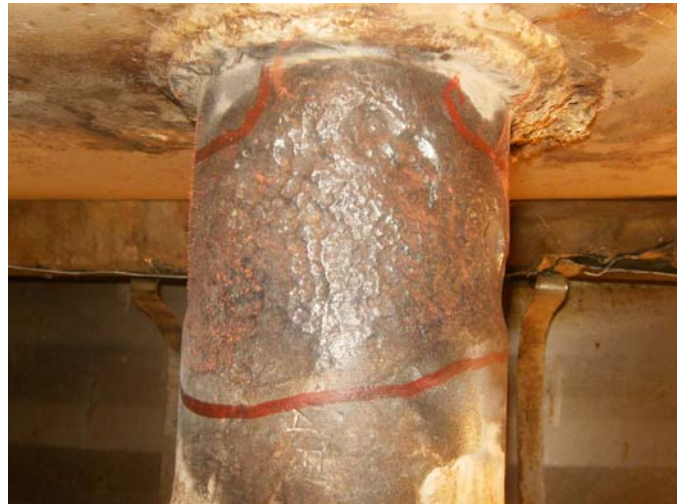
Figure 011_Nozzle N4_22Aug10

Figure 012_Nozzle N4_22Aug10

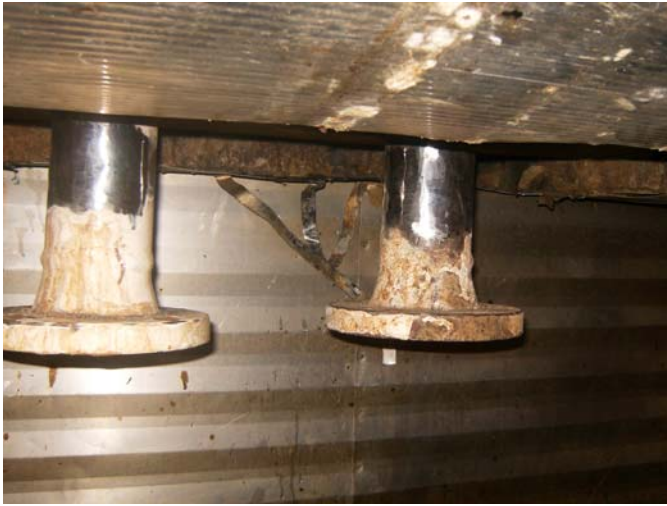
Figure 013_Compiled Repairs to Nozzles N3 & N4_22Aug10

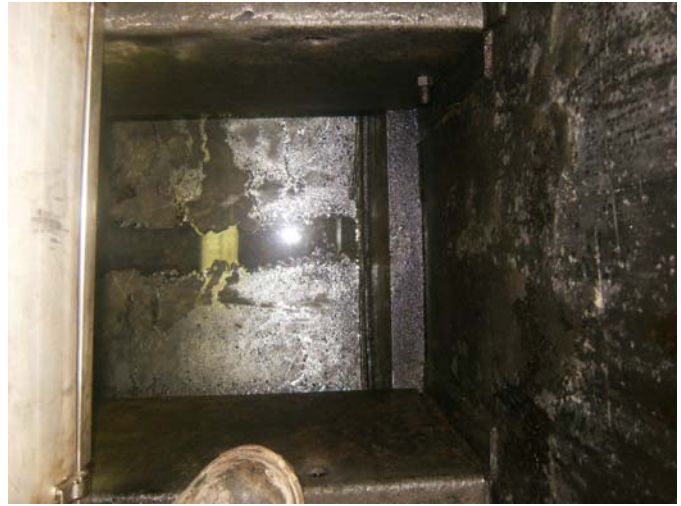
- Several areas inside the treater were not clean or visible. 2-3 inches of fluid is present on the bottom shell. Heavy product build up is present on isolated areas of the shell (5%) and throughout the structural steel & de-sand piping.

Figure 014_Fluid on Bottom Shell_22Aug10

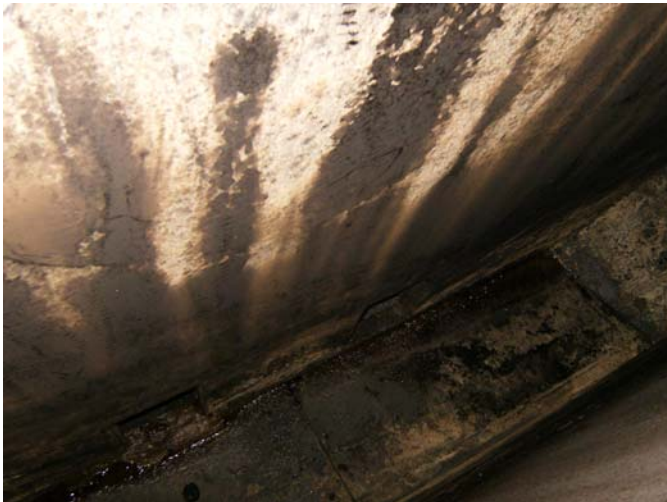
Figure 015_Product Between Weir Plates_22Aug10

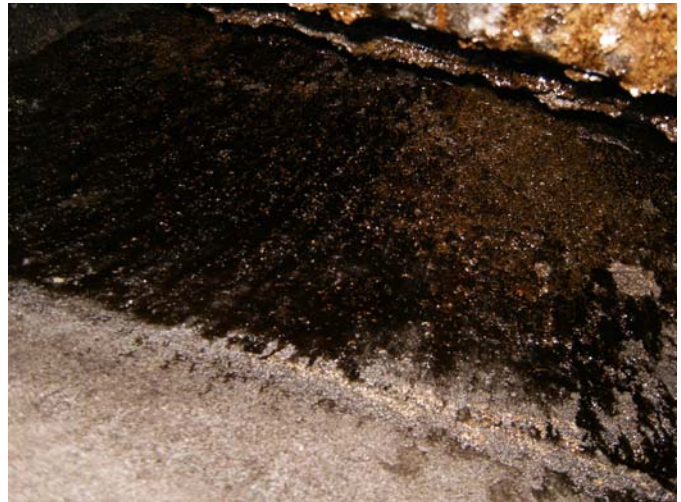
Figure 016_Product on Shell_22Aug10

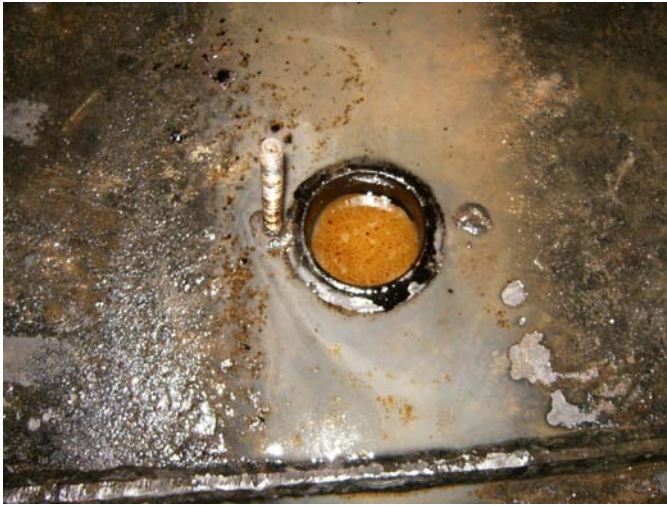
- One of the anchor bolts for the vortex breaker is broken. CNRL elected to remove the vortex breaker.
- No significant erosion, corrosion or pitting was observed on any visible areas. Internal UT thickness was carried out on the middle and upper shell to investigate for external corrosion under the insulation. All thicknesses recorded were within nominal thickness.

Figure 017_Broken Anchor Bolt for Vortex Breaker_22Aug10

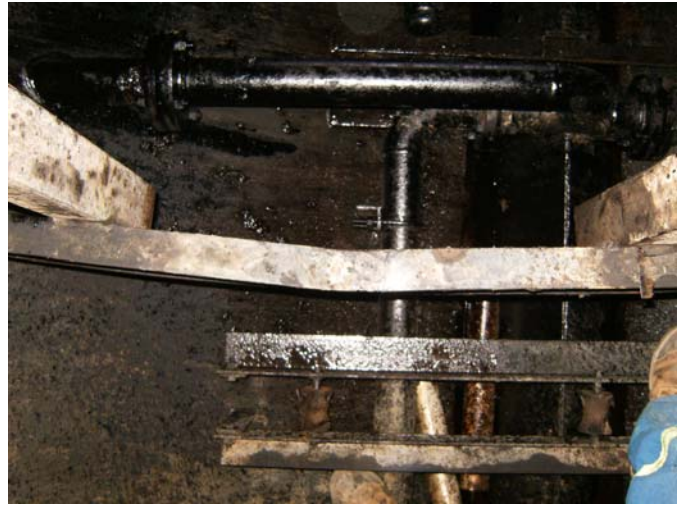
- The fire tube supports are bent slightly.
- The anode and bottom shell nozzles are dirty and not 100% visible. The anode rollers have deteriorated.
- The demister pad and associated supporting hardware is in good condition.

Figure 018_Bent Firetube Support_22Aug10
