**Canadian Natural Resources Ltd.
GENERAL PRESSURE VESSEL INFORMATION**

Job # 10.113812

District: Karr Creek	Area: Oil Treating.
Facility: Sturgeon Lake Battery	LSD: 10-29-71-23-W5
Vessel Name Equipment Number: Oil Treater	
Orientation: Horizontal	
Status: Not operating.	Regulatory Inspection

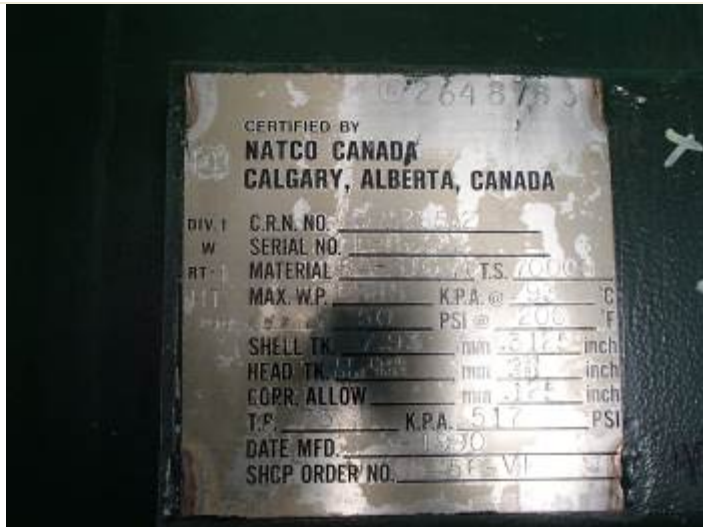
Data plate.

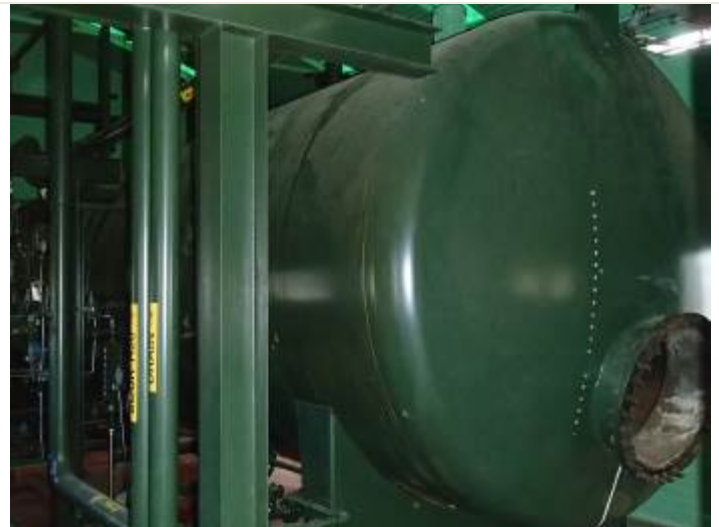
Treater overview.

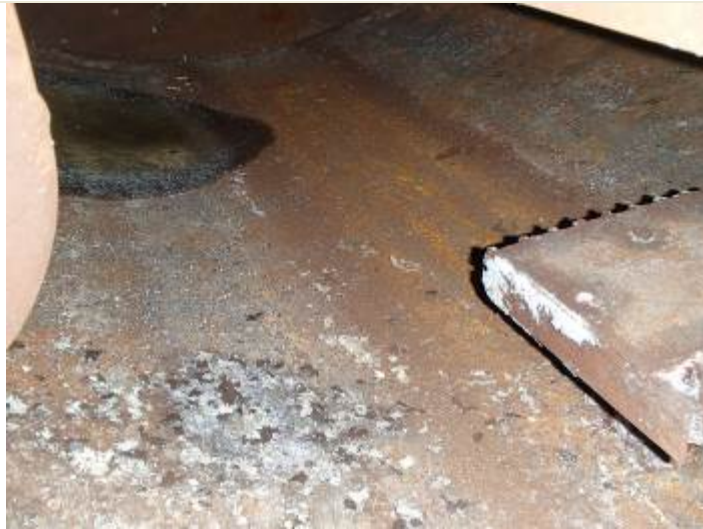
Bottom shell at oil end.

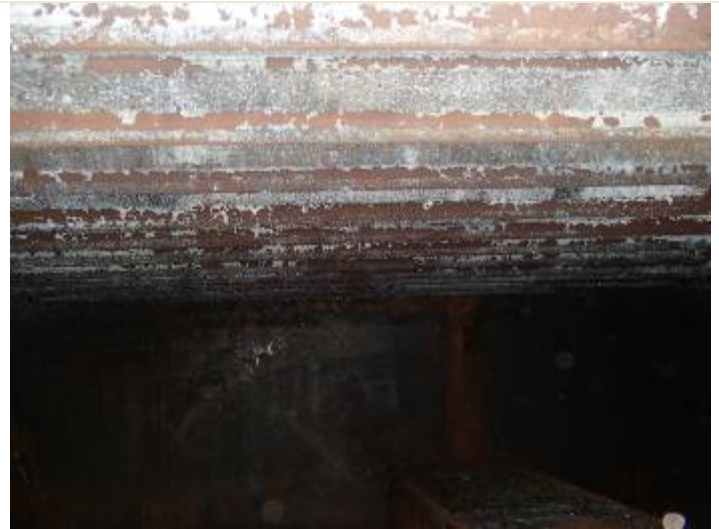
Baffles at the top shell at oil end.

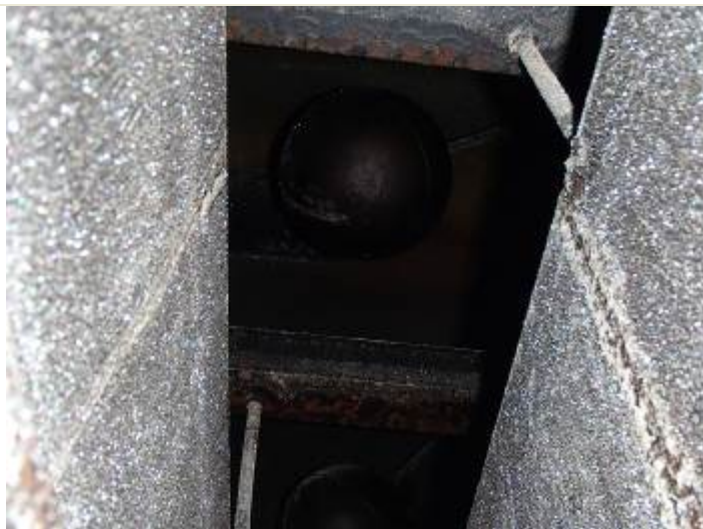
Float at the oil end

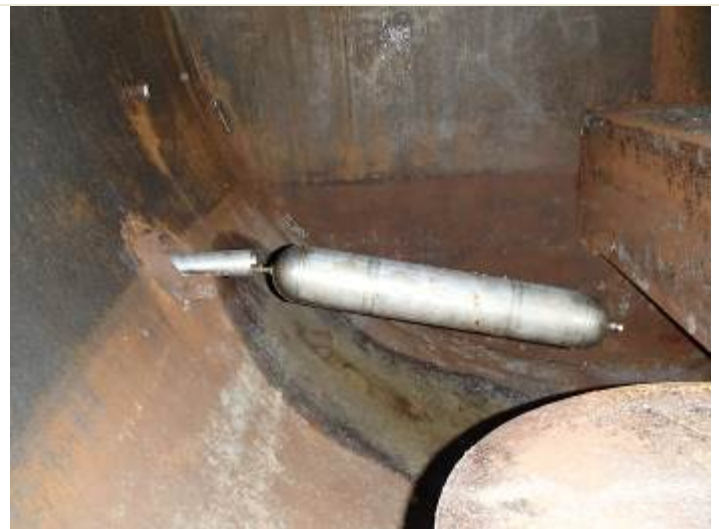
Float at the oil end.

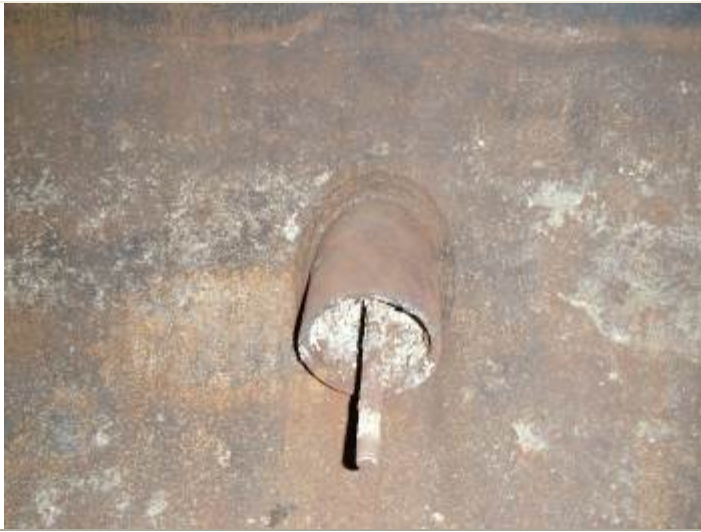
Internal Inspection Items	G	F	P	N/A	Comments
Coating Assess coating. Describe area coated, general condition of coating.				x	No coating
Anodes. How many, type, condition. % consumed. Are they being replaced?			x		4 anodes. 2 are completely consumed.
Internal Piping Is there any? If so, carbon or stainless steel. Describe condition, dents, corrosion, erosion, etc. Ensure supports are secure and any bolts are suitable for future use.				x	No internal piping.
Trays How many? Type of material. Are valves in place. Check for erosion/ corrosion; wear on tray valve legs. Cleanliness?				x	No trays
Baffles, deflector plates, etc. If present, describe condition. Look closely at welds attached to vessel wall.	x				Baffles at the oil end, mounted securely and in good condition.
Shell: Note all corrosion, erosion or mechanical damage.	x				No corrosion or mechanical damage.
Head Note all corrosion, erosion or mechanical damage. (x				No corrosion or mechanical damage.

100% Consumed anode at the oil end of Treater.

Recommendations or corrective actions : (Vessel is Fit for Service or describe corrective actions required) (MIC to review corrective actions with Operations, discuss with Chief Inspector where necessary, and get remedial action implemented)					
Recommendations: Replace all anodes. Summary: Vessel is fit for service.

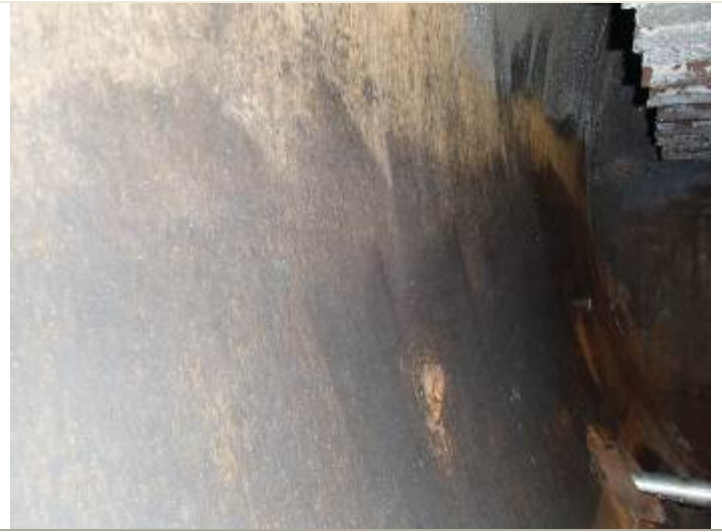
Shell at oil end of Treater.

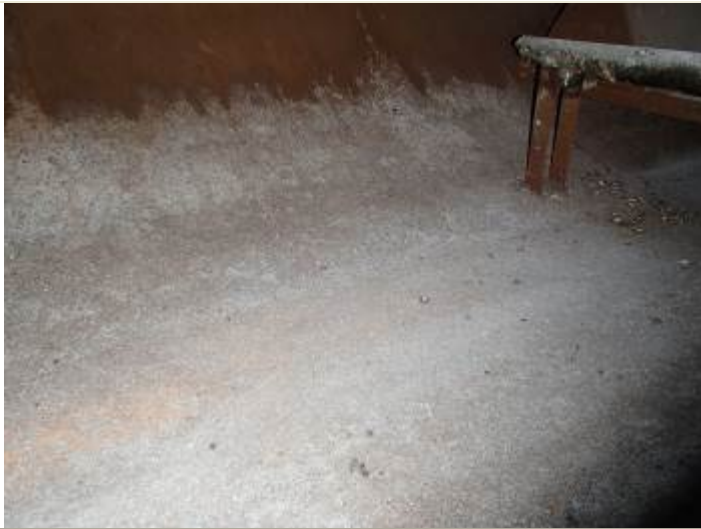
View of the bottom shell emulsion end.

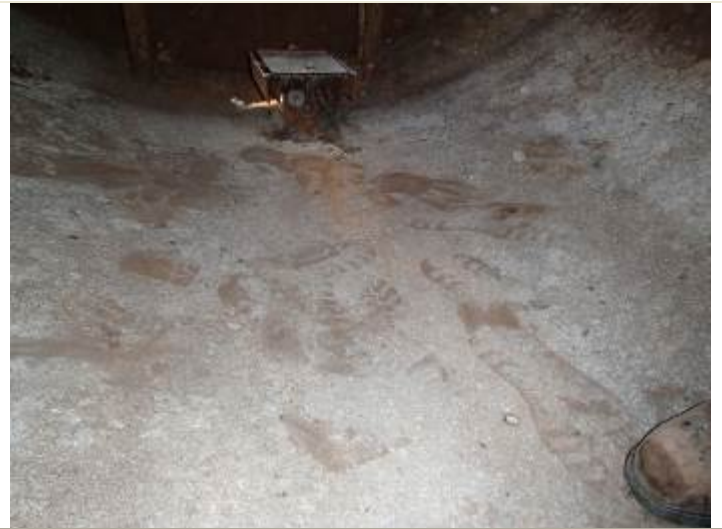
View of the bottom shell emulsion end.

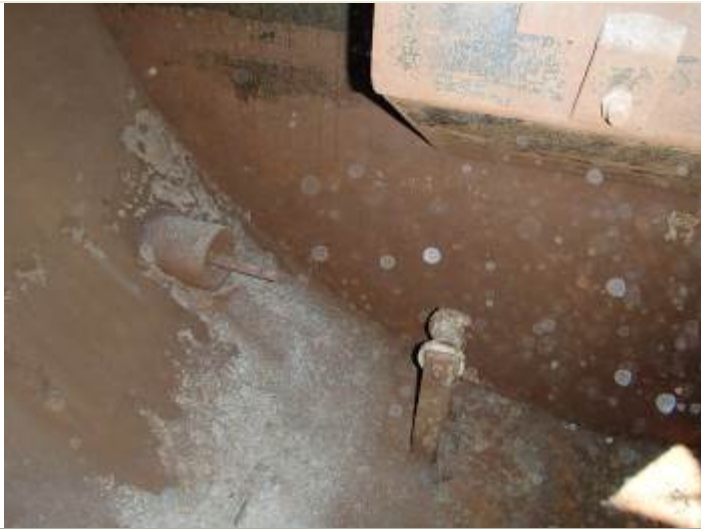
Attachment hardware intact.

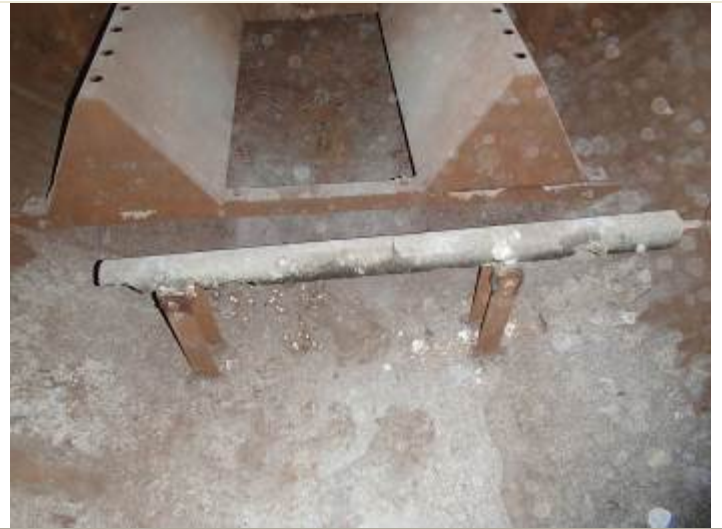
30% consumed anode at emulsion end.

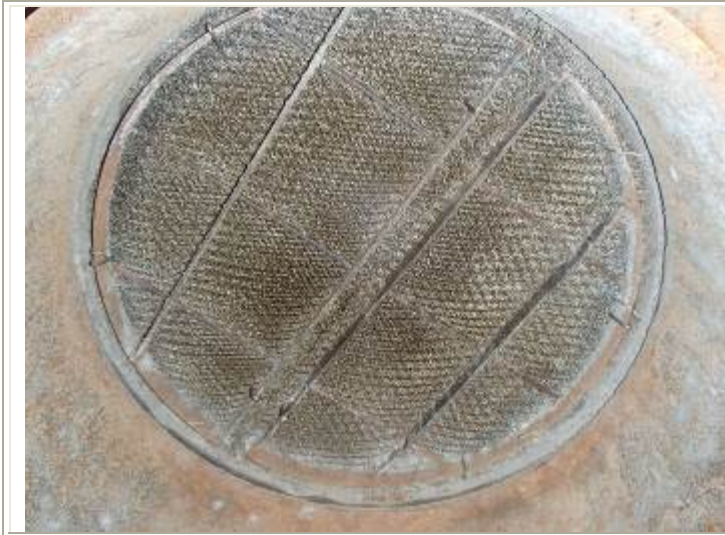
Demister

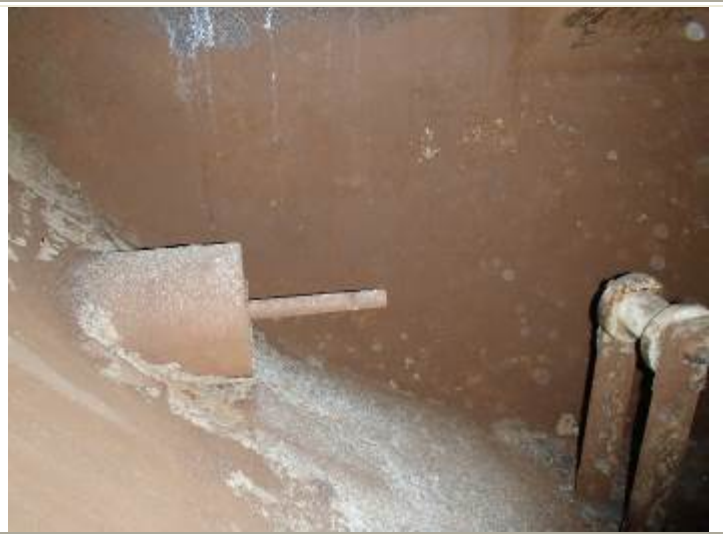
100% Consumed anode at the emulsion end of Treater.

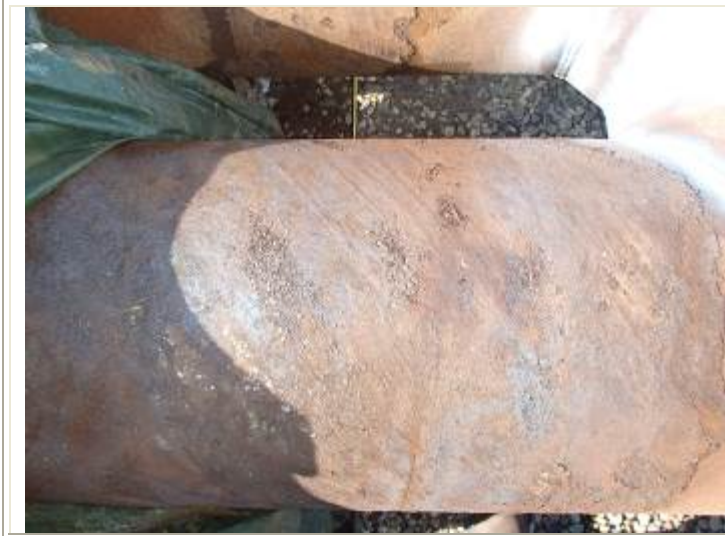
View of the scaling on the fire tube.

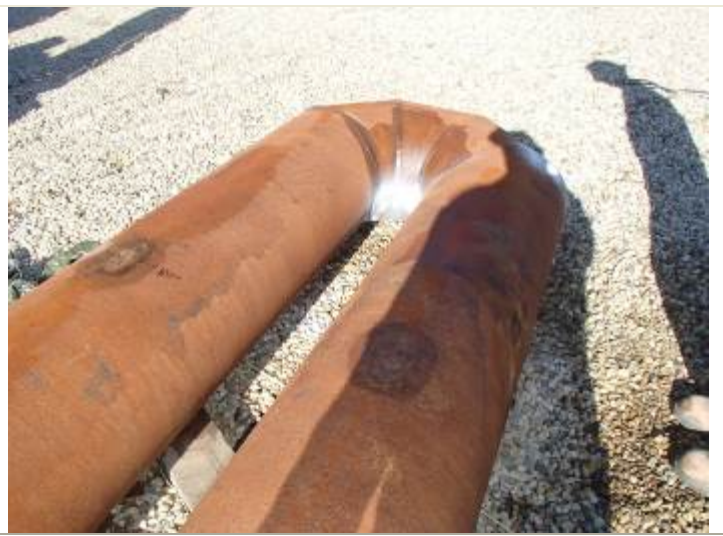
View of the scaling on the fire tube.

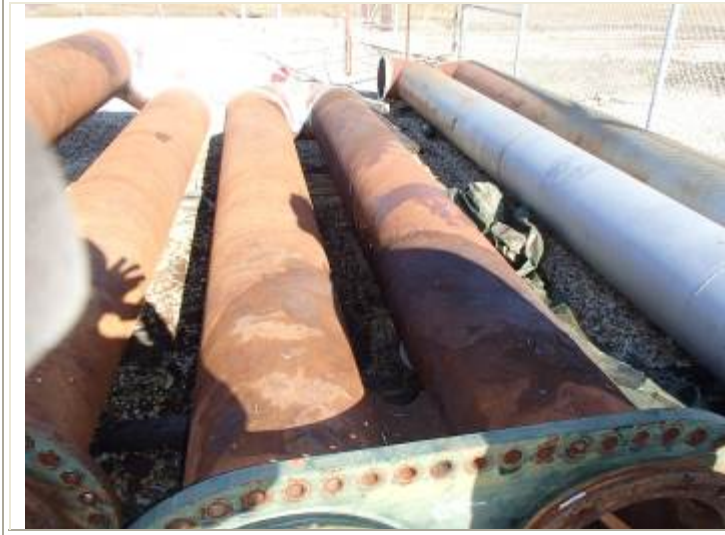
View of the scaling on the fire tube.

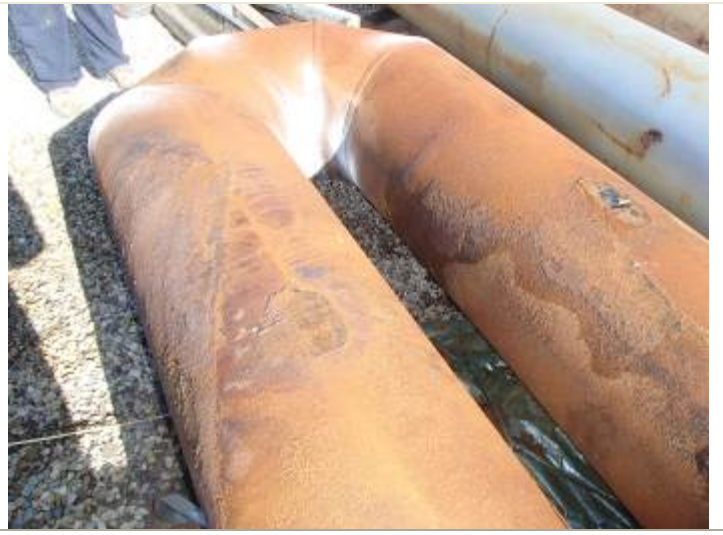
View of the scaling on the fire tube.

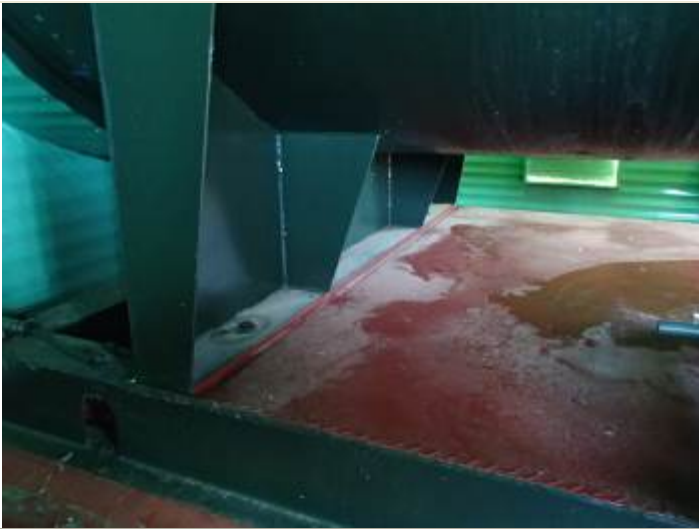
Vessel mounting.

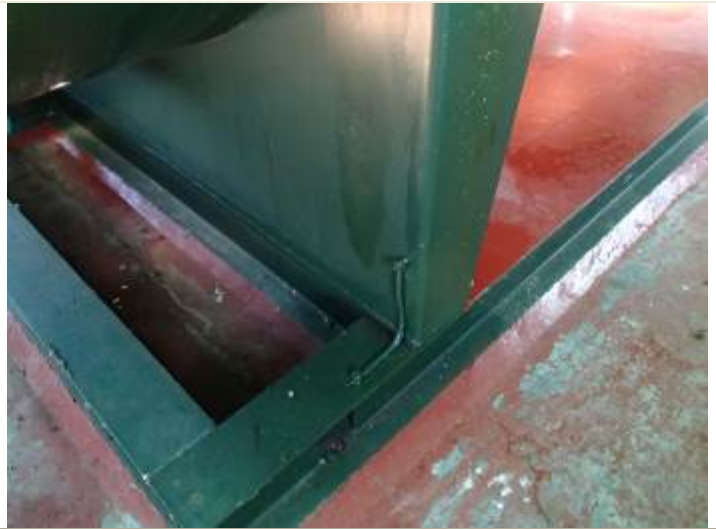
Vessel grounding

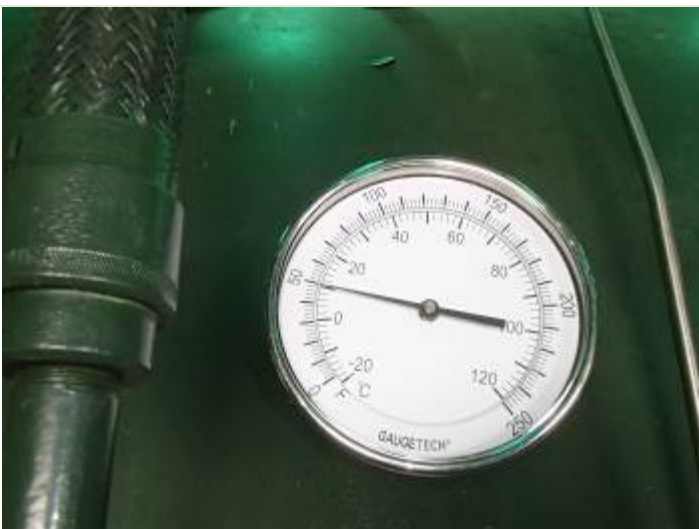
Temp gauge.

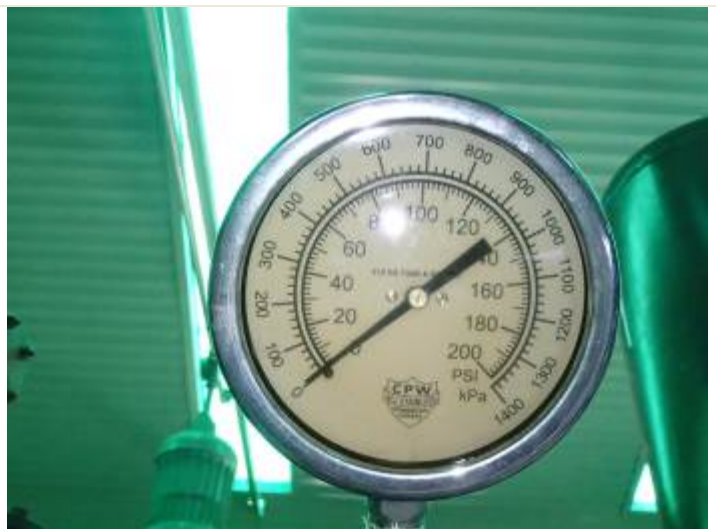
Pressure gauge.

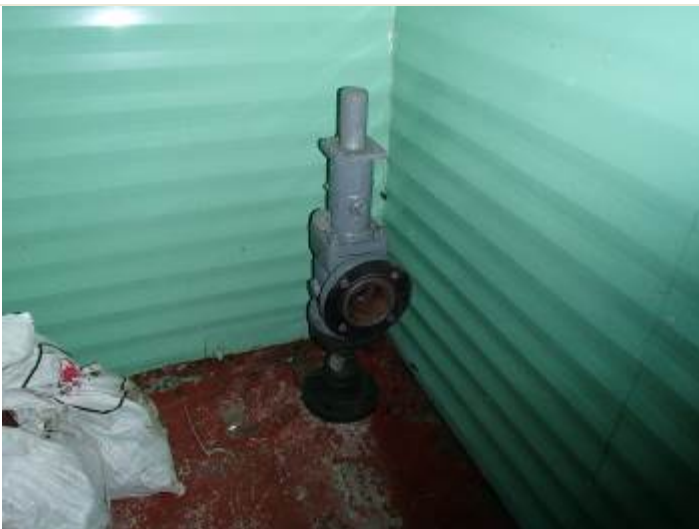
View of the PSV.

Valving Ensure no leaks are visible. Valves are properly supported and chained if necessary.			x		No leaks or evidence visible although vessel is not operating at this time.
PSV Ensure PSV is set at pressure at or below that of vessel.	x				PSV is not installed at this time.
NDE methods Was UT/ MPI done on vessel (MI coordinator to review results)	x				MT performed on the fire tubes, no cracking detected.
Other					
Recommendations or corrective actions : Vessel is Fit for Service or describe corrective actions required) (MIC to review corrective actions with Operations, discuss with Chief Inspector where necessary, and get remedial action implemented) Service the PSV prior to operating vessel

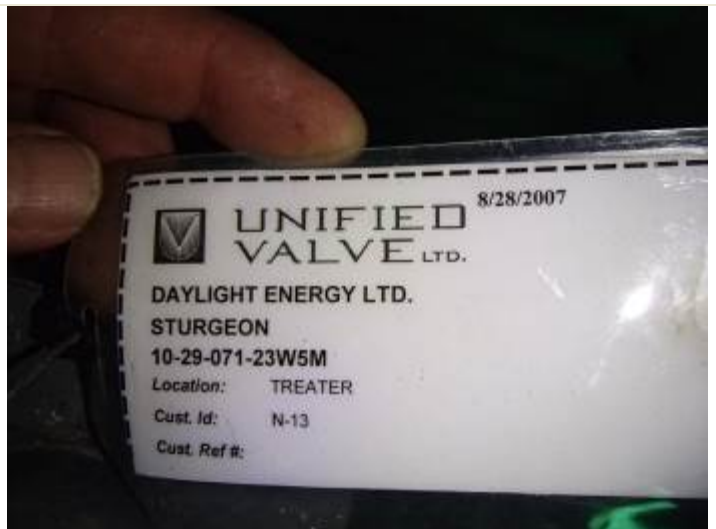
PSV service tag.

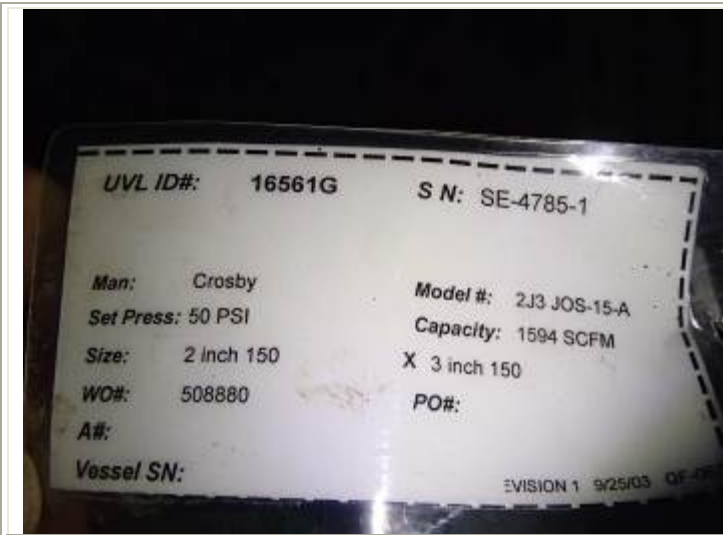
PSV service tag
