COMPANY	CNF	CNRL							June 28	une 28 2016				
<b>FACILITY</b> Ga		Gainsborough West					<b>LSD</b> 13-31-03		2-30 W1M					
EMERALD	1BER	ER					COMPANY IDENTIFICATION #				S4314			
VESSEL DATA														
<b>DESCRIPTION</b> Treater					MAN	MANUFACTURER			Kansteel					
MFG. DAT	1988					NB#/	NB#/A#/S#		S#28388					
SERIAL#	4787					CRN#		A0241.342						
UNIT NUMBER(S#)		4314			1 1		STAT	STATUS		active				
MAWP SHELL	50	kpa	⊠ p	si @ Temp	210	С	⊠ F	MDMT		□С □F		@		kpapsi
MAWP TUBE		kpa	□р	si @ Temp		С	F					<u> </u>		кра <u></u> _рзі
PSV INFO	DRMAT	ON		N/A	4			2 <sup>NI</sup>	PSV			X	N/A	
MANUFACTURER Taylor				LOCATION	Top shell		MANUFACTURER			LOCATION				
SERIAL#		43106-8 <b>CRN #</b>		CRN#	OG1315.2C		SERIAL#				CRN#			
MODEL#				PSV #	7946		MODEL#				PSV #			
SET PRESSURE		50 psi CAPACITY		CAPACITY	1478 scfm		SET F	SET PRESSURE				CAPACITY		
INLET SIZE		3"			3"		INLET SIZE				OUTLET SIZE			
LAST SERVICE				SERVICE INTERVAL			LAST	LAST SERVICE				SERVICE INTERVAL

### **INTERNAL VISUAL INSPECTION**

# EMERALD BOILER AND PRESSURE VESSEL INSPECTIONS INC. PRESSURE VESSEL INSPECTION REPORT EXTERNAL VISUAL INSPECTION

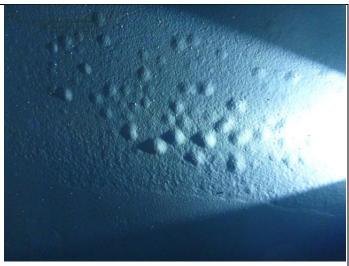
Spill over baffle corrosion

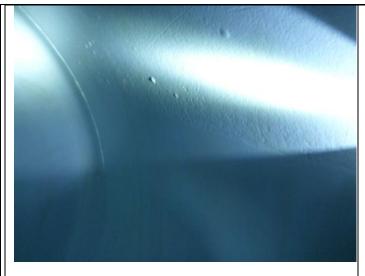
West section shell blisters

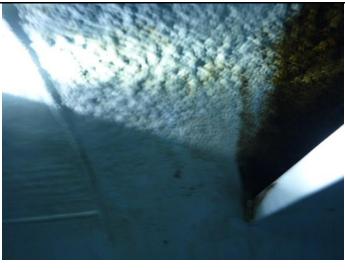
West section shell blisters

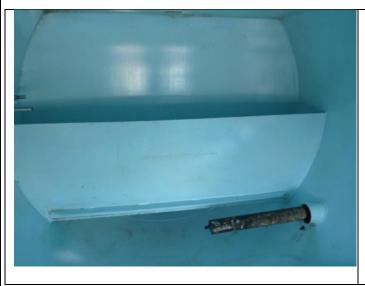
Corroded upper shell west section
