**Canadian Natural Resources Limited
GENERAL PRESSURE VESSEL INFORMATION**

Job 10.112980

District: Fort St. John North	Skid No.
Facility: Cypress Compressor Station	Location (LSD): c-61-L/94-B-15
Vessel Name Equipment Number: Glycol Contactor	
Orientation: Vertical	
Status: In Service	Regulatory Inspection

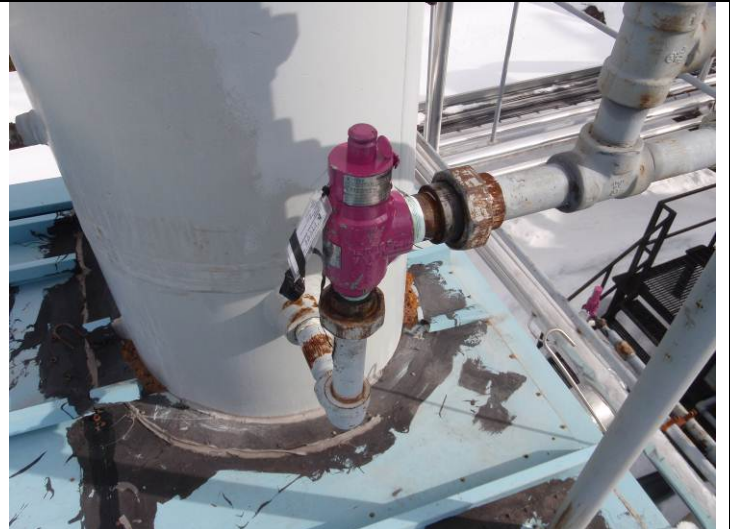
Valving Ensure no leaks are visible. Valves are properly supported and chained if necessary.	X				Valves properly supported – no sign of leaks
PSV Ensure PSV is set at pressure at or below that of vessel.	X				PSV is set below MAWP – no block valve - seal intact – discharge piping does not reduced from PSV discharge orifice
NDE methods Was UT/ MPI done on vessel (MI coordinator to review results)	X				Ultrasonic corrosion survey carried out, no metal thickness detected below nominal minus corrosion allowance.
Other					
<p>Recommendations or corrective actions : Vessel is Fit for Service or describe corrective actions required) (MIC to review corrective actions with Operations, discuss with Chief Inspector where necessary, and get remedial action implemented) Recommendations: None at this time. Summary: This vessel is in good condition, visual external and ultrasonic thickness inspection carried out – no metal thickness detected below nominal minus corrosion allowance. Long term corrosion rate based on greatest thickness loss – no corrosion rate to assess. Vessel is fit for service.</p>
