**Canadian Natural Resources Limited
GENERAL PRESSURE VESSEL INFORMATION**

Job # 10.112837

| Facility: Chowade Compressor Station | Location (LSD): c-29-L/94-B-09 |

Tank Name / Equipment Number: **400 bbl Produced Water Storage Tank**

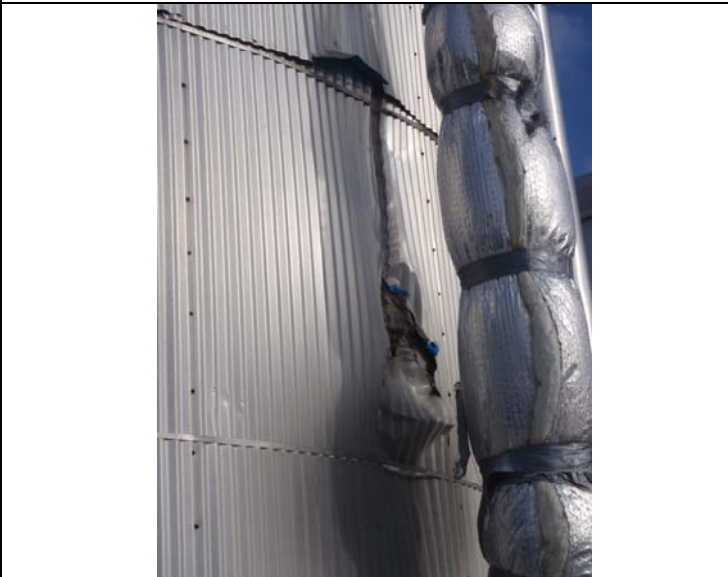
| External Inspection Items | G | F | P | N/A | Comments |
|--|---|---|---|---|--|
| Insulation Verify sealed around manways, nozzles, no damage present, and there is no egress of moisture. | X | | | | Cladding in good overall condition – isolated area of torn cladding – no exposed metal – no egress of moisture |

Torn Cladding
