**Canadian Natural Resources Limited  
GENERAL PRESSURE VESSEL INFORMATION**

**Job 10.112837**

District: <b>Fort St. John North</b>	Skid No.
Facility: <b>Chowade Gas Gathering</b>	Location (LSD): b-48-L/94-B-09
Vessel Name Equipment Number: <b>Flare Knock Out Drum</b>	
Orientation: <b>Horizontal</b>	
Status: <b>In Service</b>	<b>Regulatory Inspection</b>

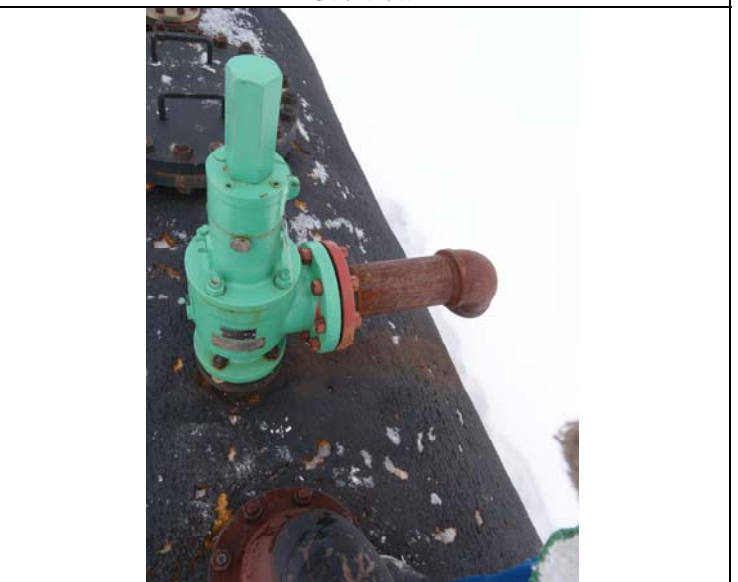
<b>Valving</b> Ensure no leaks are visible. Valves are properly supported and chained if necessary.	X				<b>Valves properly supported – no sign of leaking</b>
<b>PSV</b> Ensure PSV is set at pressure at or below that of vessel.	X				<b>PSV is set at MAWP – seal intact – no block valve – PSV vents to atmosphere – Discharge piping does not reduce</b>
<b>NDE methods</b> Was UT/ MPI done on vessel (MI coordinator to review results)	X				<b>Ultrasonic corrosion survey carried out - metal thickness detected below nominal minus corrosion allowance. – corrosion pitting found in head</b>
<b>Other</b>					
<p><b>Recommendations or corrective actions : Vessel is Fit for Service or describe corrective actions required)</b>  (MIC to review corrective actions with Operations, discuss with Chief Inspector where necessary, and get remedial action implemented)  <b>Recommendations:</b>  <b>Summary: This vessel is in good condition, visual external and ultrasonic thickness inspection carried out – no metal thickness detected below nominal minus corrosion allowance.</b>  <b>Vessel is fit for service.</b></p>

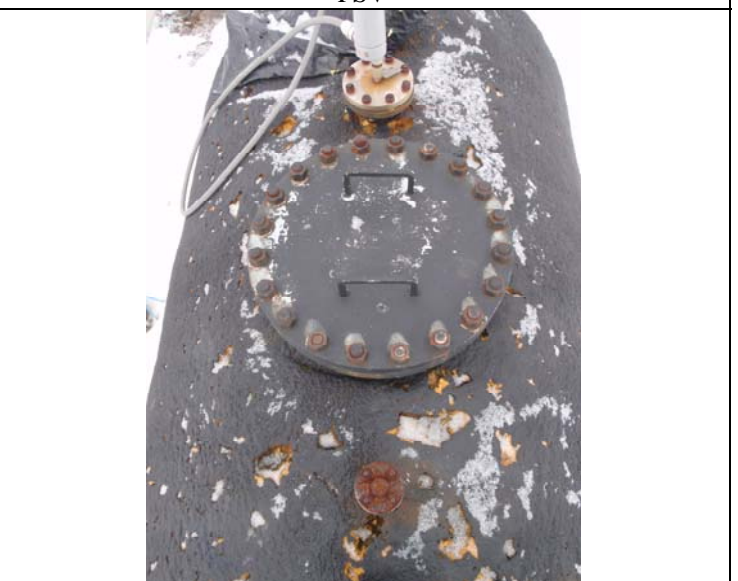
<b>External Inspection Items</b>	G	F	P	N/A	<b>Comments</b>
<b>Insulation</b> Verify sealed around manways, nozzles, no damage present, and there is no egress of moisture.		X			<b>Tar over foam insulation in fair overall condition – multiple small tares along top shell – no exposed metal –no egress of moisture</b>
<b>External Condition</b> Assess paint condition, areas peeling, record any corrosion, damage, etc (record location, size and depth of corrosion or damage)	X				<b>Limited access to underbelly – paint in good overall condition – no corrosion – no damage or exposed metal</b>
<b>Leakage</b> Record any leakage at flanges, threaded joints, weep holes on repads, etc.	X				<b>No leaks observed</b>
<b>Saddle/skirt</b> Assess condition of paint, fire protection, and concrete. Look for corrosion, buckling, dents, etc. Look at vessel surface area near supports. Verify no signs of leakage at attachment to vessel and attachment welds are acceptable. Ground wire attached?	X				<b>Saddle in good overall condition: bolted directly to skid frame – no buckling or dents – no corrosion or leaks at attachment welds – skid sits on wood blocks – ground wire attached to pilings</b>

Multiple tears in insulation along top shell
