**Canadian Natural Resources Limited
GENERAL PRESSURE VESSEL INFORMATION**

Job 10.112837

District: Fort St. John North	Skid No.
Facility: Chowade Compressor Station	Location (LSD): c-29-L/94-B-09
Vessel Name Equipment Number: Inlet Separator	
Orientation: Vertical	
Status: In Service	Regulatory Inspection

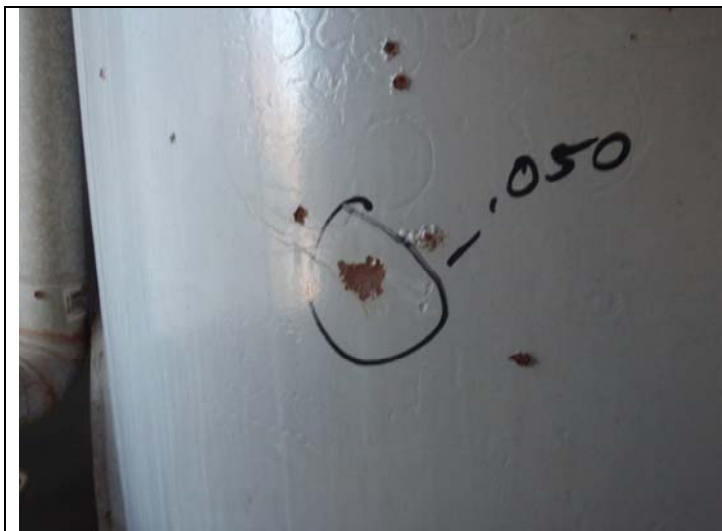
External pitting on lower shell
