**Canadian Natural Resources Limited
GENERAL PRESSURE VESSEL INFORMATION**

Job 10.112837

District: Fort St. John North	Skid No.
Facility: Chowade Compressor Station	Location (LSD): c-29-L/94-B-09
Vessel Name Equipment Number: Glycol Contactor	
Orientation: Vertical	
Status: In Service	Regulatory Inspection

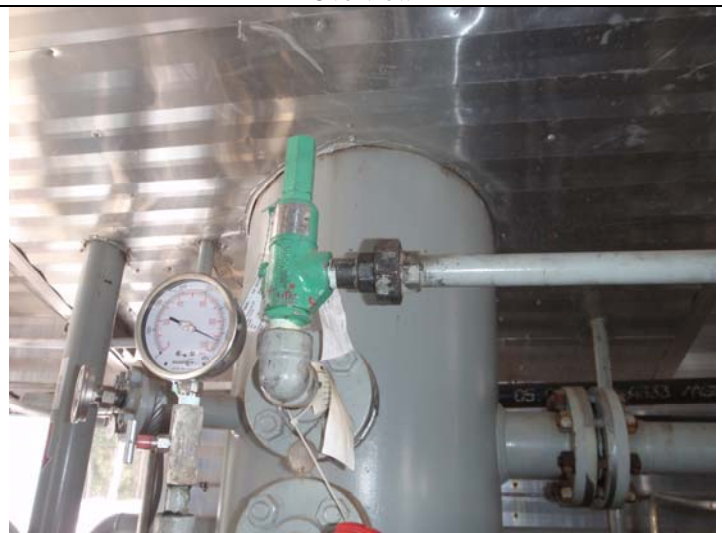
Valving Ensure no leaks are visible. Valves are properly supported and chained if necessary.	X				Valves properly supported – no sign of leaking
PSV Ensure PSV is set at pressure at or below that of vessel.	X				PSV is set at MAWP – seal intact – no block valve – discharge piping does not reduce form PSV discharge orifice size
NDE methods Was UT/ MPI done on vessel (MI coordinator to review results)	X				Ultrasonic corrosion survey carried out, no metal thickness detected below nominal minus corrosion allowance.
Other					
<p>Recommendations or corrective actions : Vessel is Fit for Service or describe corrective actions required) (MIC to review corrective actions with Operations, discuss with Chief Inspector where necessary, and get remedial action implemented) Recommendations: No Recommendations at this time Summary: This vessel is in good condition, visual external and ultrasonic thickness inspection carried out – no metal thickness detected below nominal minus corrosion allowance. Long term corrosion rate based on greatest thickness loss – no corrosion rate to assess. Vessel is fit for service.</p>
