**Canadian Natural Resources Limited
GENERAL PRESSURE VESSEL INFORMATION**

Job #4016571

District: Fort St. John, B.C	Skid No.
Facility: Gutah Compressor Station	Location (LSD): a-98-L/94-H-10
Vessel Name Equipment Number: Inlet Separator Blowcase	
Orientation: Horizontal	
Status: In Service	Regulatory Inspection

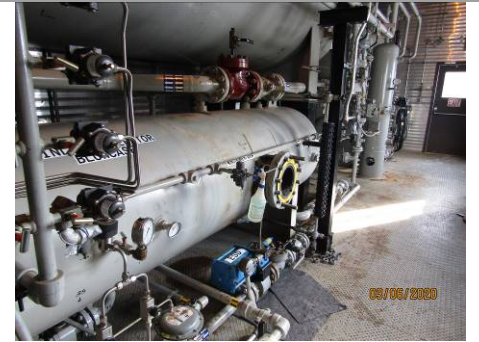
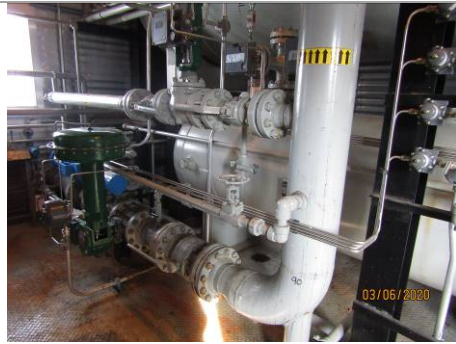
Overview

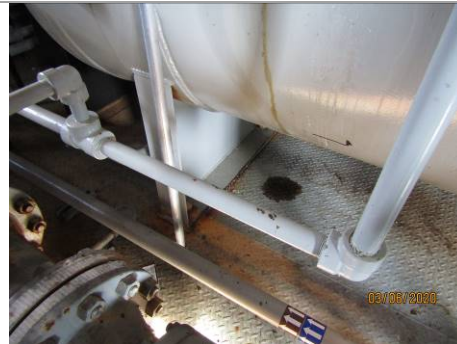
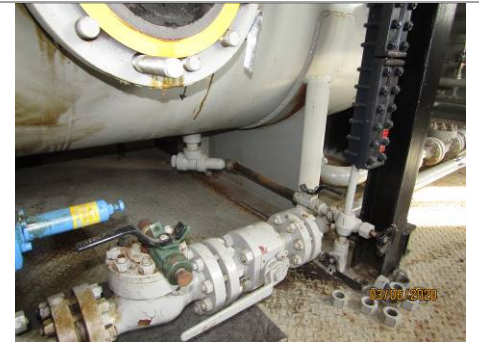
Mounting

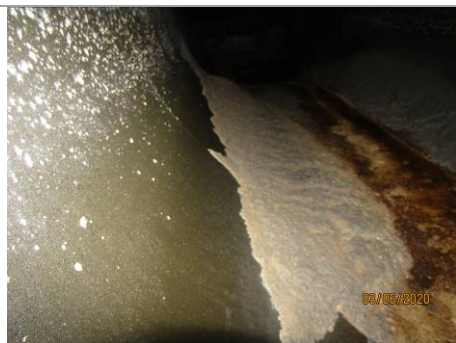
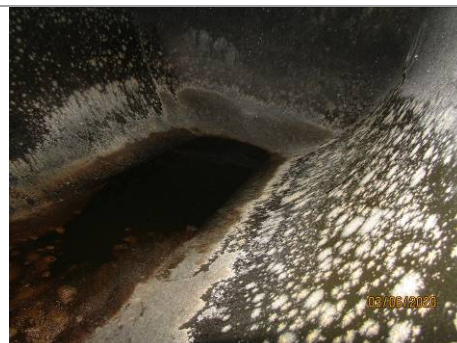
Bottom shell
