**Canadian Natural Resources Limited  
GENERAL PRESSURE VESSEL INFORMATION**

**Job # 10.112596**

District: <b>Fort St. John BC.</b>	Skid No.
Facility: <b>Cypress Gas Plant</b>	Location (LSD): <b>b-99-C/94-B-16</b>
Vessel Name Equipment Number: <b>Inlet Separator</b>	
Orientation: <b>Horizontal</b>	
Status: <b>In Service</b>	<b>Regulatory Inspection</b>

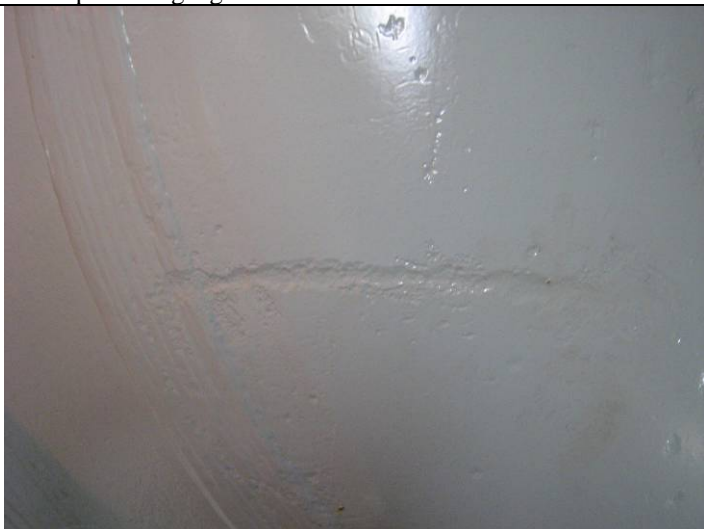
West head pitting coated over (not active)

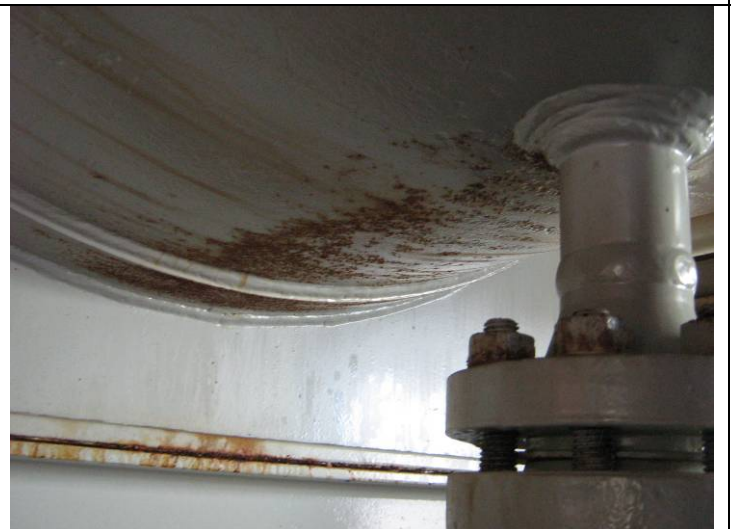
Bottom side nozzle minor rust and scale developing

<b>Valving</b> Ensure no leaks are visible. Valves are properly supported and chained if necessary.	X				<b>No leaks are visible. Valves are supported properly.</b>
<b>PSV</b> Ensure PSV is set at pressure at or below that of vessel.	X				<b>Location: Outlet piping – set at MAWP of vessel. Block valve between vessel and PSV- locked in open position. Discharge piping is same size as valve outlet.</b>
<b>NDE methods</b> Was UT/ MPI done on vessel (MI coordinator to review results)	X				<b>Ultrasonic corrosion survey carried out – pipe metal thickness detected below nominal minus corrosion allowance. Thickness calculations carried out: UT point 255 (2" elbow) – nominal thickness is 5.5mm / min thickness is 4.0mm / T min thickness is 2.8mm.</b>
<b>Recommendations or corrective actions : Vessel is Fit for Service or describe corrective actions required)</b> (MIC to review corrective actions with Operations, discuss with Chief Inspector where necessary, and get remedial action implemented) <b>Recommendations: 1. Clean up external of vessel and paint.</b>
