Tank External Inspection Report

Tank Internal Inspection Report

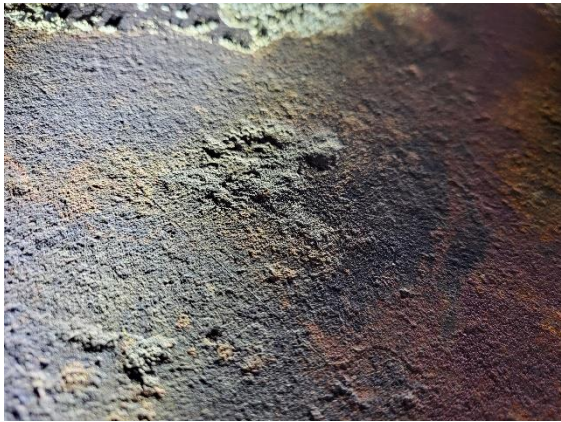
ANODES	N/A				
NDE PERFORMED	Good	Ultrasonic thickness survey to floor and shell.			
Other	N/A				
<i>* Fair and Poor conditions require comment. Additional comments on following pages as required.</i>					
Internal Inspection Summary:	<p>Emulsion Tank internal in good overall condition. Tank floor has scattered areas of general corrosion with pitting up to .020 inch. All weld seams in good condition - no corrosion or pitting. Nozzles were unobstructed with no signs of corrosion. Float is in good condition - wire has no damage. Ultrasonic thickness survey performed on tank floor. Floor nominal is .250 inch with a minimum scan of .240 inch obtained.</p>				
Fit for Service:					
YES

Floor general corrosion .020 inch

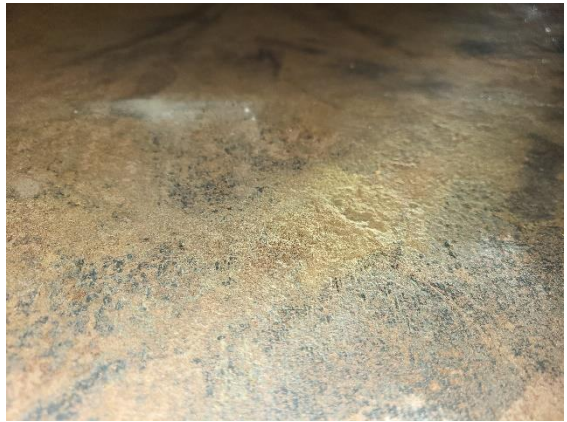
Floor general corrosion .010 inch

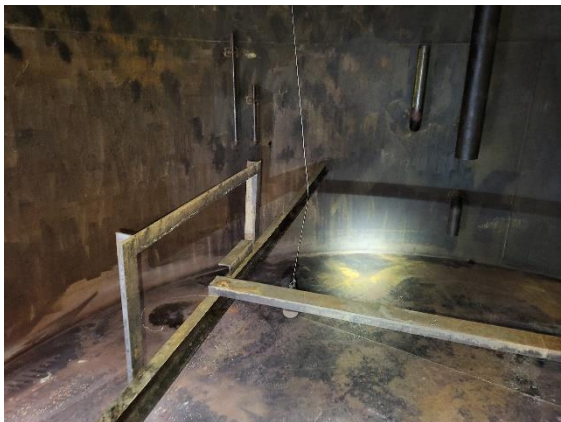
Heating tube support - tube permanently removed
