Tank External Inspection Report

| Description: | 1000 BBL Emulsion Tank | | | | |
| Serial #: | G-97-338-107 | Equipment #: | C83936 | Status: | Operating |

Tank Internal Inspection Report

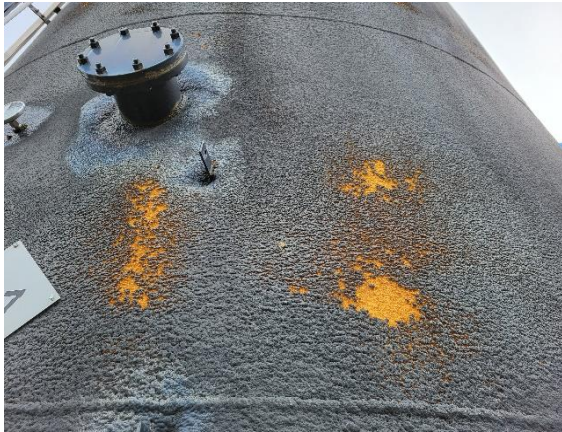
Insulation condition

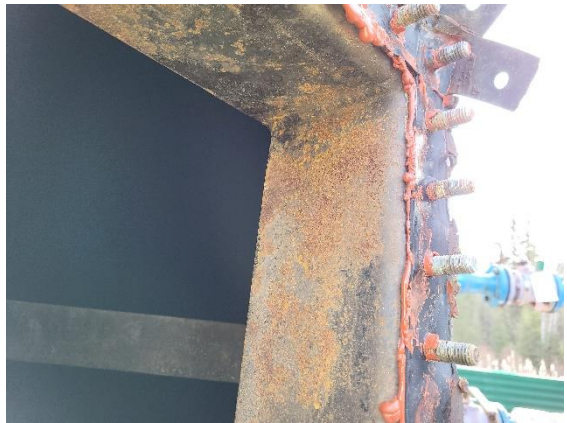
Manway entrance condition

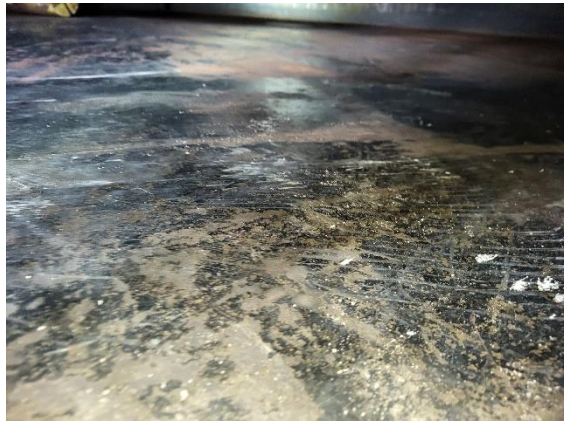
Tank floor overview

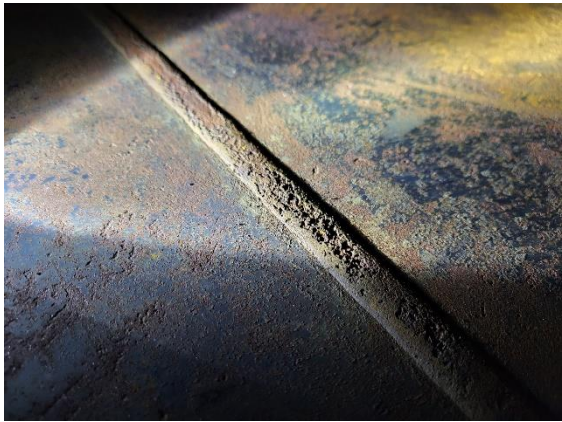
| Serial #: | G-97-338-107 | Equipment #: | C83936 | Inspection Date: | |
|--|---|--|---|---|--|
| INTERNAL WELDS | Fair | Shallow pitting to floor seam weld cap - pitting to .010 inch. | | | |

Floor weld cap pitting

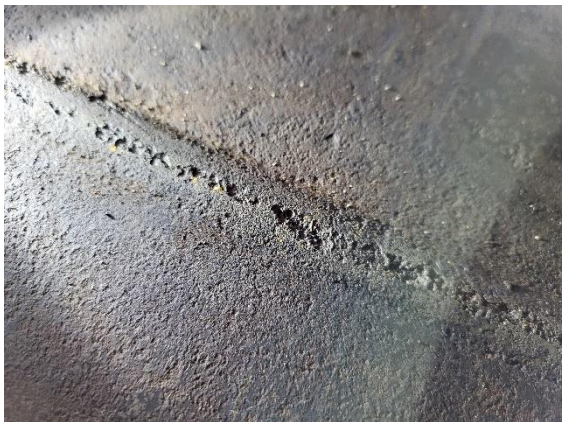
Floor weld cap pitting

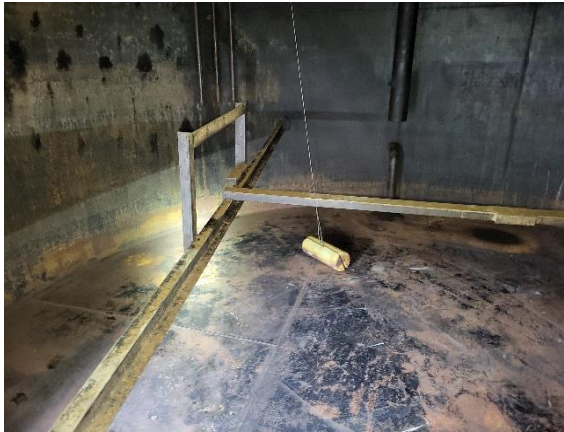
| Serial #: | G-97-338-107 | Equipment #: | C83936 | Inspection Date: | |
|--|---|--|---|---|--|
| INTERNAL SUPPORTS / GUIDES | Good | Heater tube supports still in place - tubes removed. No corrosion. | | | |

Heating tube support - tube permanently removed
