Tank External Inspection Report

Client:	CNRL	District:	Karr	Date:	15-Apr-2023
Surface LSD:	08-12-66-05 W6M	Downhole LSD:	8-7/1-7-66-4 W6M	Skid #:	N/A
Description:	750 BBL Sales Tank				
Serial #:	F-97-156-3	Equipment #:	C83937	Status:	Operating
MFR:	G.L.M. Tanks & Equipment			Year Built:	1997
Height / Length:	24 ft	Diameter:	15.25 ft	Volume:	750 BBL
AST / UST:	AST	Single / Double Wall:	Single	Open / Closed:	Closed
External Insulation:	Yes	Internal Coating:	Yes	# of Courses:	4
Tank Type:	Welded	Manway Present:	Yes	Manway Size	3 ft
Tank Floor Elevated:	Yes	Tank Placement:	Pilings	Interstitial Space:	N/A
Underside Visible:	Yes				
FLOOR:		SHELL:		DECK:	
Material:	SA-36	Material:	SA-36	Material:	SA-36
Nominal:	0.250 in	Nominal:	0.188 in	Nominal:	0.188 in
Comments:	Design Pressure = 8 oz.

Tank Internal Inspection Report

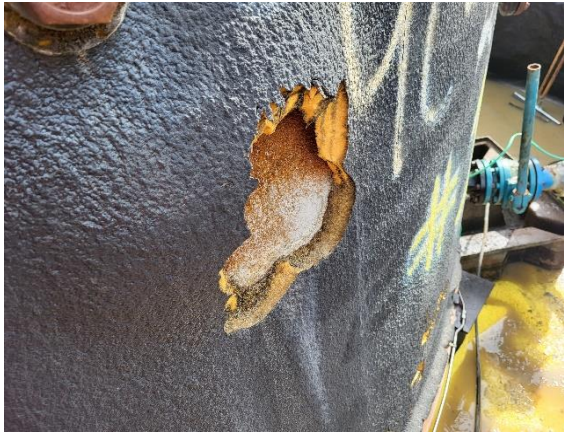
External Inspection Comments:	Sales Tank in good overall condition. Shell is 100% spray foam insulated - fair condition - bubbled and missing insulation to shell. Exposed metal shows no signs of external pitting. Piping in good condition - no deflections.
Fit for Service:	Insulation in good condition - no open or torn sections. Tank base is welded/clamped to steel base structure - no corrosion. Tank sits level. Ladder is securely attached to shell - no corrosion. Tank is fit for service.
YES

Insulation condition

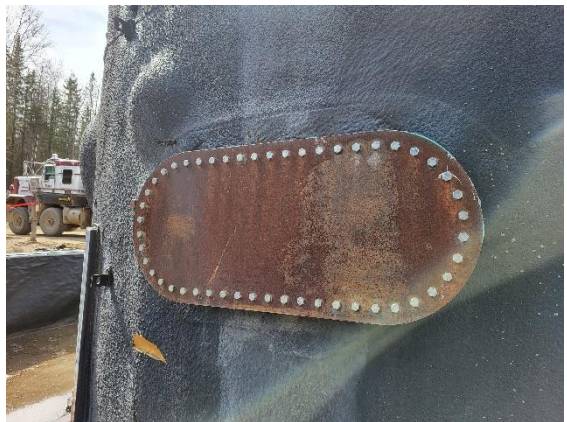
Heating tube covering

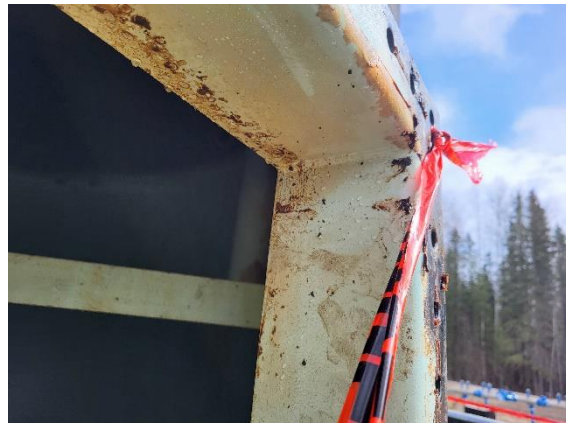
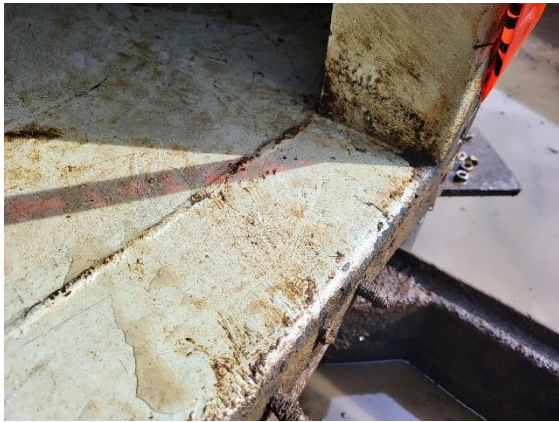
Manway entrance condition

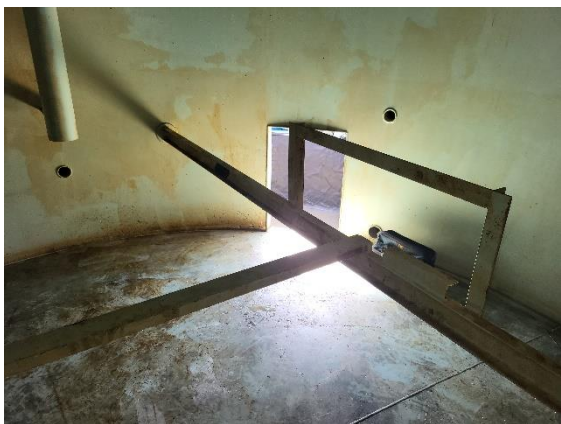
Heating tube support - tube permanently removed

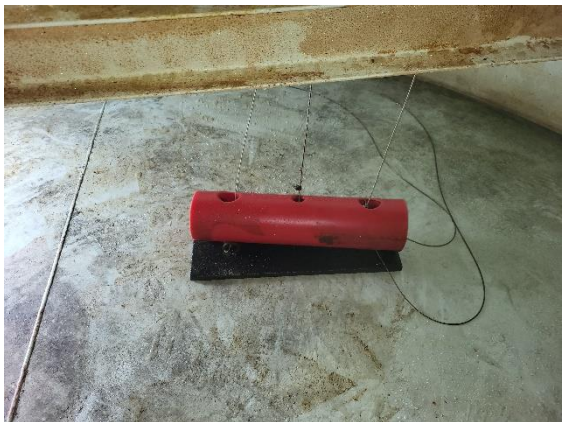
Float overview

FLOATS	Good	Appears to be in good working order.			
ANODES	N/A				
NDE PERFORMED	N/A				
Other	N/A				
<i>* Fair and Poor conditions require comment. Additional comments on following pages as required.</i>					
Internal Inspection Summary:	<p>Sales Tank internal in good overall condition. Tank bottom is epoxy coated up to the 1st course. No damaged or missing coating. Shell in good condition from 1st course and up - no corrosion or mechanical damage present. Nozzles are unobstructed with no signs of corrosion. Float is in good condition - wire has no damage. Previous coating patch areas appear to still be bonded. Tank is fit for continued service.</p>				
Fit for Service:					
YES
