Tank External Inspection Report

Client:	CNRL	District:	Karr	Date:	16-Apr-2023
Surface LSD:	08-12-66-05 W6M	Downhole LSD:	8-7/1-7-66-4 W6M	Skid #:	N/A
Description:	750 BBL Sales Tank				
Serial #:	F-97-019-21	Equipment #:	C50198	Status:	Operating
MFR:	G.L.M. Tanks & Equipment			Year Built:	1997
Height / Length:	24 ft	Diameter:	15.25 ft	Volume:	750 BBL
AST / UST:	AST	Single / Double Wall:	Single	Open / Closed:	Closed
External Insulation:	Yes	Internal Coating:	Yes	# of Courses:	4
Tank Type:	Welded	Manway Present:	Yes	Manway Size	3 ft
Tank Floor Elevated:	Yes	Tank Placement:	Pilings	Interstitial Space:	N/A
Underside Visible:	Yes				
FLOOR:		SHELL:		DECK:	
Material:	SA-36	Material:	SA-36	Material:	SA-36
Nominal:	0.250 in	Nominal:	0.188 in	Nominal:	0.188 in
Comments:	Design Pressure = 8 oz.				
External Inspection

Tank Internal Inspection Report

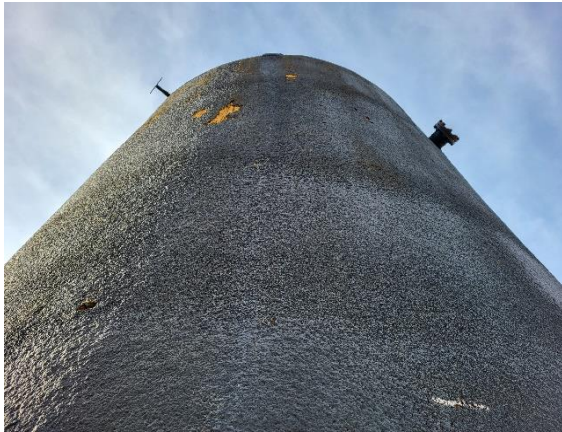
Insulation condition

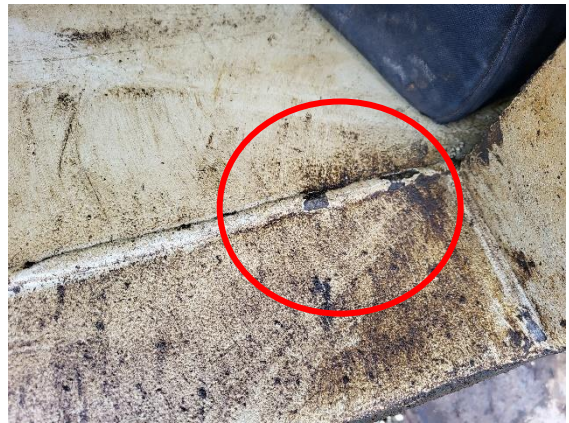
Coating chipped on manway weld

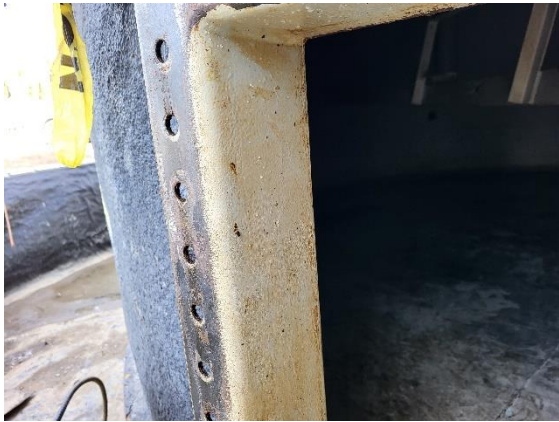
Manway entrance condition

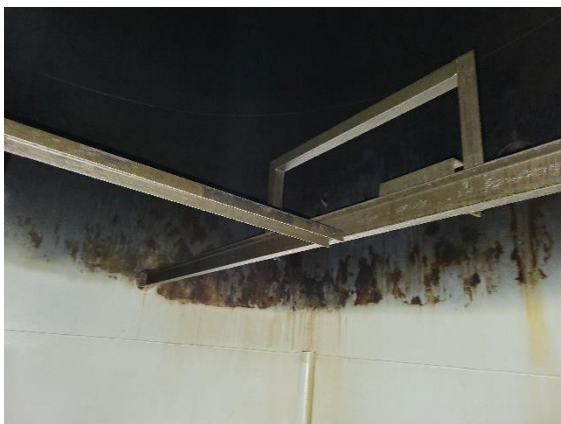
Heating tube support - tube permanently removed

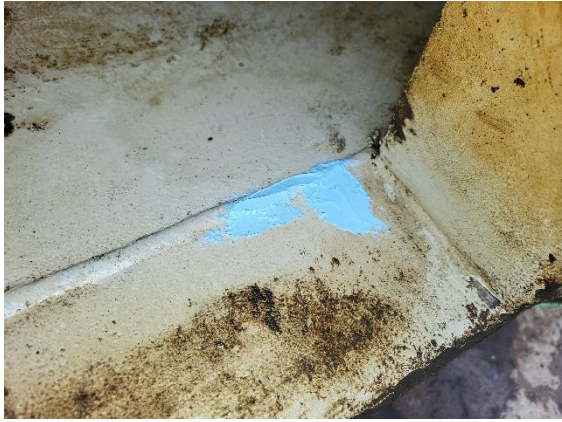
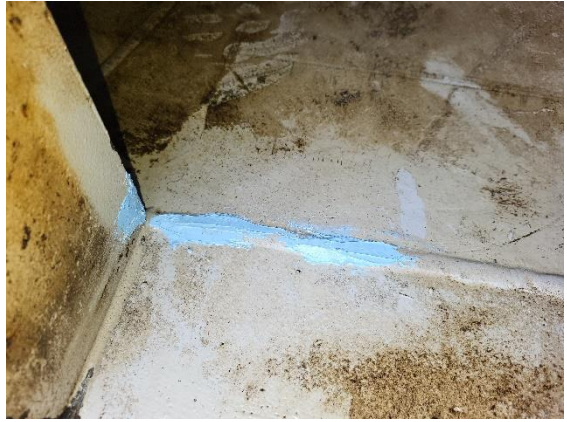
HEATING COIL	N/A				
FLOATS	Good	Appears to be in good working order.			
ANODES	N/A				
NDE PERFORMED	N/A				
Other	N/A				
<i>* Fair and Poor conditions require comment. Additional comments on following pages as required.</i>					
Internal Inspection Summary:	<p>Sales Tank internal in good overall condition. Tank bottom is epoxy coated up to the 1st course. 3 small areas of chipped coating near manway entrance - repaired by Echo NDE at time of inspection. Shell in good condition from 1st course and up - no corrosion or mechanical damage present. Nozzles are unobstructed with no signs of corrosion. Float is in good condition - wire has no damage. Previous coating patch areas appear to still be bonded. Tank is fit for continued service.</p>				
Fit for Service:					
YES

Epoxy patch area
