**Canadian Natural Resources Limited
GENERAL PRESSURE VESSEL INFORMATION**

Job# 10.111395

District: Fort St. John North	Skid No.
Facility: Umbach Compressor	Location (LSD): c-37-F/94-H-03
Vessel Name Equipment Number: Inlet Separator	
Orientation: Horizontal	
Status: In Service	Regulatory Inspection

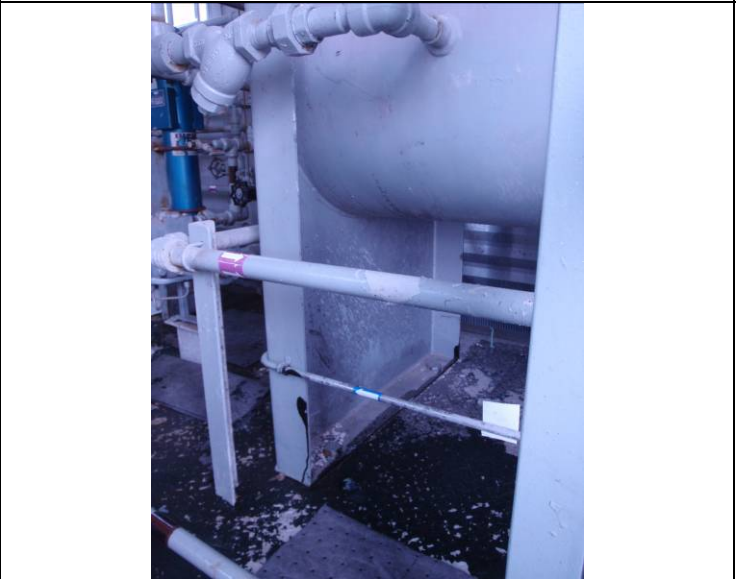
Anchor Bolts Hammer tap to ensure secure. Look for cracking in treads or signs of deformation.	X				Anchor bolts are securely fastened - no sign of deformation
Concrete foundation Check for cracks, spalling, etc.				X	None.
Ladder / Platform Describe general condition, ensure support is secure to vessel, describe any hazards.				X	None.
Nozzle Assess paint, look for leakage, and ensure stud threads are fully engaged. Record any damage, deflection, etc. Are nozzles gusseted?	X				Paint in good condition - Stud threads are fully engaged - No damage or deflections observed – no leaks. Nozzles are not gusseted.
Gauges Ensure gauges are visible, working, no leakage, and suitable for range of MAWP/Temp.	X				Pressure gauge: 0 – 1500 PSI Temp gauge: -40 – 160 F
External Piping Ensure pipe is well supported. All clamps, supports, shoes, etc. in place. Look for evidence of structural overload, deflection, etc. Paint condition, external corrosion?	X				Piping is well supported - No signs of structural overload, all clamps and supports are in place. Paint in good overall condition – no corrosion

Bolted to skid floor
