**Canadian Natural Resources Limited
GENERAL PRESSURE VESSEL INFORMATION**

Job # 10.112227

District: Fort St. John BC.	Skid No.
Facility: Milligan Main Battery	Location (LSD): b-63-G-94-H-2
Vessel Name Equipment Number: Line Heater	
Orientation: Horizontal	
Status: In Service	Regulatory Inspection

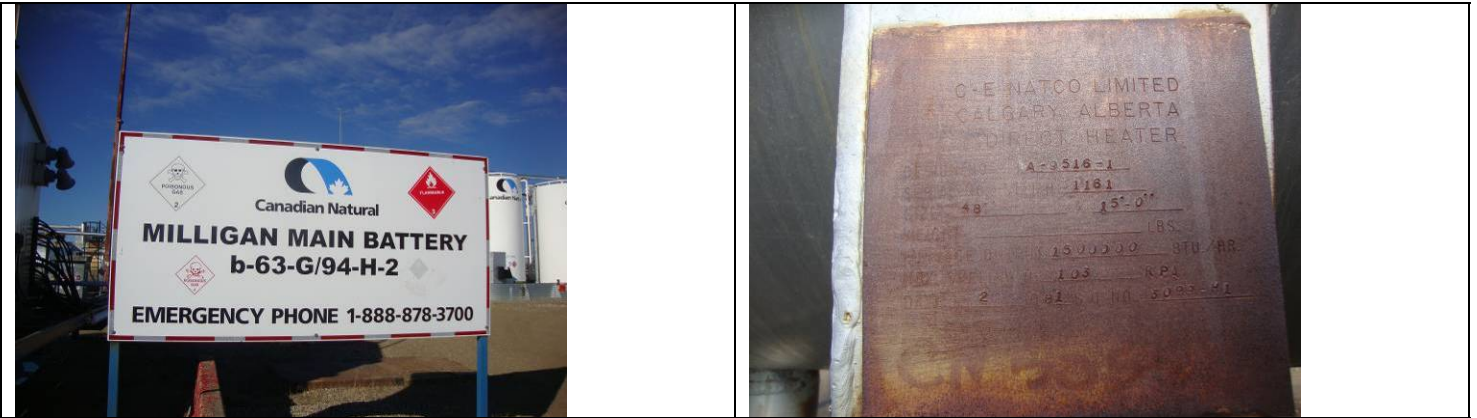
LSD

Vessel data plate

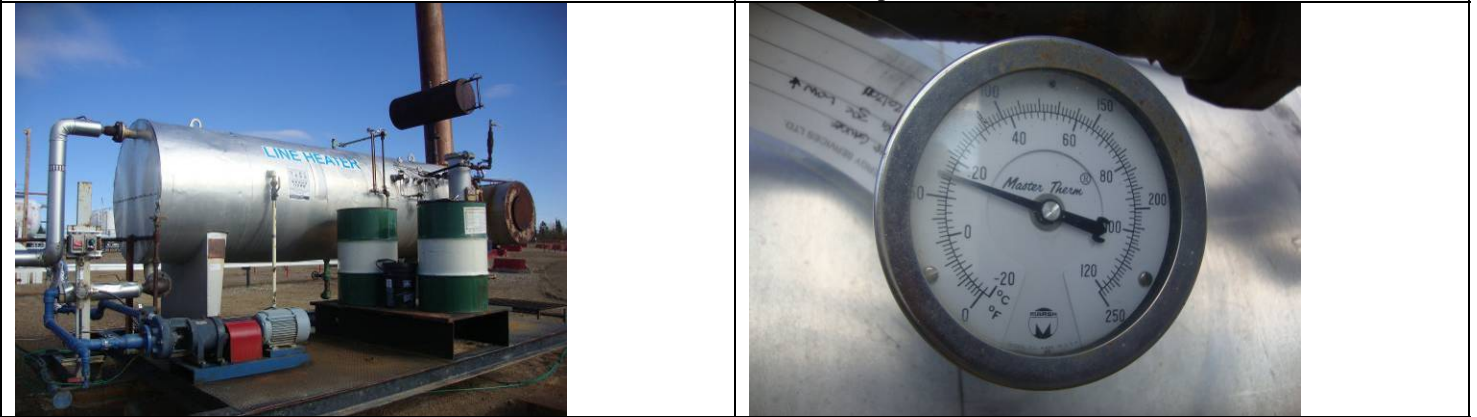
Vessel overview

Temperature gauge
