**Canadian Natural Resources Limited
GENERAL PRESSURE VESSEL INFORMATION**

Job 10.113250

District: Fort St. John	Skid No.
Facility: Milligan Battery	Location (LSD): b-63-G/94-H-02
Vessel Name Equipment Number: Glycol Heater	
Orientation: Horizontal	
Status: In Service	Regulatory Inspection

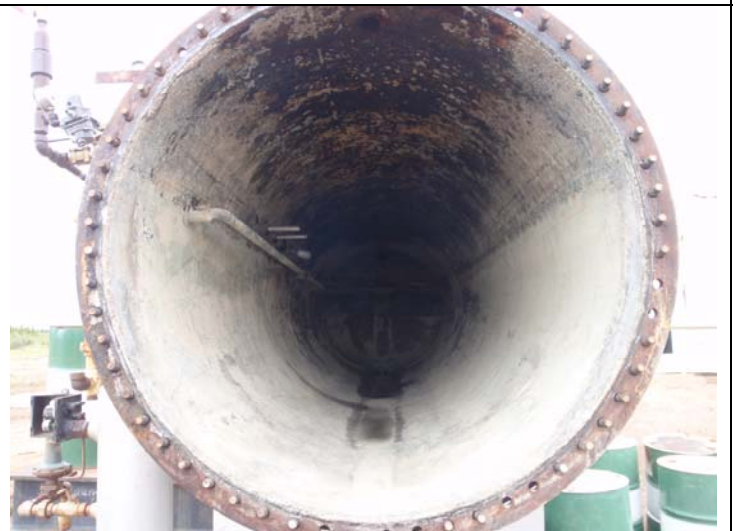
Burner removed

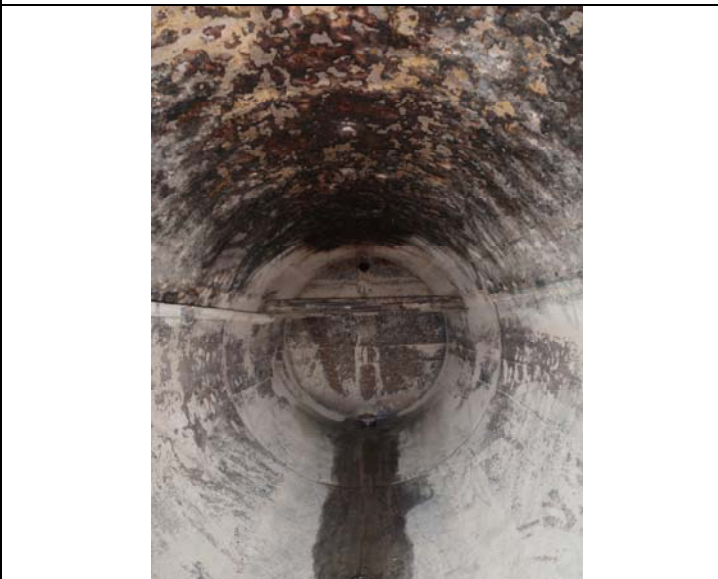
Line heater internal

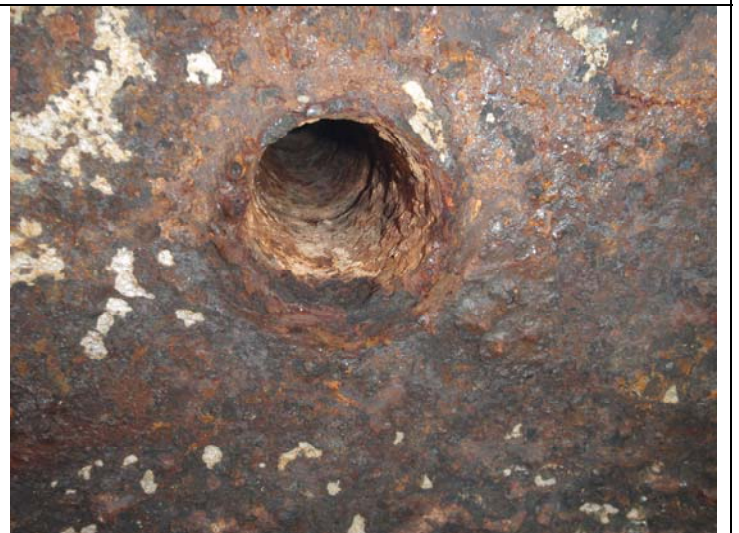
Internal nozzle – general surface corrosion and scaling

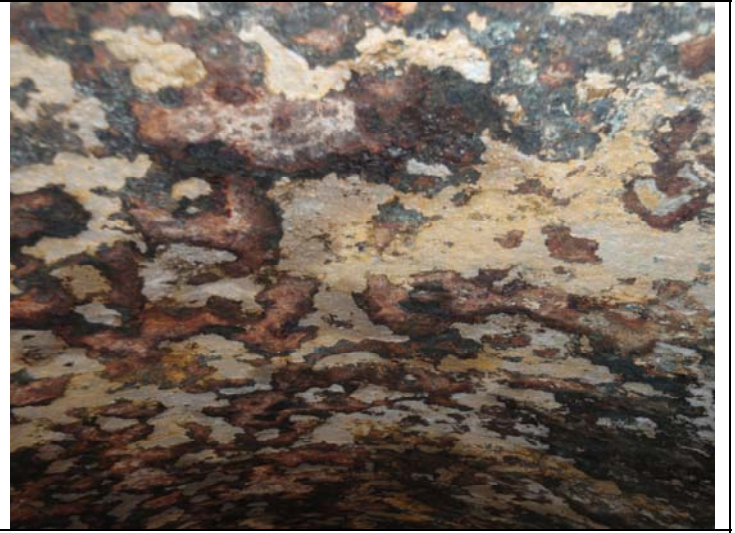
Scaling and general corrosion on upper shell
