**Canadian Natural Resources Ltd.**  
**GENERAL PRESSURE VESSEL INFORMATION**

**Job# 105.00390**

<b>District:</b> Ft St John, B.C.	<b>Skid No.</b>
<b>Facility:</b> Ladyfern Compressor	<b>Location (LSD):</b> b-88-H/94-H-01
<b>Vessel Name Equipment Number:</b> Heat Medium Heater	
<b>Orientation:</b> Horizontal	
<b>Status:</b> In Service	<b>Regulatory Inspection</b>

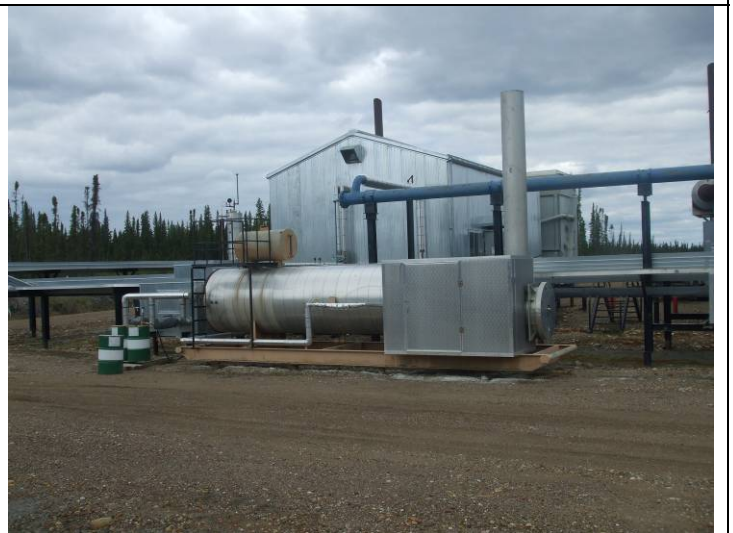
Overview

External Inspection Items	G	F	P	N/A	Comments
<b>Insulation</b> Verify sealed around manways, nozzles, no damage present, and there is no egress of moisture.	X				The Heat Medium heater is fully insulated & in good condition - no loose bands or open sections - no visible signs of moisture egress.
<b>External Condition</b> Assess paint condition, areas peeling, record any corrosion, damage, etc (record location, size and depth of corrosion or damage)				X	Shell is fully insulated.
<b>Leakage</b> Record any leakage at flanges, threaded joints, weep holes on repads, etc.	X				No leaking detected.
<b>Saddle</b> Assess condition of paint, fire protection, and concrete. Look for corrosion, buckling, dents, etc. Look at vessel surface area near supports. Verify no signs of leakage at attachment to vessel and attachment welds are acceptable. Ground wire attached?	X				Saddles covered by insulation. No visible corrosion – no missing paint. Ground cable firmly secured to Skid unit.

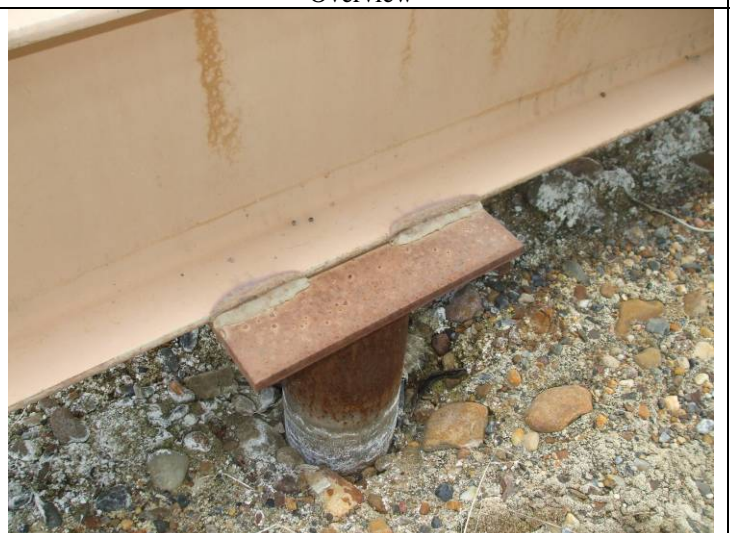
<b>Anchor Bolts</b> Hammer tap to ensure secure. Look for cracking in treads or signs of deformation.	X				The Heat Medium heater is firmly anchored to skid. No signs of deformation.
<b>Concrete foundation</b> Check for cracks, spalling, etc.				X	None.
<b>Ladder / Platform</b> Describe general condition, ensure support is secure to vessel, and describe any hazards.				X	None.
<b>Nozzle</b> Assess paint, look for leakage, and ensure stud threads are fully engaged. Record any damage, deflection, etc. Are nozzles gusseted?	X				All threads connections fully engaged. No deflection – no leaks. No gussets.
<b>Gauges</b> Ensure gauges are visible, working, no leakage, and suitable for range of MAWP/ Temp.				X	No Pressure gauge: No Temperature gauge:
<b>External Piping</b> Ensure pipe is well supported. All clamps, supports, shoes, etc. in place. Look for evidence of structural overload, deflection, etc. Paint condition, external corrosion?	X				Well supported – no deflection – all clamps and shoes in place. Piping is painted and in good condition – no surface corrosion found.

Skis securely anchored to the pilings
