**Canadian Natural Resources Limited
GENERAL PRESSURE VESSEL INFORMATION**

Job # 10.118371

District: Grande Prairie, AB.	Skid No.
Facility: Puskwa Field	Location (LSD): 16-32-71-26 W5M
Vessel Name Equipment Number: Group Separator	
Orientation: Vertical	
Status: In Service	Regulatory Inspection

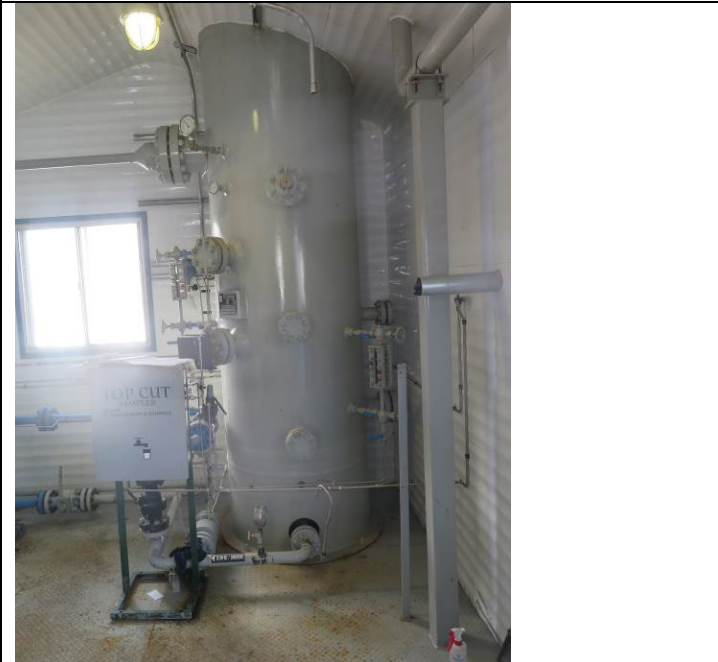
Vessel overview

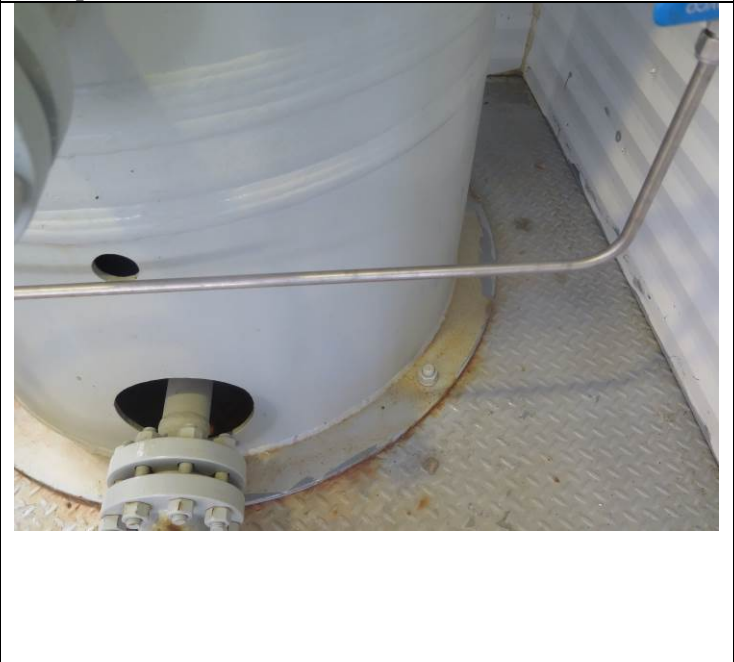
External Inspection Items	G	F	P	N/A	Comments
Insulation Verify sealed around manways, nozzles, no damage present, and there is no egress of moisture.				X	Vessel is not insulated.
External Condition Assess paint condition, areas peeling, record any corrosion, damage, etc (record location, size and depth of corrosion or damage)	X				Paint is in good overall condition – no exposed metal.
Leakage Record any leakage at flanges, threaded joints, weep holes on repads, etc.	X				No leaks observed.
Saddle/Skirt Assess condition of paint, fire protection, concrete. Look for corrosion, buckling, dents, etc. Look at vessel surface area near supports. Verify no signs of leakage at attachment to vessel and attachment welds are acceptable. Ground wire attached?	X				Skirt: no distortion to skirt – no buckles or dents. No corrosion at head to skirt welds – no leaks. Ground wire attached to skid.
Anchor Bolts Hammer tap to ensure secure. Look for cracking in treads or signs of deformation.	X				Firmly bolted to skid deck.

Base

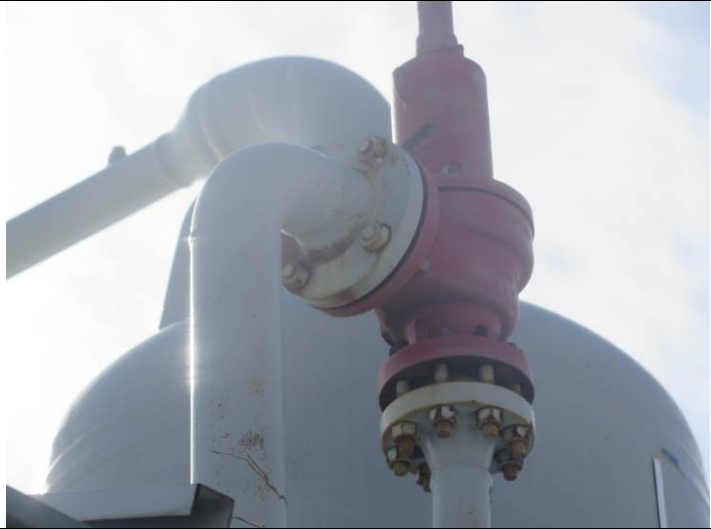
Valving Ensure no leaks are visible. Valves are properly supported and chained if necessary.	X				Valves are well supported – no leaks.
PSV Ensure PSV is set at pressure at or below that of vessel.	X				Location: Upper shell – set at MAWP of vessel. Discharge piping is same size as valve outlet. PSV seal in place – no block valve between vessel and PSV.
NDE methods Was UT/ MPI done on vessel (MI coordinator to review results)	X				Ultrasonic corrosion survey carried out – pipe metal thickness detected below nominal minus corrosion allowance. Thickness calculations carried out: UT point 11-35 (2" elbow) – nominal thickness is 5.5mm / min thickness is 4.5mm / T min thickness is 2.5mm
<p>Recommendations or corrective actions: (Vessel is Fit for Service or describe corrective actions required) (MIC to review corrective actions with Operations, discuss with Chief Inspector where necessary, and get remedial action implemented)</p> <p>Recommendations: 1. No recommendations.</p> <p>Summary: This vessel is in good condition, visual external and ultrasonic thickness inspection carried out – pipe metal thickness detected below nominal minus corrosion allowance. Thickness calculations carried out to ensure sufficient metal exists for safe operation.</p> <p>Corrosion rate based on greatest thickness loss (head) 0.100mm per year. Retirement Date to “T”min is year 2083.</p> <p>Vessel is fit for service.</p>

PSV
