anadian Natura AL PRESSURE				RTI	D 10.116029		
District: Fort St. John	n, BC	Skid No.	Skid No.						
Facility: Flatrock Co	Location (L	Location (LSD): 15-20-85-17 W6M							
	ipment Number: Horizontal T	reater		,					
Orientation: Horizon									
Status: In Service			Regulato	Regulatory Inspection					
Status. In Scrvice	PRES	SSURE VESSEL		* *					
"A" or "G" or "S" (S	Sask.) or BC Registration Nun		CRN Number						
	C38596		H 8265.231						
Vessel serial number		Size: 6 ft x	H 8265.231 Size: 6 ft x 24 ft						
Shell thickness: Not				rial: Not Stated	d				
Head thickness: Not			Head material: Not Stated						
Tube wall thickness:				Tube material:					
Tube diameter:			Tube length:						
Channel thickness:				Channel material:					
MAWP	Shell: 70 PSI		Operating p	Operating pressure					
	Tubes:								
Design Temp.	Shell: 200 ° F	Operating t	Operating temperature						
	Tubes:								
X-ray: RT-4		Heat treatm	Heat treatment: Not Stated

Photo Table

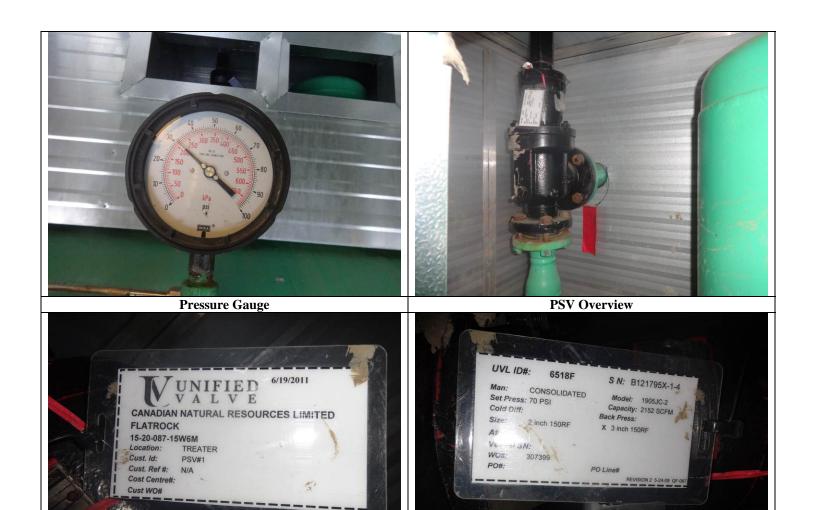
PSV Service Tag
