**Canadian Natural Resources Limited
GENERAL PRESSURE VESSEL INFORMATION Job # 10.110451**

District: Fort St John, B.C.	Skid No.
Facility: Flat Rock Battery	Location (LSD): 15-20-85-17 W6M
Vessel Name Equipment Number: Treater	
Orientation: Horizontal	
Status: In Service	Regulatory Inspection

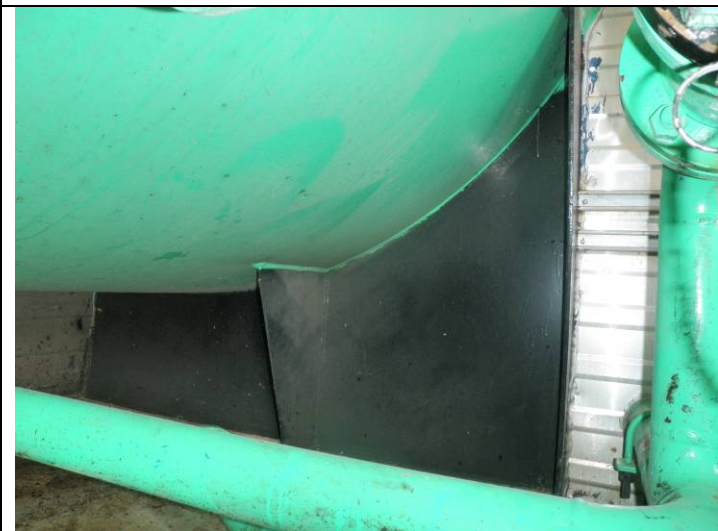
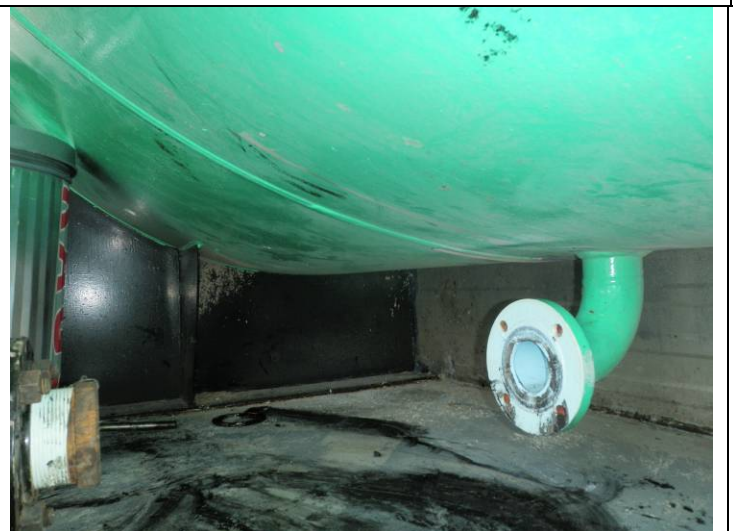
Anchor Bolts Hammer tap to ensure secure. Look for cracking in treads or signs of deformation.	X				Saddles are firmly welded to skid floor. No signs of corrosion.
Concrete foundation Check for cracks, spalling, etc.				X	None.
Ladder / Platform Describe general condition, ensure support is secure to vessel, and describe any hazards.	X				Firmly intact. No loose or missing hardware.
Nozzle Assess paint, look for leakage, and ensure stud threads are fully engaged. Record any damage, deflection, etc. Are nozzles gusseted?	X				No deflection – no leaks. Stud threads fully engaged, no gussets. Paint is in good overall condition.
Gauges Ensure gauges are visible, working, no leakage, and suitable for range of MAWP/ Temp.				X	Removed for service.
External Piping Ensure pipe is well supported. All clamps, supports, shoes, etc. in place. Look for evidence of structural overload, deflection, etc. Paint condition, external corrosion?			X		Well supported – no deflection – all clamps and shoes in place. Piping is painted and is in good overall condition.

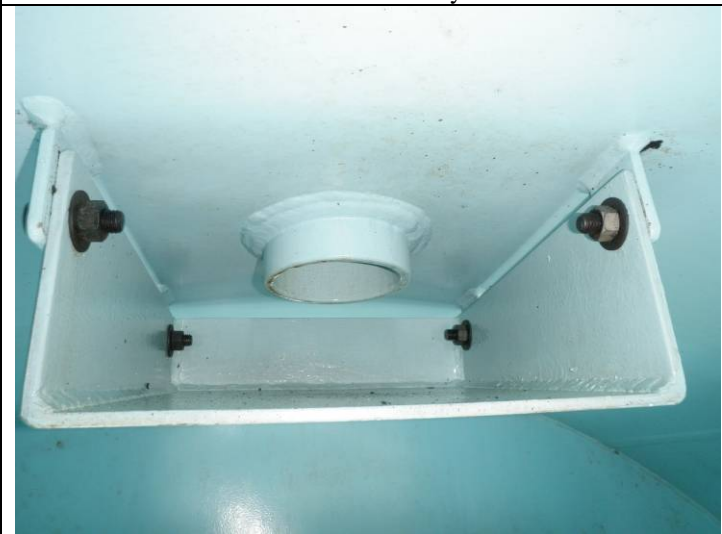
Inlet nozzle and deflector plating (no erosion)

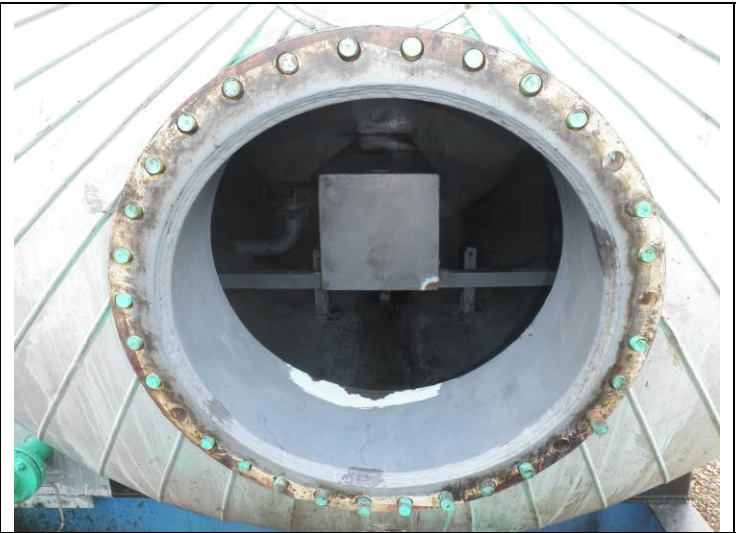
Internal Inspection Items	G	F	P	N/A	Comments
Coating Assess coating. Describe area coated, general condition of coating.	X				Coating is in good overall condition. Some minor failures at manways and shell. These coating failures were patched with Davoe #142
Anodes. How many, type, condition. % consumed. Are they being replaced?	X				4 Anodes are installed in Treater. Consumption ranges from 30 – 50%. Anodes are to be replaced during this outage.
Internal Piping Is there any? If so, carbon or stainless steel. Describe condition, dents, corrosion, erosion, etc. Ensure supports are secure and any bolts are suitable for future use.	X				Internal piping is in good condition. No signs of deflection. Well supported.
Trays How many? Type of material. Are valves in place? Check for erosion/ corrosion; wear on tray valve legs. Cleanliness?				X	No trays.
Baffles, deflector plates, etc. If present, describe condition. Look closely at welds attached to vessel wall.	X				Inlet deflector plating is intact. No signs of erosion. Electro-plating is firmly attached to shell. This equipment is no longer in use. There is erosion to the plating (5 %), but this does not affect the structural integrity of the plating.

Overview (erosion on electroplating – no longer in service)

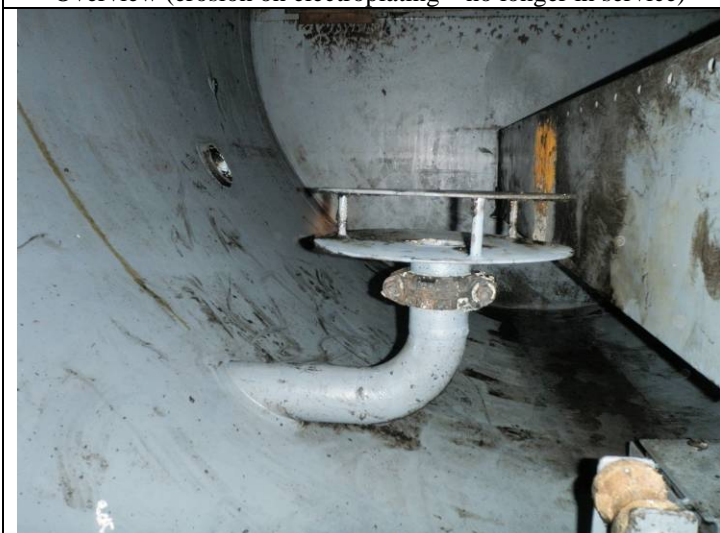
South Head Note all corrosion, erosion or mechanical damage. (If vessel is horizontal identify direction of this head)	X				Head is in good condition. No corrosion or no pitting. No signs of damage or distortion.
North Head Note all corrosion, erosion or mechanical damage. (If vessel is horizontal identify direction of this head)	X				Head is in good condition. No corrosion or no pitting. No signs of damage or distortion.
Shell Sections Record number of shell sections. Record location, size and depth of all erosion, corrosion or mechanical damage. Describe general condition. If any corrosion greater than corrosion allowance is observed in either shell or head, discuss with Chief Inspector before closing vessel.	X				Shell sections are in good condition. No signs of damage or distortion. No signs of erosion or corrosion. Signs of bio-fouling on shell. This is surface only and is not penetrating the coating.

Bio-fouling on weir – surface only

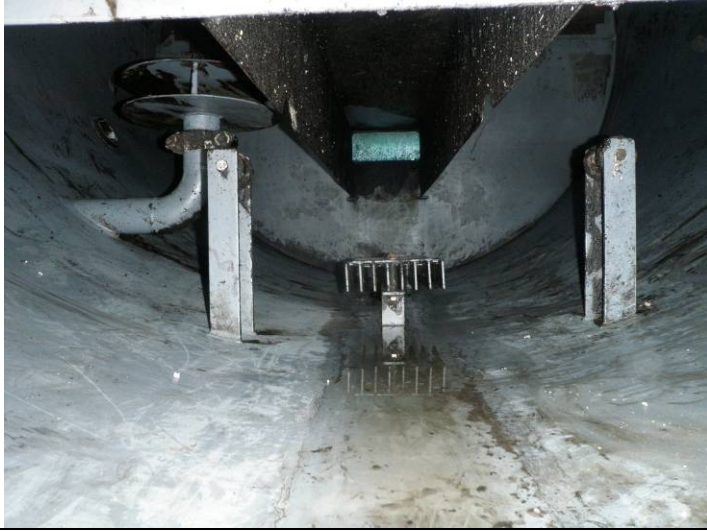
Head to shell surface and weld
