**Canadian Natural Resources Limited  
GENERAL PRESSURE VESSEL INFORMATION**

**Job 4021893**

District: <b>Grande Prairie, AB</b>	Skid No.
Facility: <b>South Wapiti Compressor Station</b>	Location (LSD): <b>10-01-68-09 W6M</b>
Vessel Name Equipment Number: <b>Inlet Separator</b>	
Orientation: <b>Horizontal</b>	
Status: <b>In Service</b>	<b>Regulatory Inspection</b>

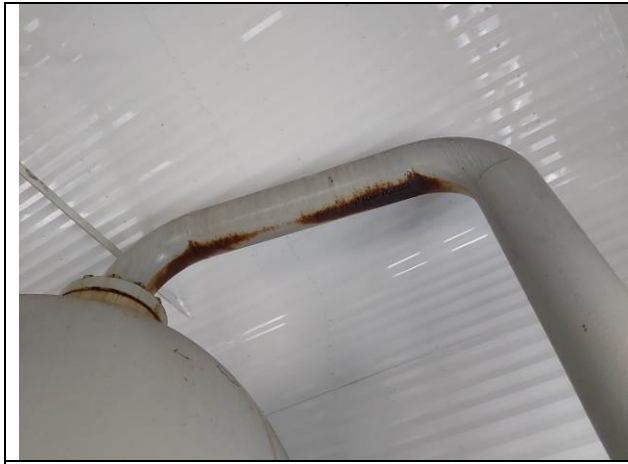
**Outlet piping – surface corrosion – no pitting**

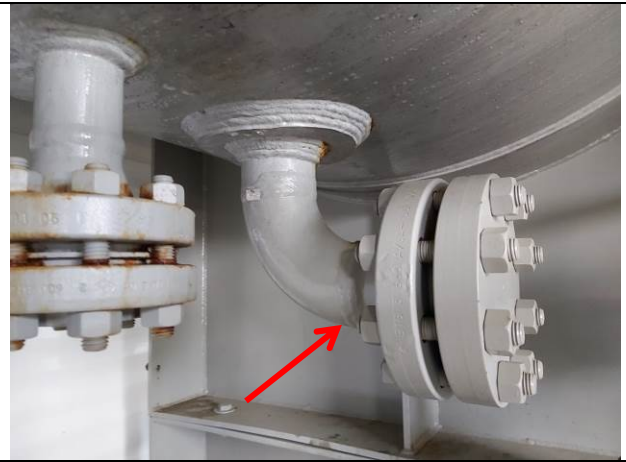
<b>NDE methods</b> Was UT/ MPI done on vessel (MI coordinator to review results)	X			<b>Ultrasonic corrosion survey carried out – pipe metal thickness detected below nominal minus corrosion allowance. Thickness calculations carried out:</b> <b>UT point 365 (2” elbow) – nominal thickness is 8.7mm / min thickness is 7.9mm / T min thickness is 2.5mm.</b> <b>2” nozzle – nominal thickness is 8.7mm / min thickness is 3.5mm / T min thickness is 2.5mm.</b> <b>3” nozzle – nominal thickness is 15.2mm / min thickness is 9.4mm / T min thickness is 3.1mm.</b>
--	---	--	--	--

3 in xxs – 9.4/11.8mm isolated pit at DS weld

**Recommendations:** 1. Plan for nozzle replacements on this vessel in the future.

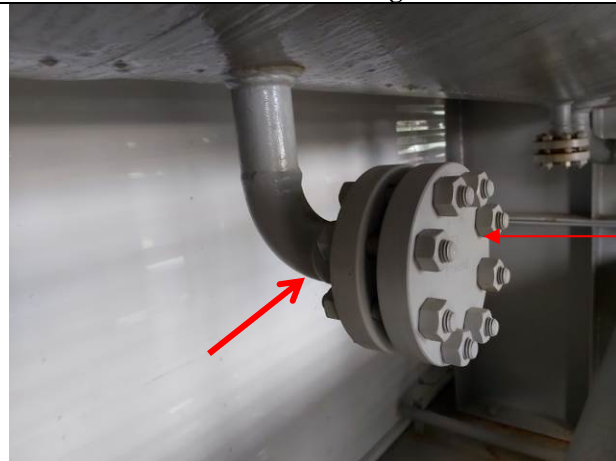
**Corrosion rate based on greatest thickness loss (2 inch nozzle) 0.300mm per year. Retirement Date to “T”min is year 2023.**

2 in 160 – 3.5/7.0mm isolated pit at DS weld

Elbow scheduled for replacement

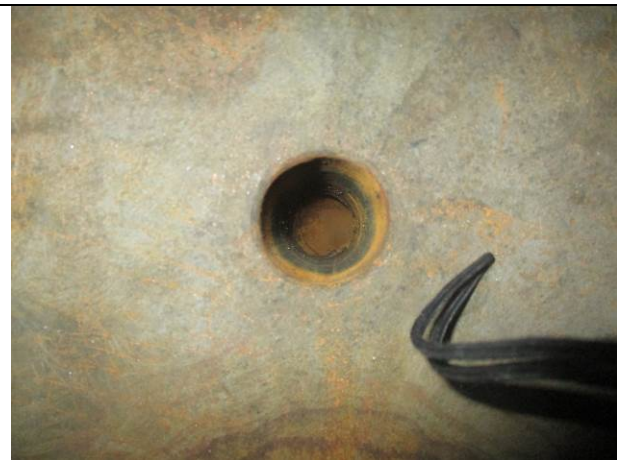
**2 inch nozzle scheduled for fitting replacement**

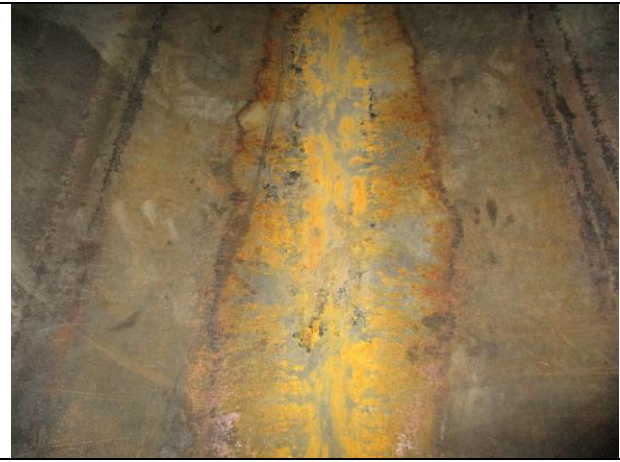
**Thin scale on bottom shell – no pitting**

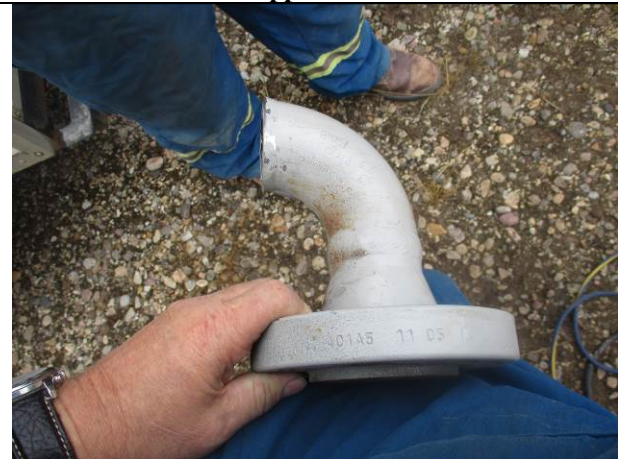
**2 inch fitting cut from vessel – deep pitting detected on corrosion survey**

<b>Steps</b>	<b>Comments</b>
<b>Cut off corroded nozzle</b>	<b>The corroded elbow was removed at the butt weld to nozzle</b>
<b>MTR reviewed</b>	<b>Reviewed and accepted</b>
<b>Prep weld areas</b>	<b>Existing nozzle prepped for new fitting</b>
<b>Fit up new fitting and tack in place</b>	<b>Fitting tack welded in place and checked for two hole and level</b>
<b>Install root of weld</b>	<b>Completed</b>
<b>Magnetic particle inspect root weld</b>	<b>Completed – Passed</b>
<b>Complete welding operation</b>	<b>Completed</b>

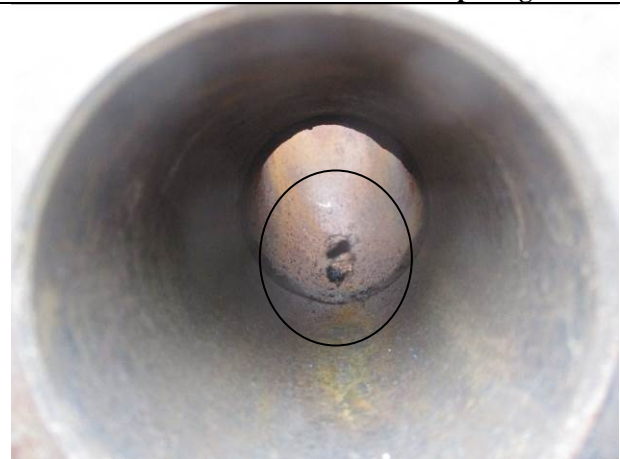
**2 inch fitting – deep pitting detected on corrosion survey**
