**Canadian Natural Resources Limited
GENERAL PRESSURE VESSEL INFORMATION**

Job# 05.001317

District: Grange Prairie AB.	Skid No.
Facility: Gold Creek Gas Gathering	Location (LSD): 02-11-68-06-W6M
Vessel Name Equipment Number: Treater (Crude Emulsion)	
Orientation: Horizontal	
Status: In Service	Regulatory Inspection

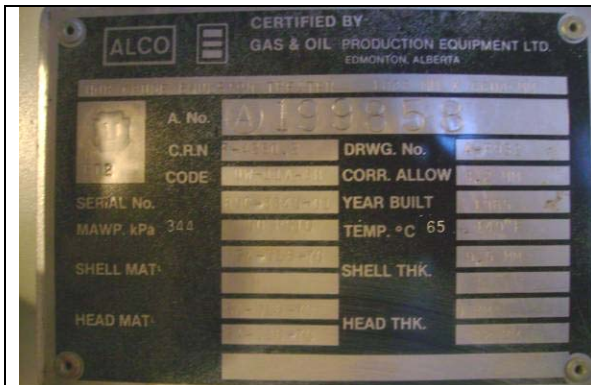
vessel data plate

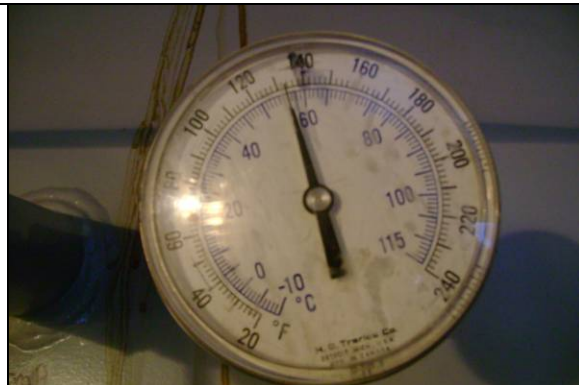
vessel temperature gauge

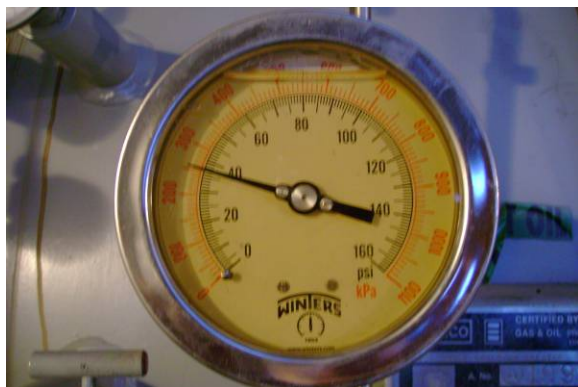
vessel pressure gauge

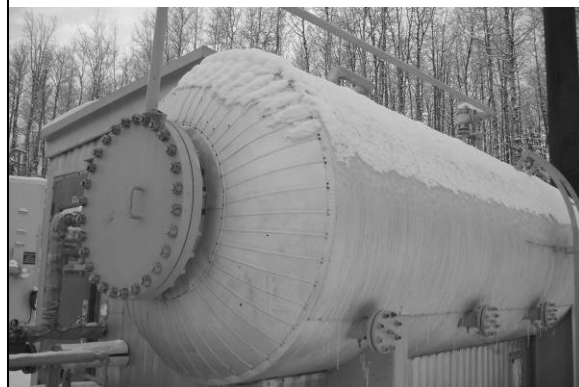
vessel overview of manway

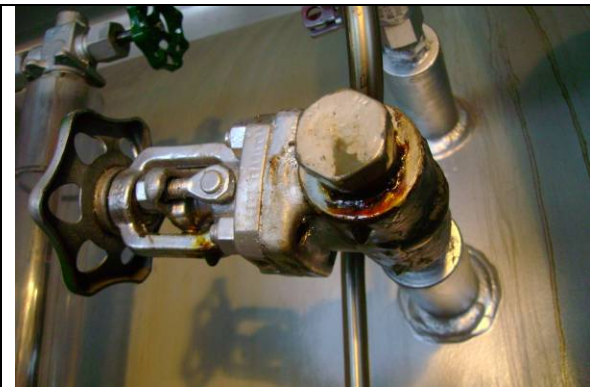
Valving Ensure no leaks are visible. Valves are properly supported and chained if necessary.		X			Leaks are visible at valve. Valves are supported properly
PSV Ensure PSV is set at pressure at or below that of vessel.	X				Located on top shell – set at MAWP of vessel. PSV sent out for servicing at this time. Discharge piping is same size as valve outlet – found plugged with hydrate – cleaned out. PSV seal in place – no block valve between vessel and PSV.

leak at valve

Recommendations: Seal all leaking pipe and valve joints identified with leaks.

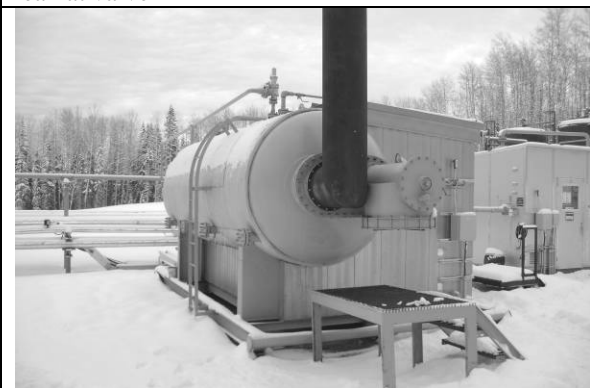
vessel overview
