<p>RTD QUALITY SERVICES INC. #104, 11302 – 98 AVENUE GRANDE PRAIRIE, ALBERTA T8V-8H4 PHONE 1-780-814-7227 FAX 1-780-402-3030</p>	<p align="center">GENERAL NDE REPORT</p> <p>Date <u>September 29, 2015</u> Page <u>1</u> of <u>3</u> RTD Job #: <u>10.116626</u> RTD Dep. #: <u>Grande Prairie Asset</u></p>
--	---

Client: <u>Canadian Natural Resources Limited</u> Address: <u>Grande Prairie, AB</u> P.O.#: _____ Client Rep.: <u>Jordan Hack</u>	Lot #: <u>LaGlace North Oil Battery</u> Location: <u>LSD: 10-14-76-10 W6M</u> Procedure: <u>MT-005 Rev. 4, UT-001 Rev. 4</u> Code: <u>ASME VIII Div 1</u>
--	--

Description: To perform Ultrasonic, Magnetic Particle and Visual inspection on two fire tubes removed from Oil Treater A0245115

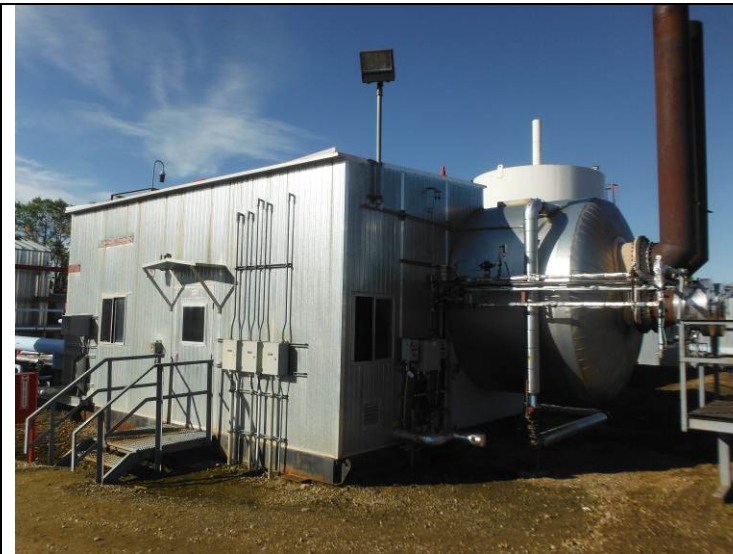
Overview Treater

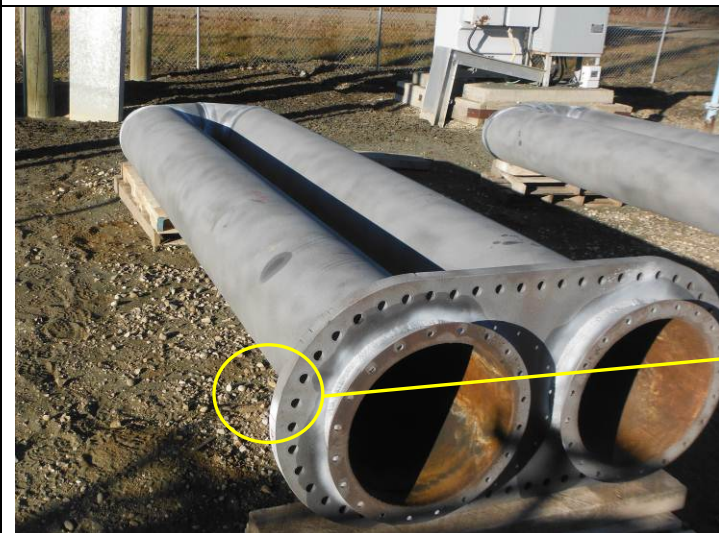
Overview – Firetube RT

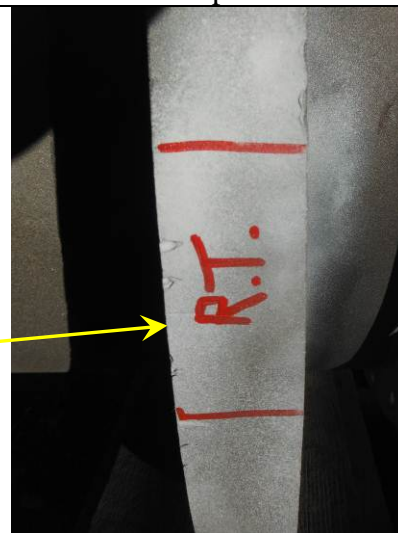
Firetube stamped RT

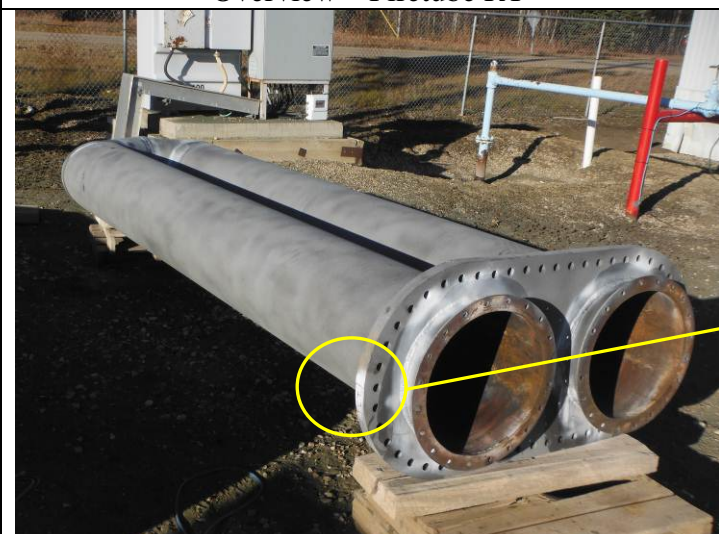
Overview – Firetube LT

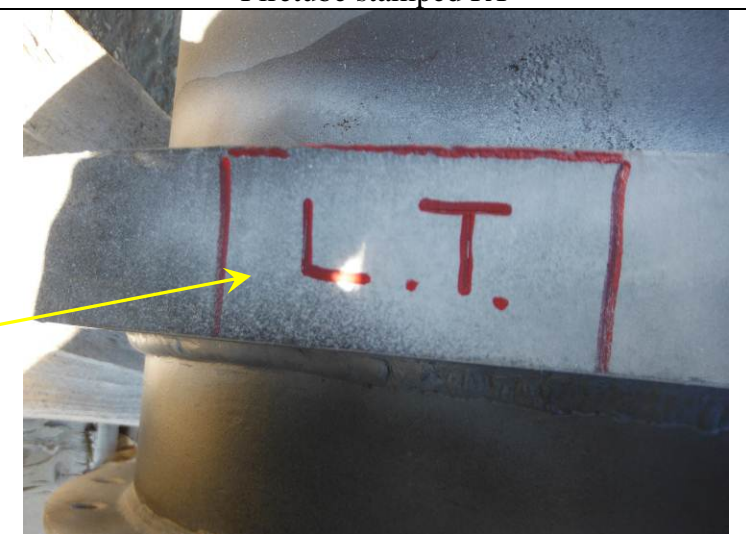
Firetube stamped LT

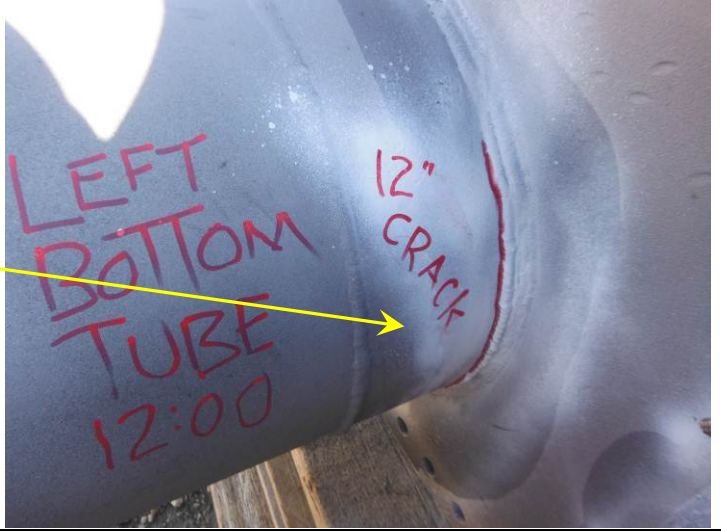
Results: **1. Magnetic particle inspection:**
Fire tube RT: No cracking detected.
Fire tube LT: 12 inch crack identified on bottom tube to plate weld 10:00 to 2:00 position.

Firetube LT – 12 inch crack location

Repairs: **1. Carry out weld repair on identified crack on fire tube LT using an approved CNRL repair procedure.**
