**Magnetic Particle  
 Inspection Report**

MT\_87-3568-0\_jun2013

Client: Devon Canada Corporation		Equipment Owner: Devon		Date: June 11, 2013	
Item Inspected: Both Fire Tubes from Treater			Acceptance Code: ASME VIII, Div 1		
Location: Valhalla Oil Battery 10-14-76-10 w6m					
Procedure: MT-01	Surface Preparation: Sand Blasted	Method: Wet Continuous	Light Source: 3 x C cell Halogen		
Equipment: AC Yoke	Manufacturer: Magnaflux	Serial # HY-10	Cal. Due: Oct 1, 2013	Cal Std: ASME 10 lbs S/N: A392	
Contrast Paint: Magnaflux WCP-2	Batch# 02269	Black Light: None	Cal. Due: N/A	Serial # n/a	
Wet Particles: Magnaflux 7HF	Batch# 00116	Particles: N/A	Batch # N/A	Temp: 10-20'C

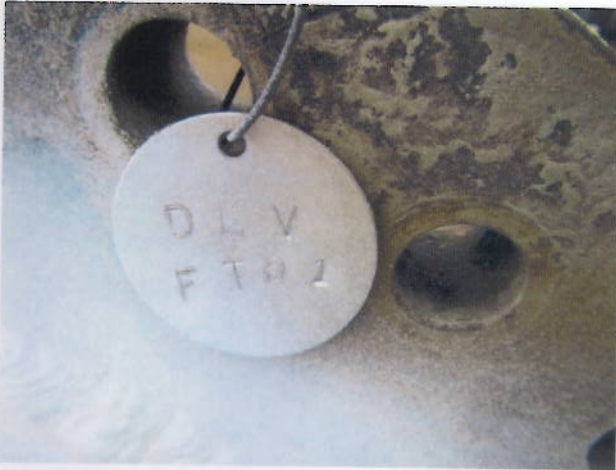
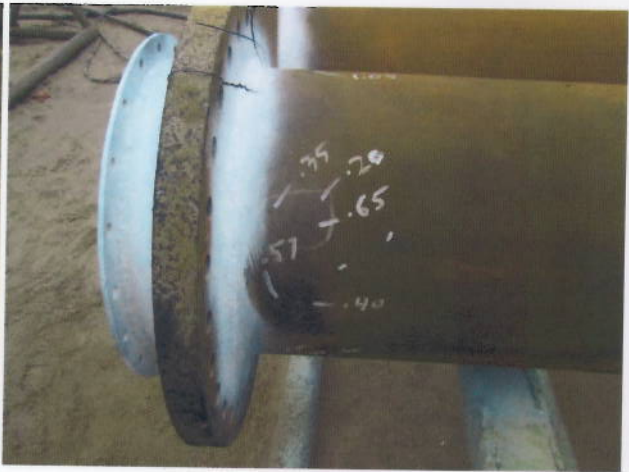
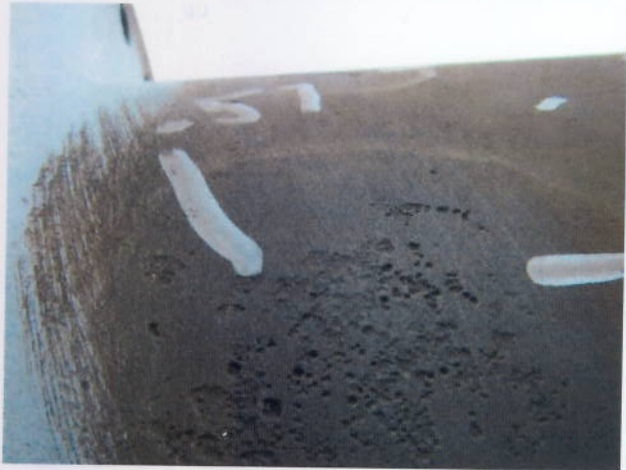
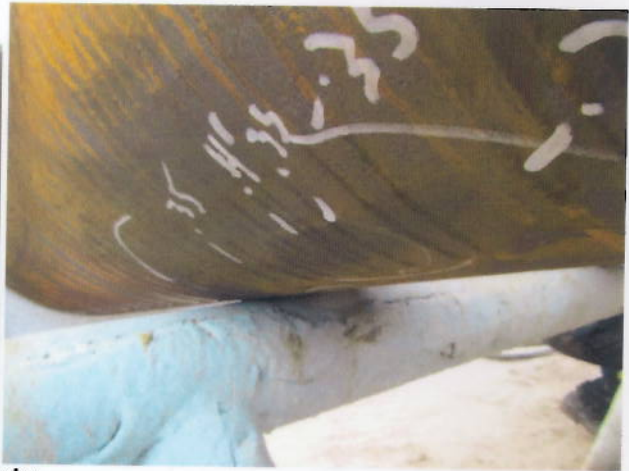
These fire tubes were left in the rain overnight after sandblasting and were covered with a wet thick rust. The surface of these tubes were cleaned as much as possible with rags and a wire brush but the visual inspection was still limited. There is areas of corrosion and pitting on all sides of both fire tubes. The average depth of the pitting on tube 1 is 0.53mm . The deepest pit found on tube 1 was 1.05mm. The average depth of the pitting on tube 2 is 0.22mm . The deepest pit found on tube 2 was 0.47mm.

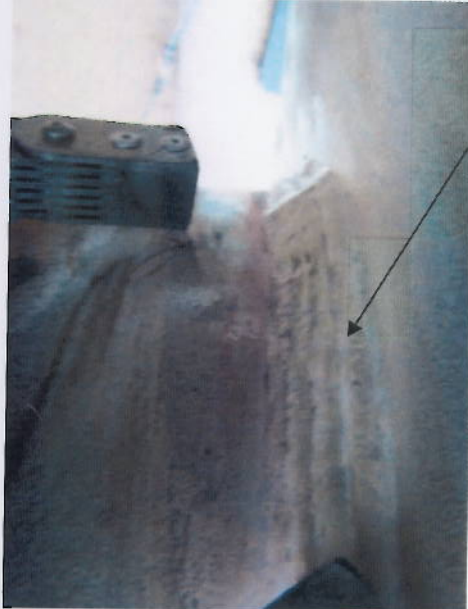
Three small cracks were found on the back of the flange to tube weld. Cracks were removed.

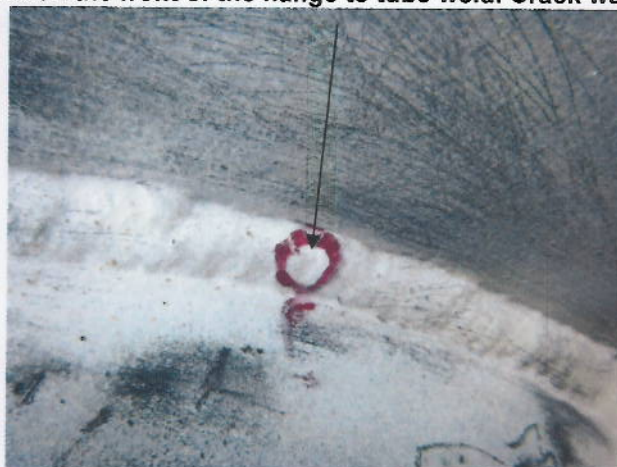
Crack found on the front of the flange to tube weld. Crack was removed.
