**Canadian Natural Resources Limited  
GENERAL PRESSURE VESSEL INFORMATION**

**Job 10.116529**

District: <b>Grande Prairie, AB</b>	Skid No.
Facility: <b>LaGlace North Oil Battery</b>	Location (LSD): <b>10-14-76-10 W6M</b>
Vessel Name Equipment Number: <b>Oil Treater</b>	
Orientation: <b>Horizontal</b>	
Status: <b>In Service</b>	<b>Regulatory Inspection</b>

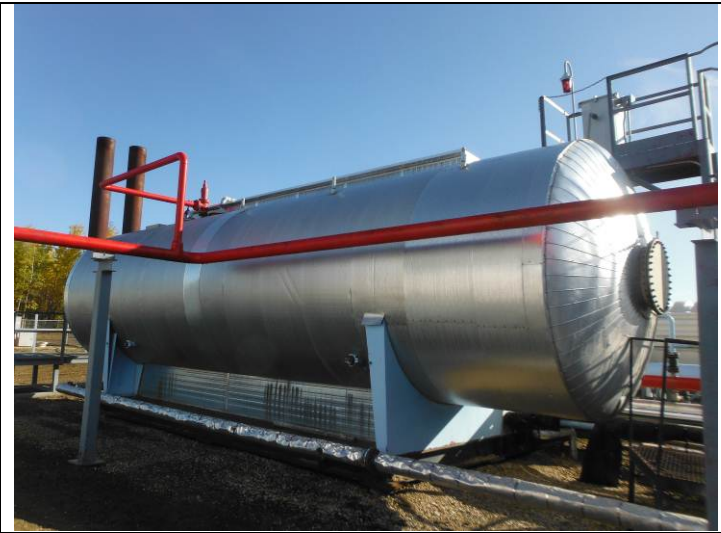
Overview and PSV location

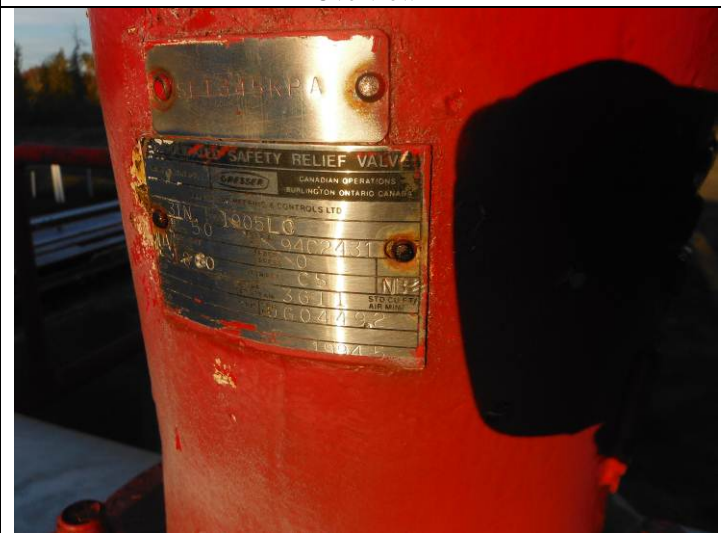
PSV data plate – service tag removed

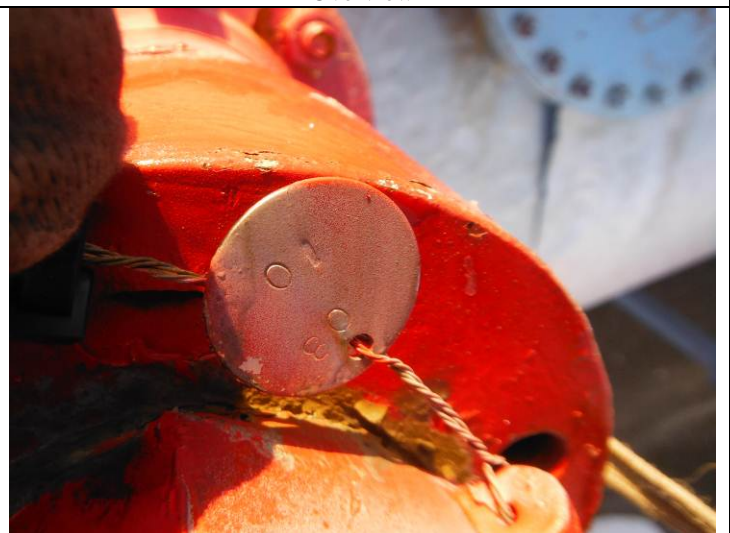
Unified Valve service coin – 03/2010

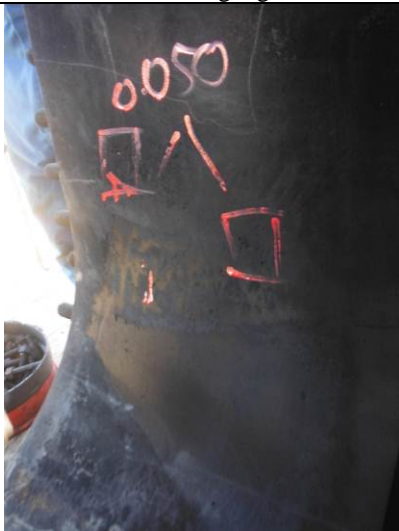
Firetube throat – corrosion to 0.050 depth

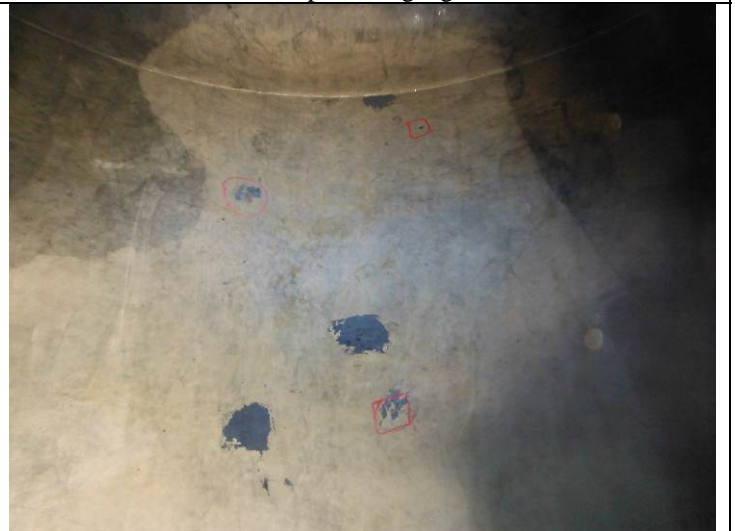
<b>Internal Inspection Items</b>	<b>G</b>	<b>F</b>	<b>P</b>	<b>N/A</b>	<b>Comments</b>
<b>Coating</b> Assess coating. Describe area coated, general condition of coating.	X				<b>Vessel is coated with epoxy. Several coating chips on lower shell repaired at time of inspection.</b>
<b>Anodes.</b> How many, type, condition. % consumed. Are they being replaced?	X				<b>All anodes will be replaced during TAR.</b>
<b>Internal Piping</b> Is there any? If so, carbon or stainless steel. Describe condition, dents, corrosion, erosion, etc. Ensure supports are secure and any bolts are suitable for future use.	X				<b>Good condition – no pitting, corrosion or mechanical damage.</b>
<b>Trays</b> How many? Type of material. Are valves in place. Check for erosion/ corrosion; wear on tray valve legs. Cleanliness?				X	<b>No trays.</b>
<b>Baffles, deflector plates, etc.</b> If present, describe condition. Look closely at welds attached to vessel wall.	X				<b>Internal baffles and weir plate is in good condition with no corrosion. No mechanical damage. No welding defects on attachment welds.</b>

Bottom shell – several coating chips

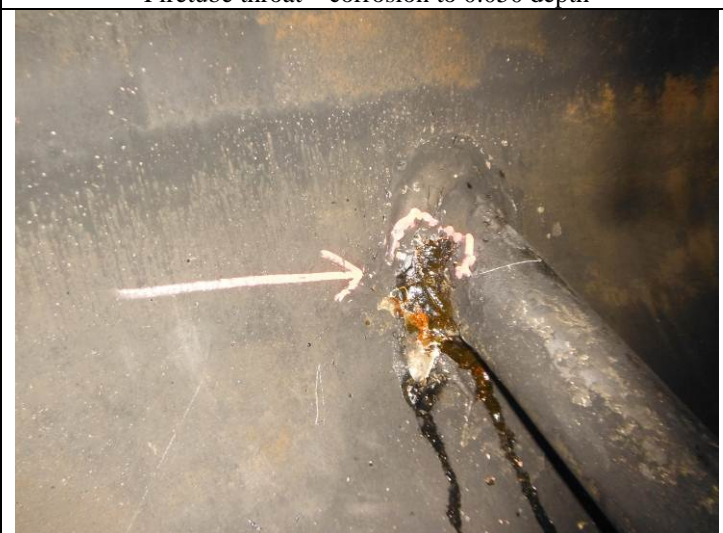
<b>Welds</b> Inspect all welds, including attachment welds. Record all service-related damages and if there is any discuss with Chief Inspector before closing.	X				<b>Through-wall in firetube support weld. ll welds area in</b>
<b>Repairs Required.</b> If yes, ensure procedure and copy of AB 40 is on file, and one sent to local ABSA, and Chief Inspector	X				<b>Repair firetube support structure.</b>
<b>NDE</b> Was any NDE done. ( MI coordinator to review results)		X			<b>Magnetic particle inspection carried out on fire tube. 12 inch crack detected on firetube. Reference MT report.</b>
<p><b>Recommendations or corrective actions : Vessel is Fit for Service or describe corrective actions required)</b>  (MIC to review corrective actions with Operations, discuss with Chief Inspector where necessary, and get remedial action implemented)  <b>Recommendations: 1.Repair fire tube and firetube support structure using an approved CNRL repair procedure.</b>  <b>Summary:</b> This vessel is in good overall condition, visual internal carried out.  <b>Vessel is fit for service</b></p>

Firetube support – weld through-wall location

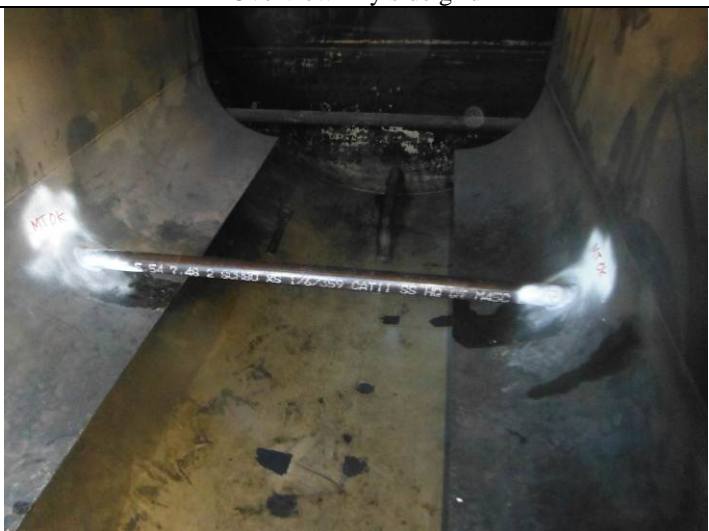
New firetube support – MT ok

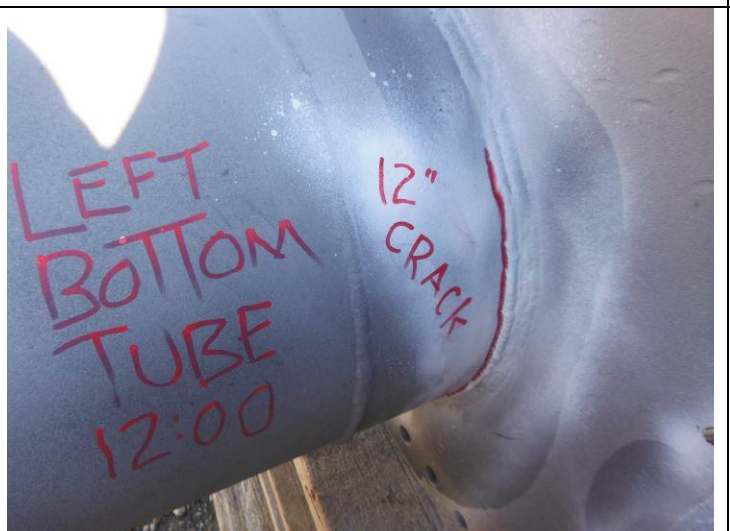
Overview Firetube LT crack location – reference MT report
