Report No: DH000047

Client	Harvest Operations Corporation	Inspection Date	Mar 2, 2009		
Prov. Reg. #	AB 2910927	Inspection Type	VE / UT		
Equipment	Glycol Contactor	LSD	11-06-071-11W4		
Tag/Equip. #		Location	Piche		
Status	In Service	Area			
Manufacturer	ALCO Gas & Oil	Comp/Unit			
Serial Number	93C-5030-01	Service	Sweet		
CRN #	M1842.2	Year Built	1993		
Unit Name		Manway	None		
Nat. Board #:		Coating			
Next Inspection	2013	Next Insp Type	VE / UT		
Length		Height	300 in		
Volume		RT	2	HT	
Job No.	09-0096	Owned By			
Foreman					
ABSA	Plant: H	Vessel: P	Process: G	Special: B	ASME Sec. VIII div. 1
History Log

Component	Vertical Shell				
MAWP	1650 PSI @ 150 °F		MDMT	-20 °F @ 1650 PSI	
Material	SA-516-70N	Material Thickness	1 in		
Diameter	20 in	Length			
Corrosion Allowance	0.063 in

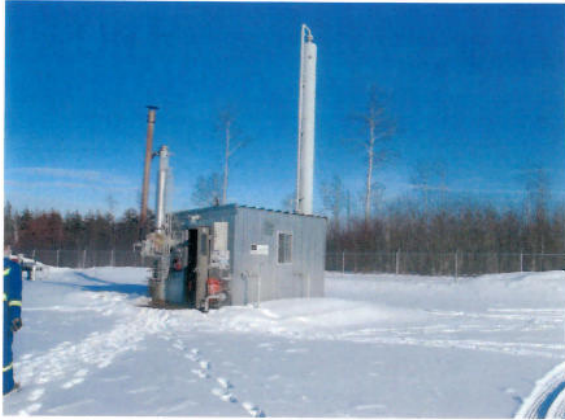
Figure: 1

The building was generally in good condition and well supported. The checker plate steel floor was clean and in good condition. The building was well lit. The doors and windows functioned well and were in good condition. The cladding was generally in good condition with small dents throughout. There were no combustibles in the building. There was generally good access to the equipment in the building.

Building

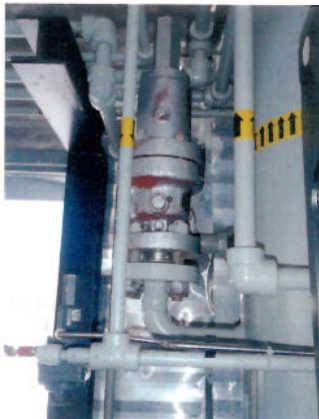
Figure: 2

The PSV was securely attached to the piping and in good condition. The PSV outlet piping provided positive drainage for the valve. The vent size was adequate and vent lines were positioned safely. The valve was mounted in the vertical position. The seal wire was securely attached and in good condition. The nameplate was securely attached and legible. The service tag was securely attached. The set pressure was acceptable for the vessel. The PSV was last serviced in April 2005.

PSV

1. The PSV is due for service. After the PSV is serviced please forward a copy of the service report to RAE Engineering for review.
2. The vessel is otherwise fit for service.

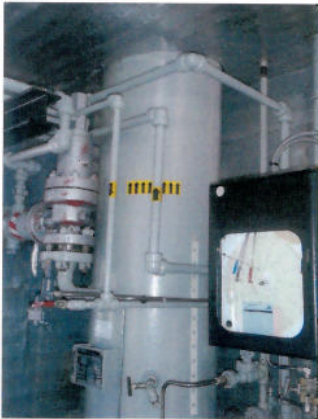
Figure: 3

The nameplate was legible and securely mounted to the vessel. The vessel was identified as per the A-number on the nameplate. The vessel was painted and the paint was in good condition. The heads, shell, nozzles and bolting appeared to be in good condition. There was no damage or distortion evident on the vessel surface. There was no stress evident on piping or nozzle connections. The vessel was adequately supported. The vessel had flanged connections, with no evidence of leakage at the piping connections. The gauges were in good condition. The vessel was vertical and mounted on a skirt that was bolted to the floor with 4 bolts. There was limited access to the bottom head through the skirt of the vessel. There were no structural attachments fixed to the vessel. The roof seal was in good condition showing no signs of leaks.

Vessel Mid Shell View

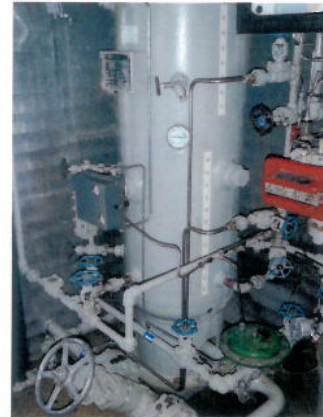
Figure: 4

Vessel Lower Shell & Bottom Head View

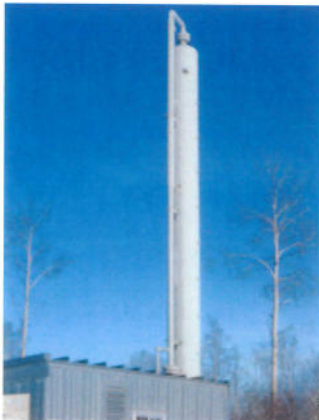
Figure: 5

Vessel Top View

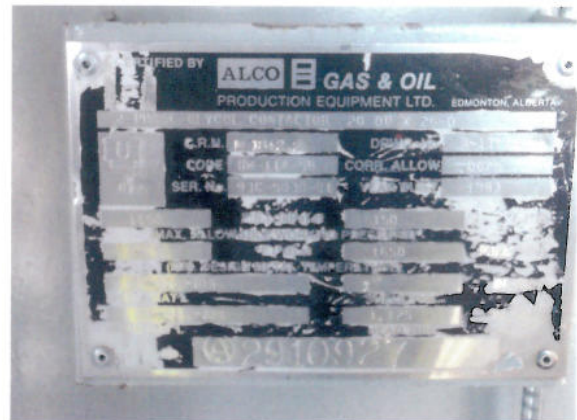
Figure: 6

Nameplate
