**Canadian Natural Resources Limited
GENERAL PRESSURE VESSEL INFORMATION**

Job # 10.111289

District: Ft. St. John	Skid No.
Facility: Helmet South Gas Plant	Location (LSD): c-40-G/094-P-07
Vessel Name Equipment Number: Sour Glycol Contactor	
Orientation: Vertical	
Status: Out of Service	Regulatory Inspection

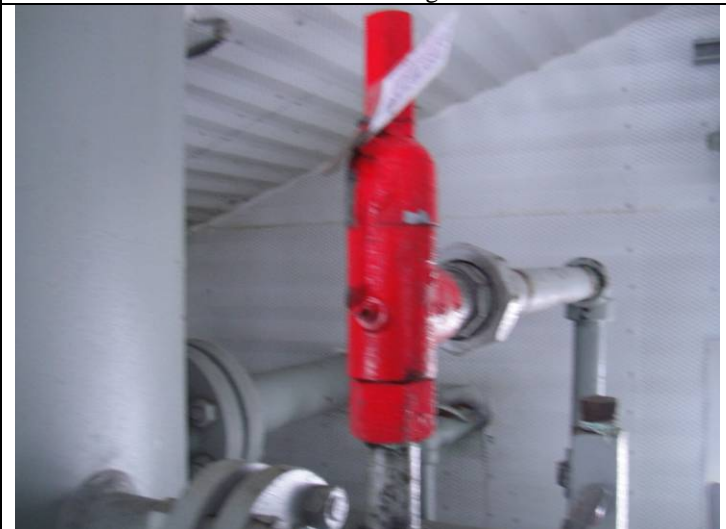
Valving Ensure no leaks are visible. Valves are properly supported and chained if necessary.	X				Valves are properly supported._ No leaks.
PSV Ensure PSV is set at pressure at or below that of vessel. Seal is intact? Supported properly? Discharges to closed header or atmosphere?	X				PSV is located on Outlet piping and is set below the vessel MAWP_ No block valves.
NDE methods Was UT/ MPI /PT conducted on vessel – identify areas. (MI coordinator to review results)				X	None at this time.
Recommendations or corrective actions : Vessel is Fit for Service or describe corrective actions required) (MIC to review corrective actions with Operations, discuss with Chief Inspector where necessary, and get remedial action implemented) Recommendations: None at time of inspection. Summary: Vessel is in overall good condition, visual external carried out.					
Vessel is out of service.
