**Canadian Natural Resources Limited  
GENERAL PRESSURE VESSEL INFORMATION**

**Job: 10.113559**

District: <b>Fort St. John BC.</b>	Skid No.
Facility: <b>Graham Gas Plant</b>	Location (LSD): <b>c-76-K-94-B-08</b>
Vessel Name Equipment Number: <b>Glycol Contactor</b>	
Orientation: <b>Vertical</b>	
Status: <b>In Service</b>	<b>Regulatory Inspection</b>

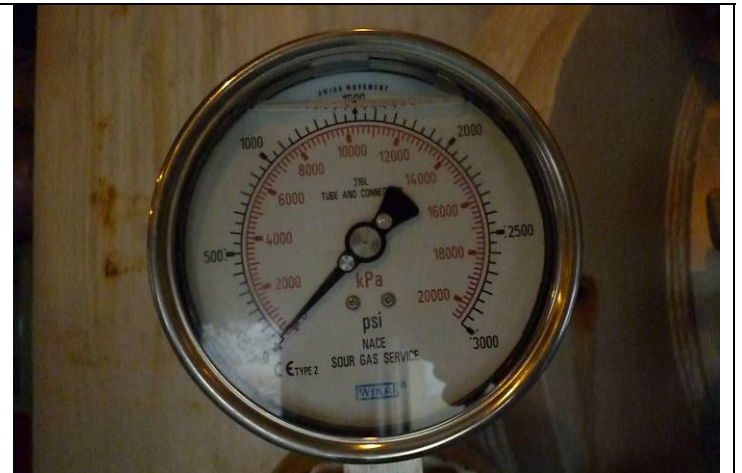
<b>Anchor Bolts</b> Hammer tap to ensure secure. Look for cracking in treads or signs of deformation.	X				<b>Vessel skirt bolted firmly to skid floor – no deformation.</b>
<b>Concrete foundation</b> Check for cracks, spalling, etc.				X	
<b>Ladder / Platform</b> Describe general condition, ensure support is secure to vessel, and describe any hazards.	X				<b>Bolted firmly to shell of vessel. No broken or loose sections. Paint in good condition. No exposed metal.</b>
<b>Nozzle</b> Assess paint, look for leakage, and ensure stud threads are fully engaged. Record any damage, deflection, etc. Are nozzles gusseted?	X				<b>Flanged and threaded nozzle joints are fully engaged. No damage or deflections – no leaks. Nozzles are not gusseted.</b>
<b>Gauges</b> Ensure gauges are visible, working, no leakage, and suitable for range of MAWP/ Temp.	X				<b>Clear and clean- no leaks. Within operational range for service. Pressure gauge 0 – 3000 PSI.</b>

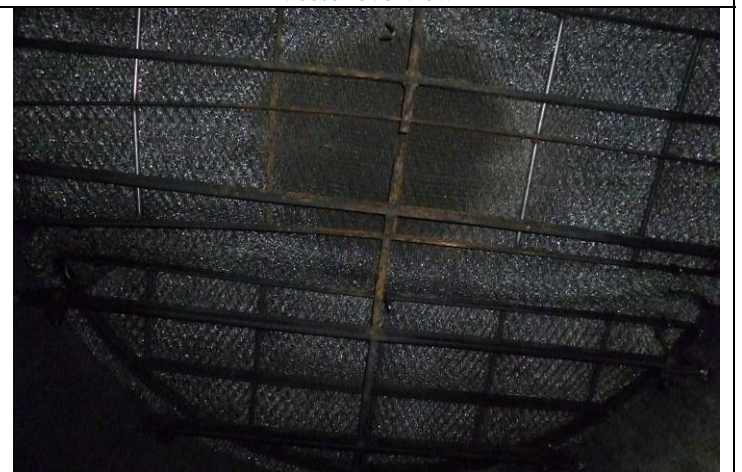
Bottom demister pad

<b>Top Head</b> Note all corrosion, erosion or mechanical damage. (If vessel is horizontal identify direction of this head)	X				Not viewed – demister pad in place.
<b>Bottom Head</b> Note all corrosion, erosion or mechanical damage. (If vessel is horizontal identify direction of this head)	X				Not viewed – no access.
<b>Shell Sections</b> Record number of shell sections. Record location, size and depth of all erosion, corrosion or mechanical damage. Describe general condition. If any corrosion greater than corrosion allowance is observed in either shell or head, discuss with Chief Inspector before closing vessel.	X				In good condition – product scale on surface- welds in good condition. Nozzles unobstructed. Tray attachment welds in good overall condition – no service related damage. Mane way attachment welds in good condition – no corrosion in man ways.
<b>Demister pad</b> Is it in place? Is it clean? If any corrosion is apparent in vessel, lift pad and check top head for corrosion.	X				Top demister pad and bottom demister pad – in place. No open or torn sections – top pad not clean – bottom pad clean. Support bars bolted securely.

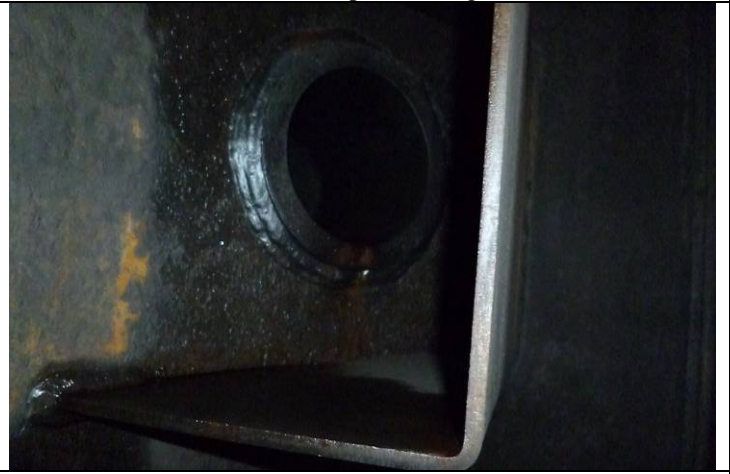
Inlet nozzle and deflector

<b>Internal Inspection Items</b>	<b>G</b>	<b>F</b>	<b>P</b>	<b>N/A</b>	<b>Comments</b>
<b>Coating</b> Assess coating. Describe area coated, general condition of coating.				X	Vessel not coated.
<b>Anodes.</b> How many, type, condition. % consumed. Are they being replaced?				X	None.
<b>Internal Piping</b> Is there any? If so, carbon or stainless steel. Describe condition, dents, corrosion, erosion, etc. Ensure supports are secure and any bolts are suitable for future use.	X				Piping in place – no dents or deflections. No corrosion or erosion.
<b>Trays</b> How many? Type of material. Are valves in place? Check for erosion/ corrosion; wear on tray valve legs. Cleanliness?	X				Top tray – in place no bent or loose sections caps in place. Mid section tray not bent – clips secure. Bottom down comer in good condition. Mid tray covered with water. Trays were not remove for inspection.
<b>Baffles, deflector plates, etc.</b> If present, describe condition. Look closely at welds attached to vessel wall.	X				Deflector plate welded to shell – no erosion.

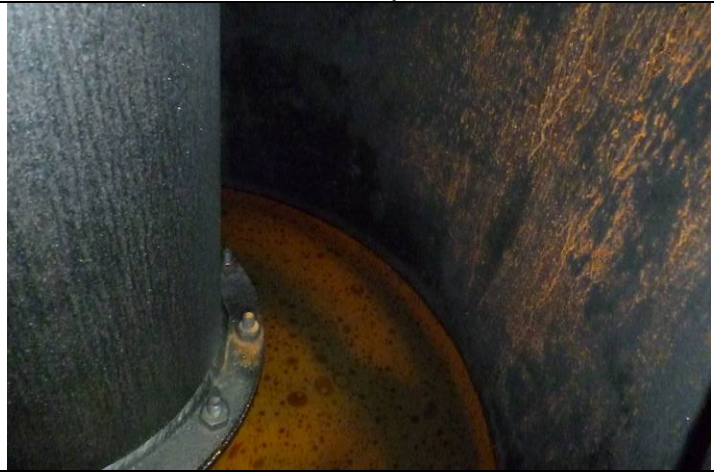
Water at bottom chimney

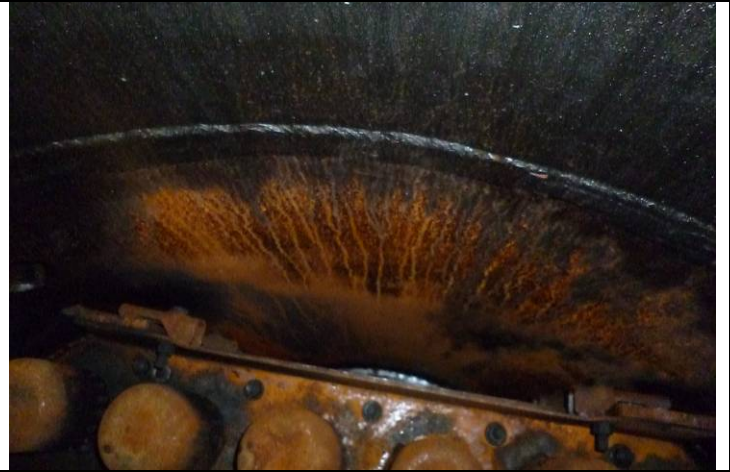
Shell weld

<b>Welds</b> Inspect all welds, including attachment welds. Record all service-related damages and if there is any discuss with Chief Inspector before closing.	X				No corrosion or erosion noted. No service related damage. Welds in good condition.
<b>Repairs Required.</b> If yes, ensure procedure and copy of AB 40 is on file, and one sent to local ABSA, and Chief Inspector				X	
<b>NDE</b> Was any NDE done. ( MI coordinator to review results)					
<p><b>Recommendations or corrective actions : Vessel is Fit for Service or describe corrective actions required)</b> (MIC to review corrective actions with Operations, discuss with Chief Inspector where necessary, and get remedial action implemented)</p> <p><b>Recommendations: No recommendations at this time.</b></p> <p><b>Summary: This vessel is in good condition, visual external and ultrasonic thickness inspection carried out – pipe metal thickness detected below nominal minus corrosion allowance. Thickness calculations carried out to ensure sufficient metal exists for safe operation.</b></p> <p><b>Corrosion rate based on greatest thickness loss (nozzle) 0.026mm per year. Retirement Date to “T”min is year 2123.</b></p> <p><b>Vessel is fit for service.</b></p>

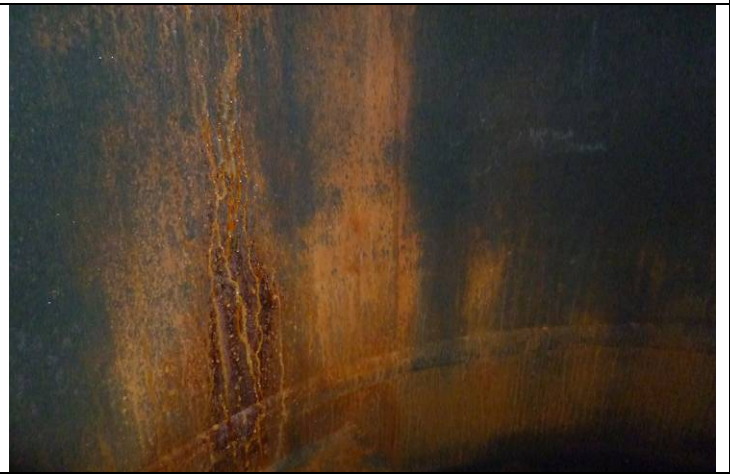
Shell scale
