Canadian Natural Resources Limited GENERAL PRESSURE VESSEL INFORMATION Job # 05.002122											
District: Fort St J		Skid No.									
Facility: Caribou	Compressor Station		Location (LSD): d-62-C/94-A-16								
Vessel Name Equ	ipment Number: Glycol	Contactor									
Orientation: Vert	ical										
Status: In Se	rvice		Regulatory Inspection								
		PRESSURE VESS	SEL N	AMEPLATE DA	TA						
"A" or "G" or "S" (Sask.) or BC Registration Number. A 3098592				CRN Number <b>M-2316.21</b>							
Vessel serial num		Size: 23 in X 32 ft									
Shell thickness: 2		Shell material: SA 516 70MT									
Head thickness: 3		Head material: SA 516 70MT									
Tube wall thickne Tube diameter:		Tube material:									
Channel thickness		Tube length: Channel material:									
	Shell: 1440 PSI										
MAWP	5101.1440151			Operating pressure		Shell:					
	Tubes:						Tubes:				
Design Tomp	Shell: 130 deg F			Onenetine temp	Shell:

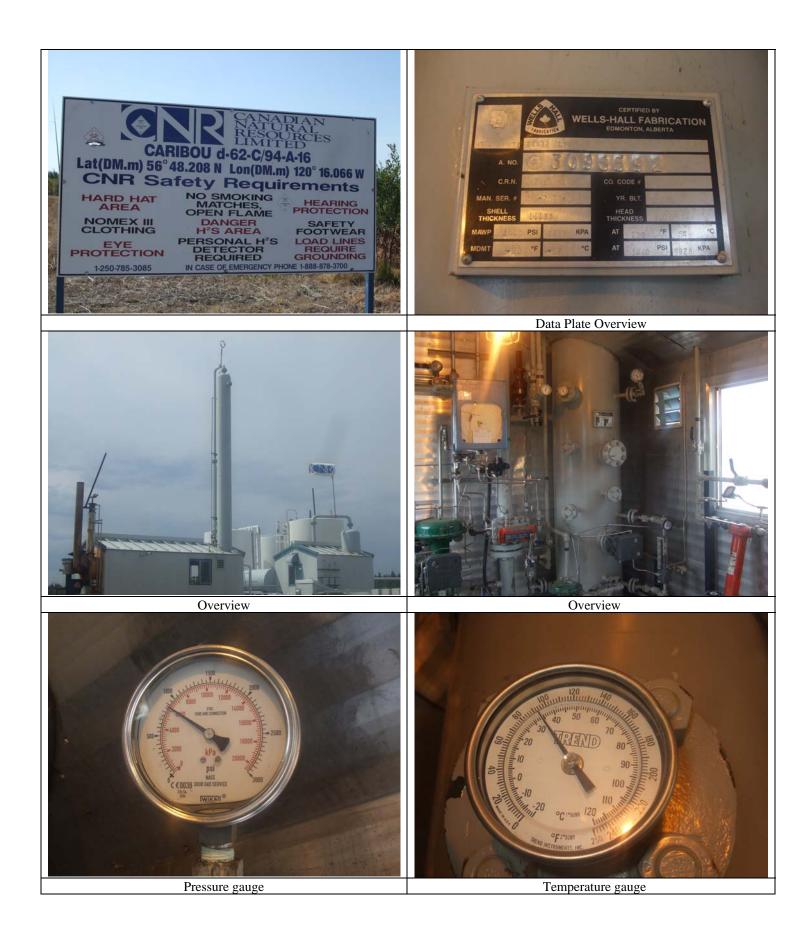
**Summary:** This vessel is in good condition, visual external and ultrasonic thickness inspection carried out – No metal thickness detected below nominal minus corrosion allowance.

Vessel is fit for service.

**Recommendations:** 1) No recommendations at this time.
