**Canadian Natural Resources Limited  
GENERAL PRESSURE VESSEL INFORMATION**

**Job # 10.110039**

District: <b>Fort St John, B.C.</b>	Skid No.
Facility: <b>Caribou Compressor Station</b>	Location (LSD): <b>d-62-C/94-A-16</b>
Vessel Name Equipment Number: <b>Glycol Contactor</b>	
Orientation: <b>Vertical</b>	
Status: <b>In Service</b>	<b>Regulatory Inspection</b>

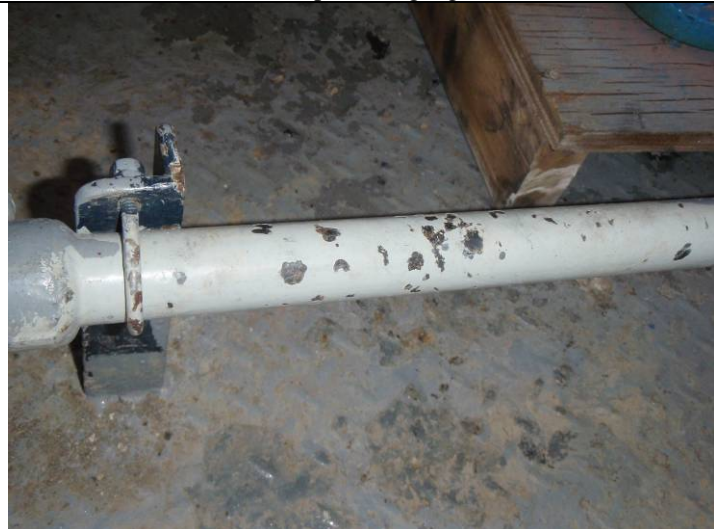
Paint chips on attached piping
