**CORROSION SURVEY  
CNRL**

District	LSD	Vessel Name	Vessel Number	Serial Number
BULRUSH 89F	00-00-000-0000	GLYCOL CONTACTOR	A3098509	95-7937-0

## Vessel External Inspection Report

Client:	CNRL	District:	Bullrush	Date:	14-Mar-2023	
Surface LSD:	B-88-F/94-A-16	Downhole LSD:	N/A	Skid #:	N/A	
Description:	Glycol Contactor		RT:	1	HT:	Yes
Jur #:	A3098509	Equipment #:	N/A		CRN:	M 2316.21
MFR:	Wells Hall Fabrication	MFR S/N:	95-7937-0			
NB #:	N/A	Year Built:	1995		O.D.:	24 in
Shell MAWP:	1440 psi	Shell MAWT:	130 °F		Shell MDMT:	-20 °F
Tube MAWP:	N/A	Tube MAWT:	N/A		Tube MDMT:	N/A
Shell OP Pressure:	800 psi	Shell OP Temp:	80 °F		Manway (size):	N/A
Tube OP Pressure:	N/A	Tube OP Temp:	N/A		Cor. Allowance:	N/A
Head Type:	Ellipsoidal	Head Material:	N/A		Head Nominal:	1.086 in
Shell type:	Plate	Shell Material:	N/A		Shell Nominal:	1.125 in
Status:	Operating	External Insulation:	No		Orientation:	Vertical

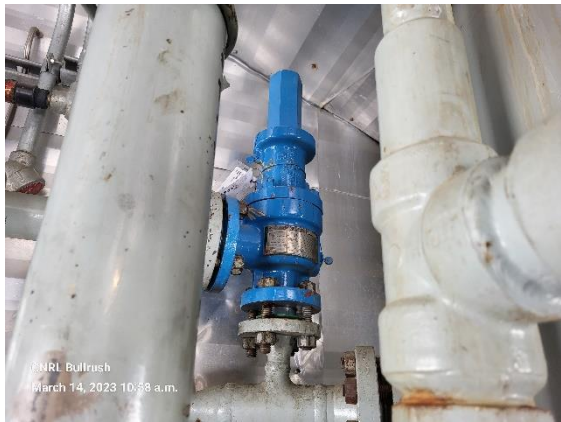
**PSV overview**

PSV#:	FSJ 7677	Make/Model:	26EA13-120	CRN:	0G2369.5C
MFR:	Farris	MFR S/N:	CE-42794-1-A10	MFR Date:	N/A
Service Co.:	Unified Valve	Service Tag #:	1883V	Last Service:	8/28/2017
Set:	1440 psi	Cap:	5650 scfm	PSV Side:	Shell
Code:	NB / UV	Location:	Outlet piping	Vented to:	Atmosphere
Cap Seal:	Intact	Nameplate:	Secure, Legible	Drainage:	Good, no concerns
Properly Supported:	Yes	External Body Condition:	Good, no concerns		
	Size:	Type:	Block Valve:	Locked / Carsealed:	
Inlet:	1.00 in	Flanged	No	N/A	
Outlet:	2.00 in	Flanged	No	N/A	
PSV Comments:	Good overall condition. Properly supported in the upright position - set at vessel MAWP. PSV last serviced 2017. Check PSV service intervals, re-service as required.
