**Canadian Natural Resources Limited
GENERAL PRESSURE VESSEL INFORMATION**

District: Grande Prairie, AB	Skid No.
Facility: North Tony Creek Gas Gathering	Location (LSD): 16-07-65-20-W5M
Vessel Name Equipment Number: Glycol Contactor.	
Orientation: Vertical	
Status: Not in service. (No blind flanges)	Regulatory Inspection

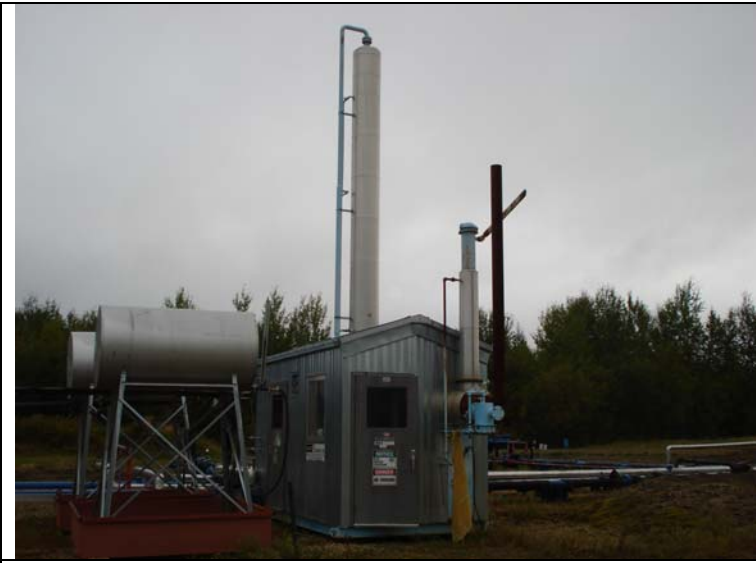
Overview.

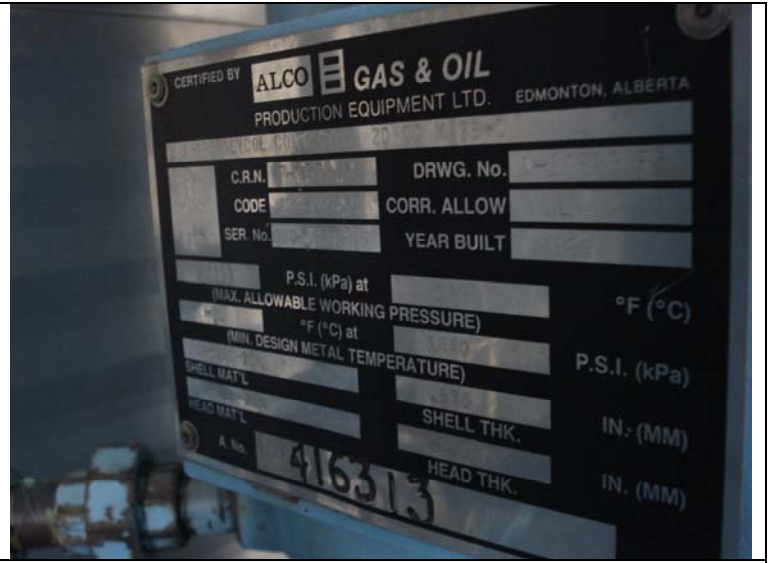
Data Plate

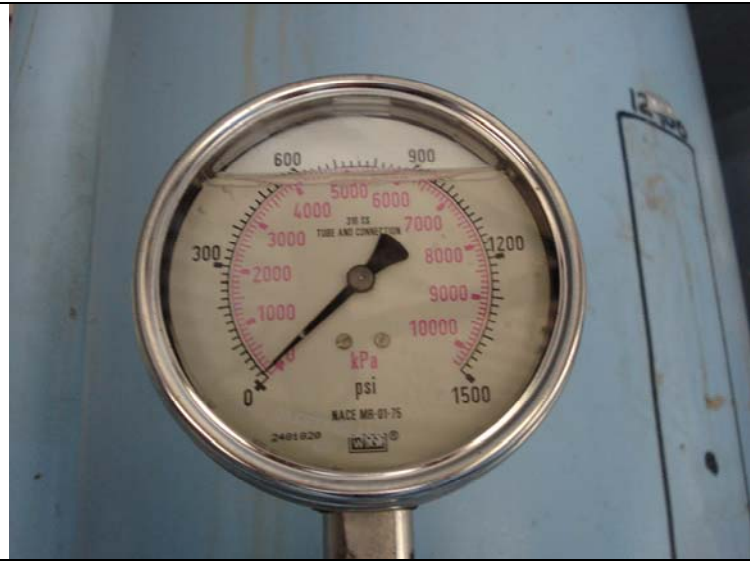
Pressure Gauge

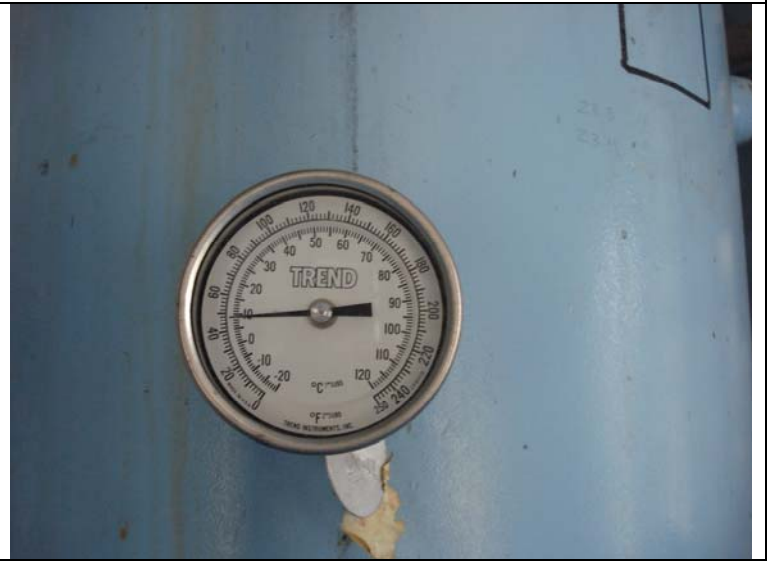
Temp Gauge

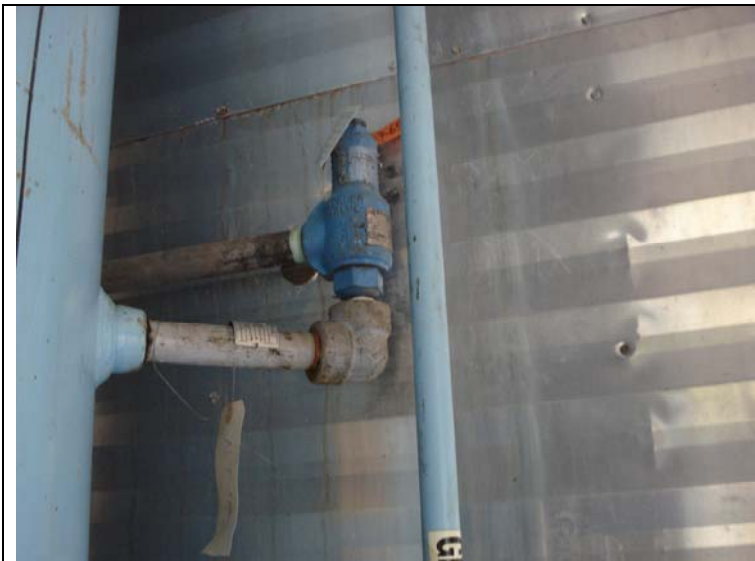
PSV location

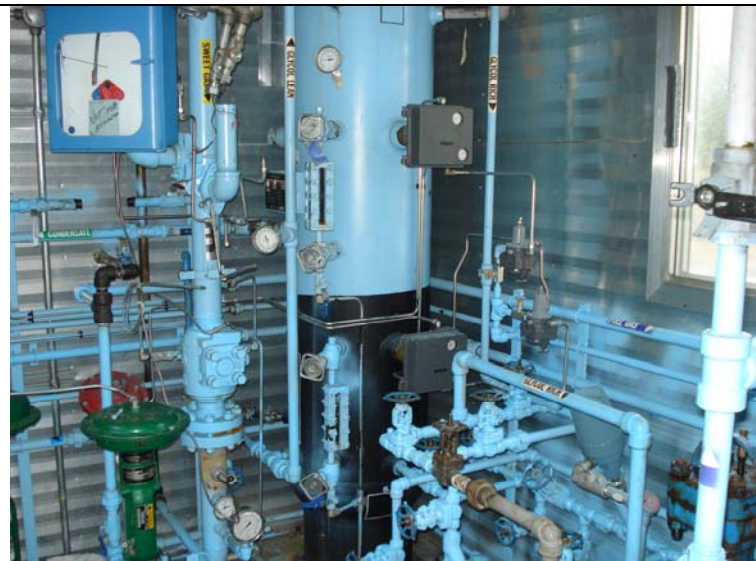
View of shell below roof.
