**Canadian Natural Resources Limited
GENERAL PRESSURE VESSEL INFORMATION**

Job 10.114702

District: Fort Saint John, B.C.	Skid No.
Facility: Wolverine	Location (LSD): d-66-D / 93-P-02
Vessel Name Equipment Number: Glycol Contactor	
Orientation: Vertical	
Status: In Service	Regulatory Inspection

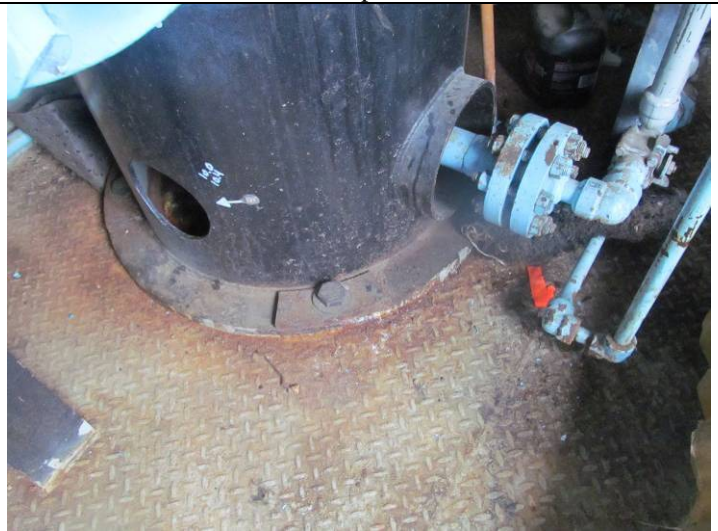
Skirt

Anchor Bolts Hammer tap to ensure secure. Look for cracking in treads or signs of deformation.	X				Vessel skirt bolted firmly to skid – no deformation.
Concrete foundation Check for cracks, spalling, etc.				X	
Ladder / Platform Describe general condition, ensure support is secure to vessel, and describe any hazards.				X	
Nozzle Assess paint, look for leakage, and ensure stud threads are fully engaged. Record any damage, deflection, etc. Are nozzles gusseted?	X				Flanged and threaded nozzle joints are fully engaged. No damage or deflections – no leaks. Nozzles are not gusseted.
Gauges Ensure gauges are visible, working, no leakage, and suitable for range of MAWP/ Temp.	X				Pressure gauge: 0 to 2000 PSI. Temperature gauge: 0 to 250 deg F.
External Piping Ensure pipe is well supported. All clamps, supports, shoes, etc. in place. Look for evidence of structural overload, deflection, etc. Paint condition, external corrosion?	X				Piping is well supported, no deflection, all clamps and supports are in place. Piping is painted – no exposed metal surface.

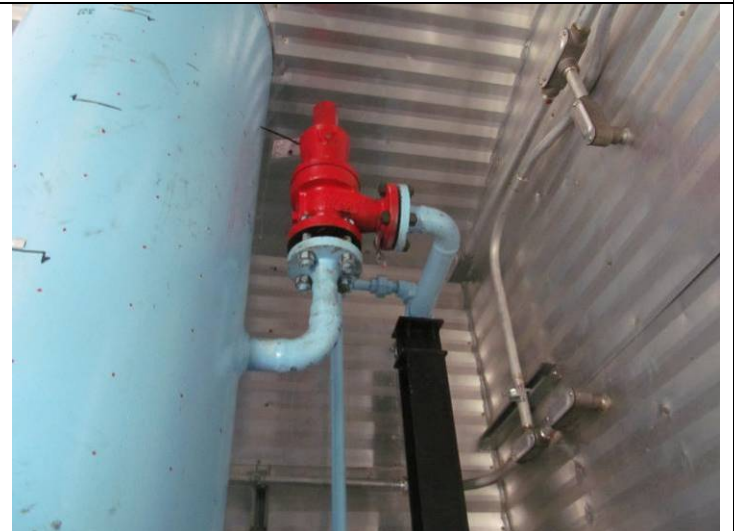
Valving Ensure no leaks are visible. Valves are properly supported and chained if necessary.	X				Valves are supported properly – no leaks.
PSV Ensure PSV is set at pressure at or below that of vessel.	X				Located on lower shell – set at MAWP of vessel. No block valve / seal intact / outlet piping is same size as orifice – discharges to closed header.
NDE methods Was UT/ MPI done on vessel (MI coordinator to review results)	X				Ultrasonic corrosion survey carried out – no metal thickness detected below nominal minus corrosion allowance – no pitting.
<p>Recommendations or corrective actions : (Vessel is Fit for Service or describe corrective actions required) (MIC to review corrective actions with Operations, discuss with Chief Inspector where necessary, and get remedial action implemented) Recommendations: 1. No recommendations. Summary: This Glycol Contactor is in good condition, visual external and ultrasonic thickness inspection carried out – no metal thickness detected below nominal minus corrosion allowance. Corrosion rate based on greatest thickness loss (head) 0.060mm per year. Retirement Date to “T”min is year 2089.</p> <p>Vessel is fit for service.</p>

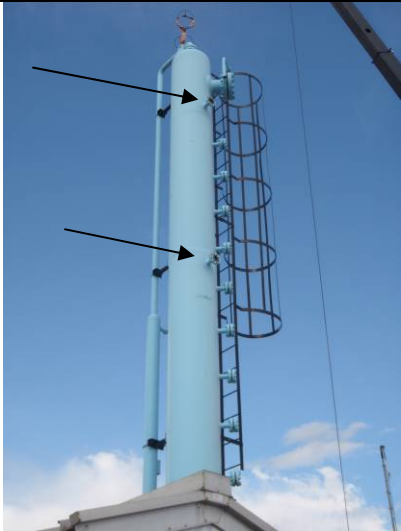
Internal Inspection Items	G	F	P	N/A	Comments
Coating Assess coating. Describe area coated, general condition of coating.	X				Not coated
Anodes. How many, type, condition. % consumed. Are they being replaced?				X	none
Internal Piping Is there any? If so, carbon or stainless steel. Describe condition, dents, corrosion, erosion, etc. Ensure supports are secure and any bolts are suitable for future use.	X				Borescope viewed two 1 inch glycol coils; one at the top tray and one at the bottom shell – appeared to be in good condition - no corrosion or mechanical damage found
Trays How many? Type of material. Are valves in place. Check for erosion/ corrosion; wear on tray valve legs. Cleanliness?	X				Using the borescope <u>two</u> trays were inspected; the top tray and middle tray – trays appeared in good condition – found to be clean with no mechanical damage or corrosion to the trays or bubble caps

Trays were viewed using 2 inch nozzle access

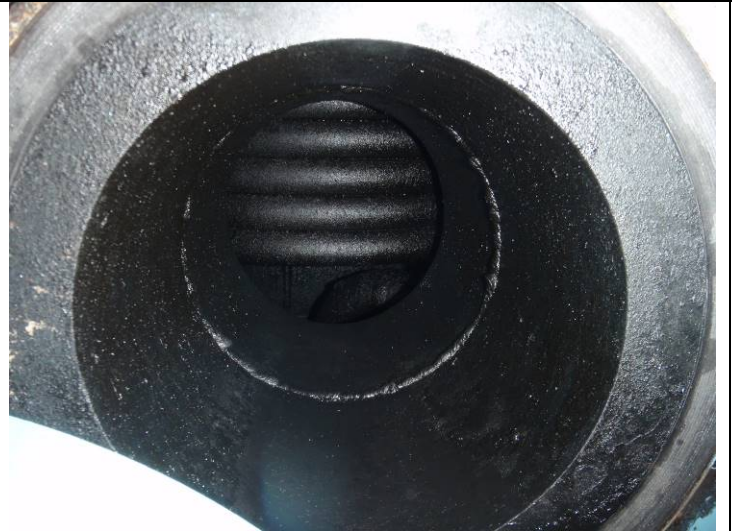
8 inch nozzle at bottom shell and glycol pass

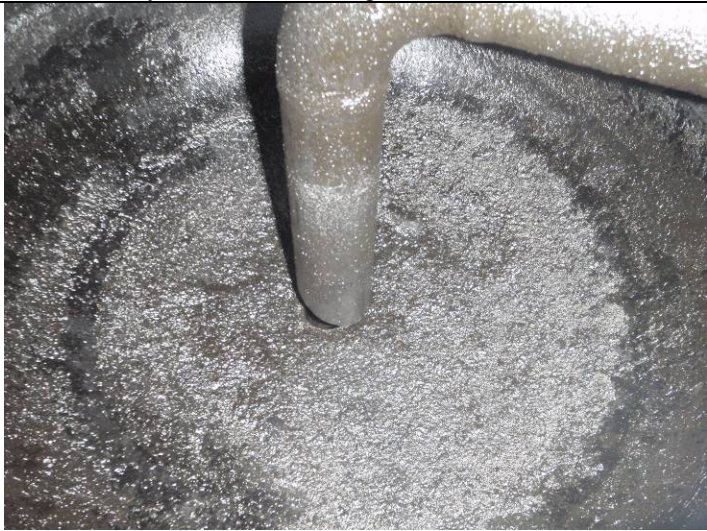
Baffles, deflector plates, etc. If present, describe condition. Look closely at welds attached to vessel wall.	X				Baffle found near bottom head – appears to be in good condition – no corrosion or distortion
Top Head Note all corrosion, erosion or mechanical damage. (If vessel is horizontal identify direction of this head)				X	Not viewed
Bottom Head Note all corrosion, erosion or mechanical damage. (If vessel is horizontal identify direction of this head)	X				Bottom head appears in good overall condition – no corrosion or mechanical damage noted
Shell Sections Record number of shell sections. Record location, size and depth of all erosion, corrosion or mechanical damage. Describe general condition. If any corrosion greater than corrosion allowance is observed in either shell or head, discuss with Chief Inspector before closing vessel.	X				Shell is in good condition where view with borescope – no corrosion or mechanical damage found
