Canadian Natural Resources Limited GENERAL PRESSURE VESSEL INFORMATION								Job # 10.111424
District: <b>Grande Prairie, AB</b>				Skid No.				
Facility: <b>Waskahigan Battery</b>				Location (LSD): <b>06-14-63-24-W5M</b>				
Vessel Name & Equipment Number: <b>Glycol Contactor</b>				Moved from Ante Creek field to site				
Orientation: <b>Vertical</b>								
Status: <b>Not In Service</b>				Regulatory Inspection				
PRESSURE VESSEL NAMEPLATE DATA								
Registration Number <b>A0416743</b>				CRN Number <b>F 9578.231</b>				
Vessel serial number: <b>97C-5832-09B</b>				Size: <b>20 in. x 29 ft.</b>				
Shell thickness: <b>22.2 mm</b>				Shell material: <b>SA 516 70N</b>				
Head thickness: <b>20.8 mm</b>				Head material: <b>SA 516 70N</b>				
Tube wall thickness:				Tube material:				
Tube diameter:				Tube length:				
Channel thickness:				Channel material:				
Design pressure	Shell: <b>1440 PSI</b>			Operating pressure	Shell:

Inspected By: Dellas Wiedman

Date: Feb 15, 2012

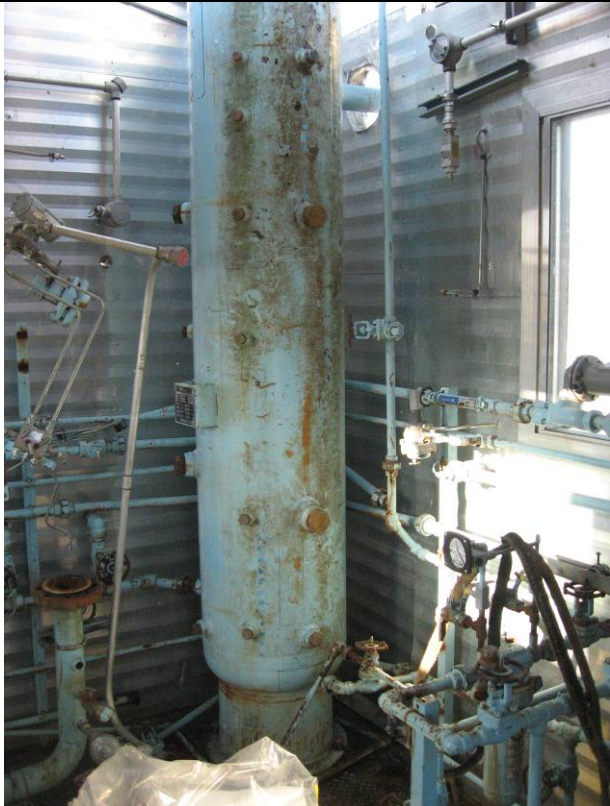
Skirt and lower shell – dirt, not corrosion
