**Canadian Natural Resources Limited
GENERAL PRESSURE VESSEL INFORMATION**

Job # 105.00151

District: Grande Prairie AB.	Skid No.
Facility: Bonanza Compressor Site	Location (LSD): 13-34-81-11W6M
Vessel Name Equipment Number: Glycol Contactor	
Orientation: Vertical	
Status: In Service	Regulatory Inspection

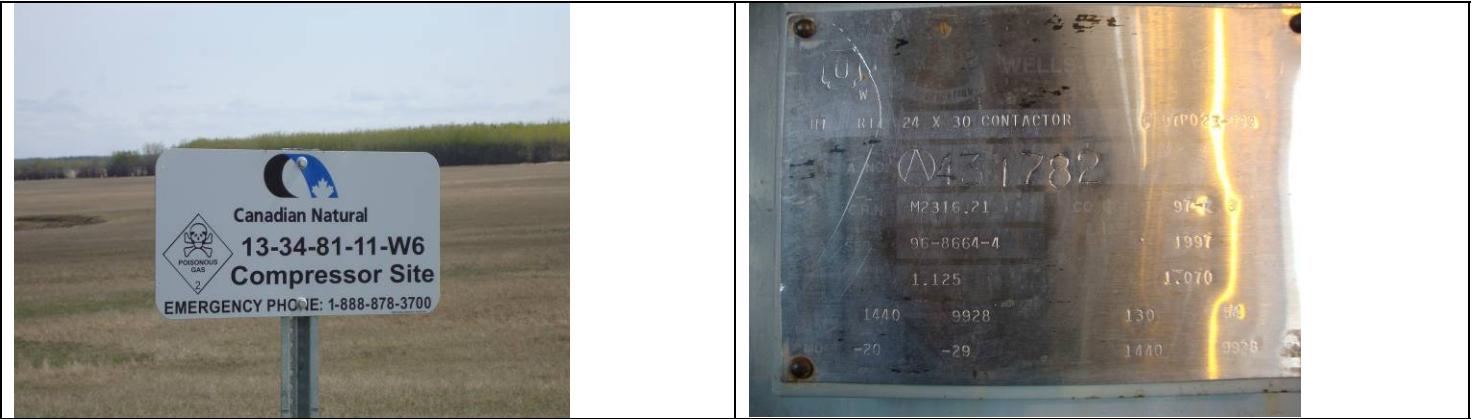
LSD

Vessel data

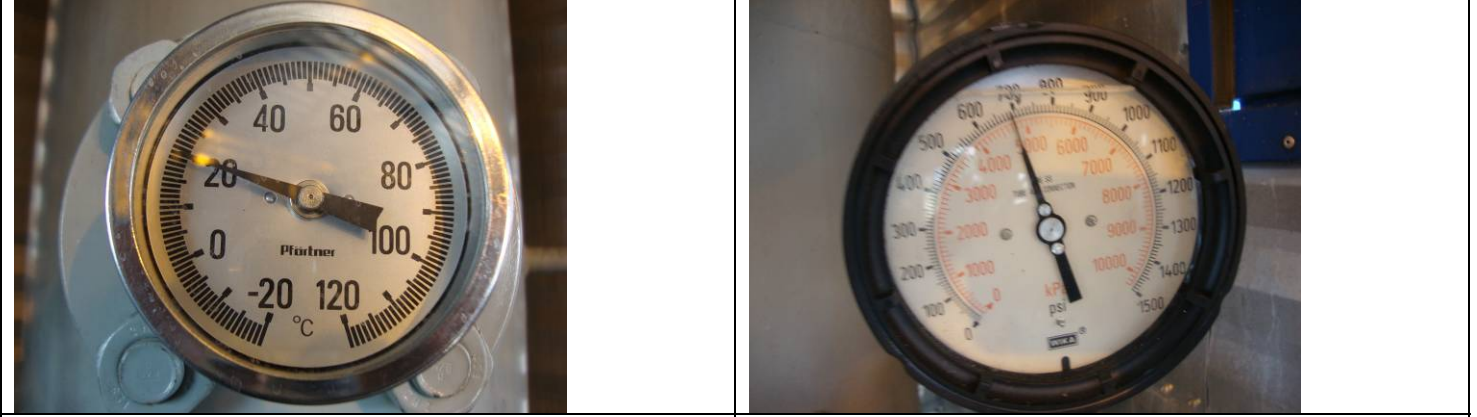
Vessel temperature gauge

Vessel pressure gauge

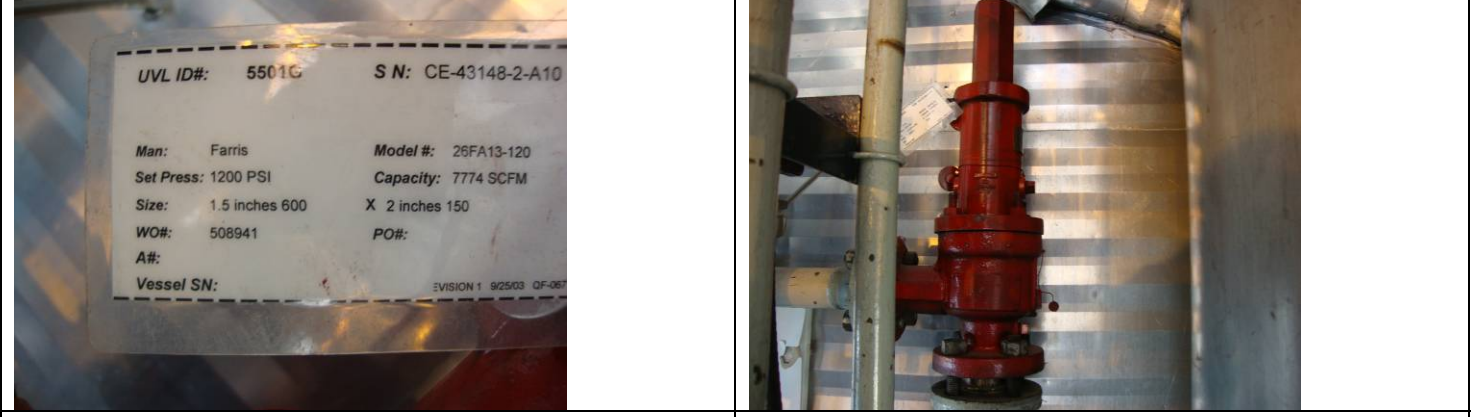
PSV data tag

Vessel PSV

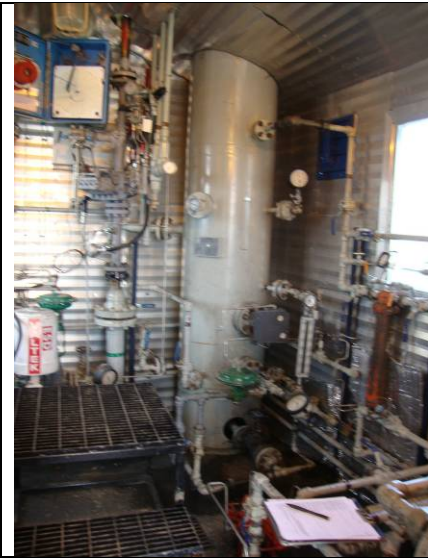
Vessel overview

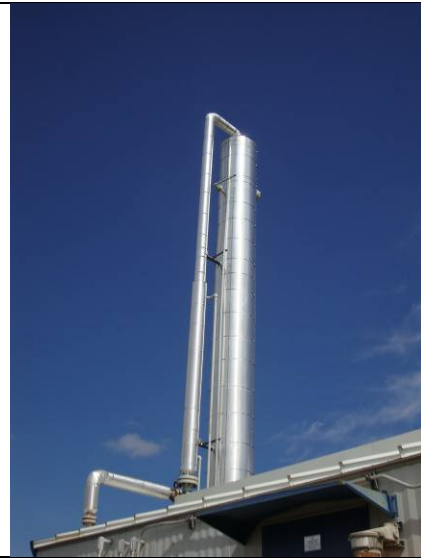
Vessel overview
