**Canadian Natural Resources Limited
GENERAL PRESSURE VESSEL INFORMATION**

Job # 10.110194

District: Ft. St. John, BC	Skid No.
Facility: Inga Battery	Location (LSD): 06-19-88-23 W6M
Vessel Name Equipment Number: Glycol Contactor	
Orientation: Vertical	
Status: In Service	Regulatory Inspection

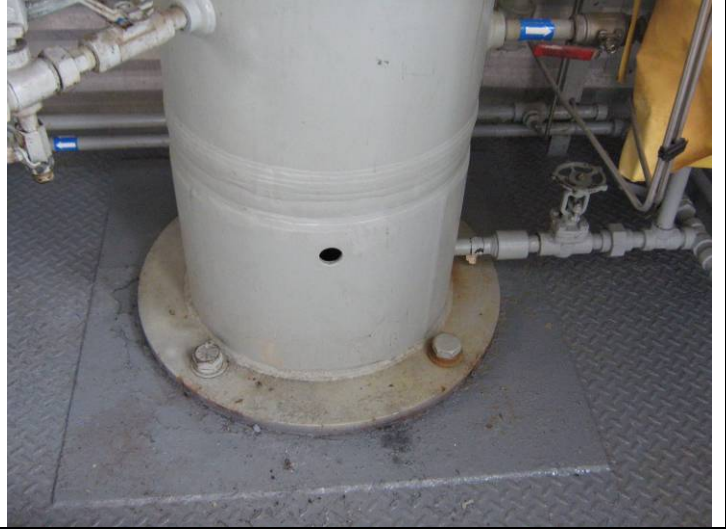
External Inspection Items	G	F	P	N/A	Comments
Insulation Verify sealed around manways, nozzles, no damage present, and there is no egress of moisture.		X			Vessel is not insulated. Roof closure is not sealed – egress of moisture.
External Condition Assess paint condition, areas peeling, record any corrosion, damage, etc (record location, size and depth of corrosion or damage)	X				Paint in good condition – no exposed metal. No corrosion. No damage.
Leakage Record any leakage at flanges, threaded joints, weep holes on repads, etc.	X				No leaks observed.
Saddle/Skirt Assess condition of paint, fire protection, concrete. Look for corrosion, buckling, dents, etc. Look at vessel surface area near supports. Verify no signs of leakage at attachment to vessel and attachment welds are acceptable. Ground wire attached?	X				Skirt is bolted to skid floor. No evidence of corrosion at shell to skirt weld – no leaks. No distortion. No buckles. Paint in good condition – no exposed metal. Skid package is mounted on pilings at ground level. Skid package has ground wire attached.

Roof closure not sealed – egress of moisture

Recommendations: 1. Seal roof closure Summary: Vessel is in overall good condition, visual external inspection and ultrasonic corrosion survey performed – no metal thickness detected below nominal minus corrosion allowance. Long term corrosion rate based on greatest thickness loss (head) 0.157mm per year. Retirement Date to “T”min is year 2049. Vessel is fit for service.
